**AC Inspection as Found**  
**ALCOA REMEDIATION**  
1401 BAUXITE CUTOFF  
BAUXITE, AR 72011

**AC Inspection - Rev. 2**

**Description:** 75 HP PACEMAKER

**Hi-Speed Job Number:** 104397

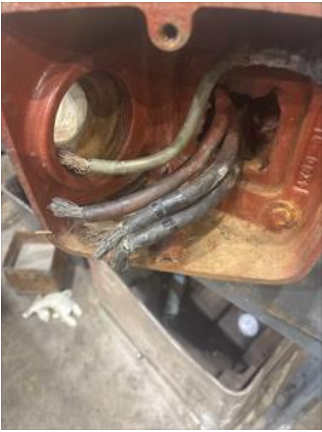
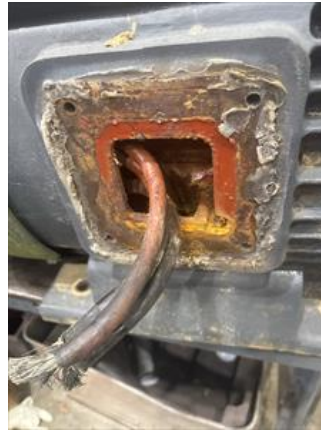
P69

14. Lead Condition

(P) Pass

Short

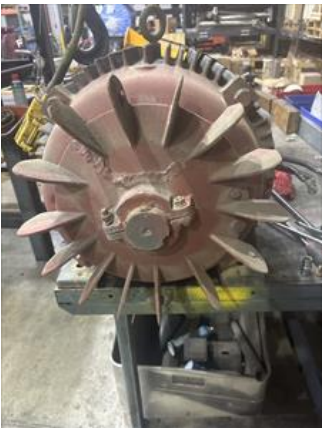
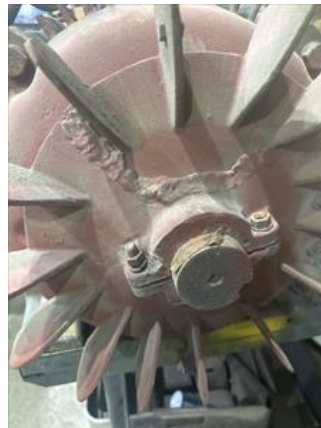
P115

20. Fan Condition

Fan has been cracked and welded previous repair.had shim between fan bore and shaft.

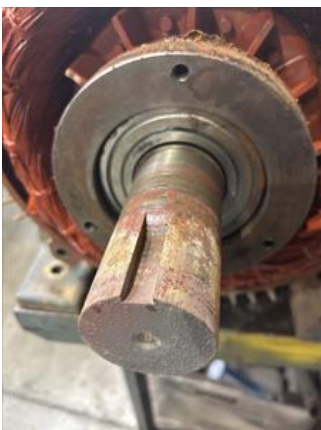
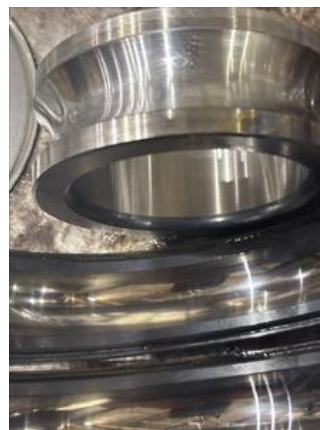
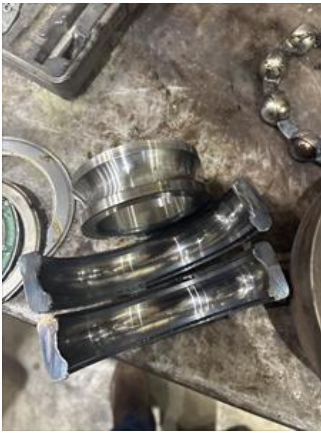
31. Drive End Bearing Number-	<b>6313</b>
32. Drive End Bearing Qty.	<b>1</b>
33. Drive End Bearing Type	<b>(Ball) Ball Bearing</b>
34. Drive End Lubrication Type	<b>(Grease) Grease Lubricated</b>
35. Drive End Bearing Insulation or Grounding Device?	<b>na</b>
36. Drive End Wavy Washer/Snap-Ring Other Retention Device?	<b>no</b>
37. Drive End Bearing Condition	<b>normal wear</b>

*Normal bearing wear and dirty.***Dynamic Balance Report**

1-6313

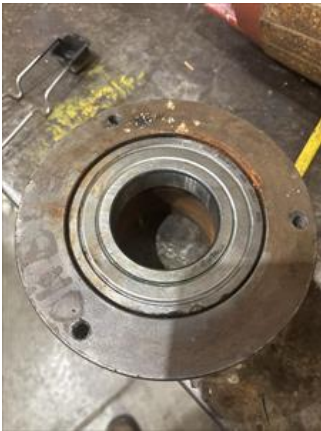
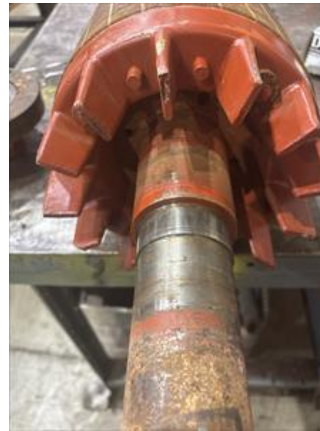
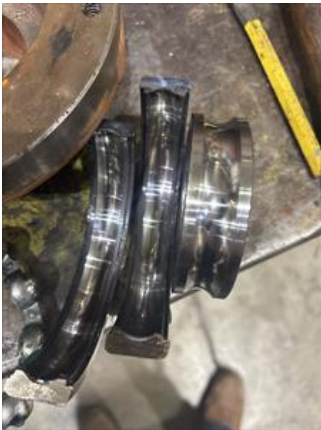
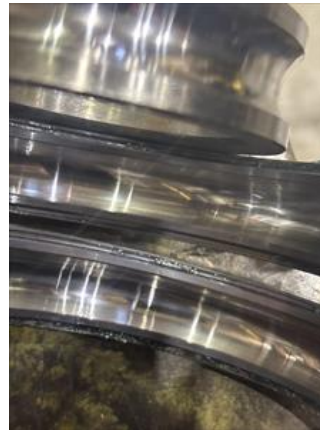
38.	Opposite Drive End Bearing Brand		
39.	Opposite Drive End Bearing Number-	6213	
40.	Opposite Drive End Bearing Qty.	1	
41.	Opposite Drive End Bearing Type	(Ball) Ball Bearing	
42.	Opposite Drive End Lubrication Type	(Grease) Grease Lubricated	
43.	Opposite Drive End Bearing Insulation or Grounding Device?	na	
44.	Opposite Drive End Wavy Washer/Snap-Ring Other Retention Device?	na	
45.	Opposite Drive End Bearing Condition	normal wear	P117

1-6213

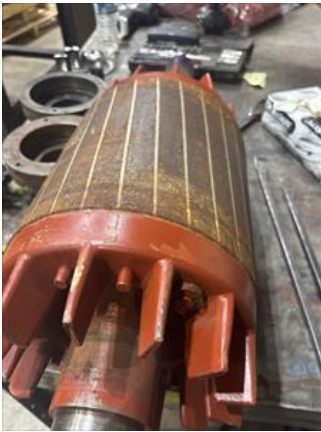
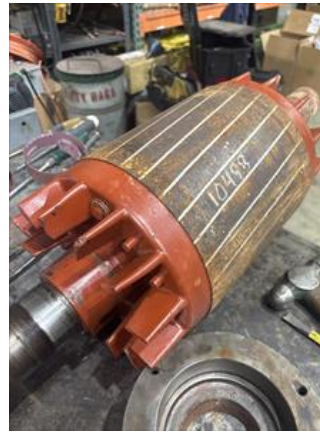
P41

51. Rotor Condition

iron rust
