AC Inspection as Found

Arkansas Lime Company 600 Limedale Rd

AC Inspection - Rev. 2

Description:250 HP TOSHIBA

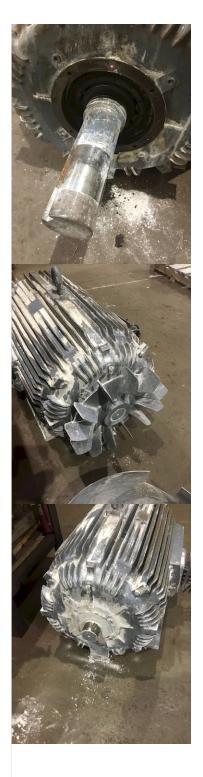
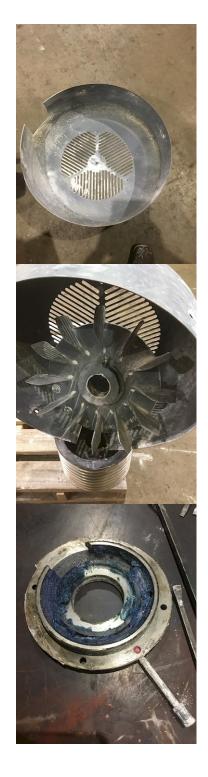
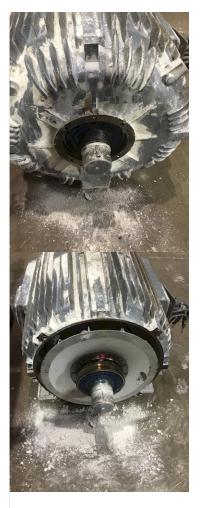
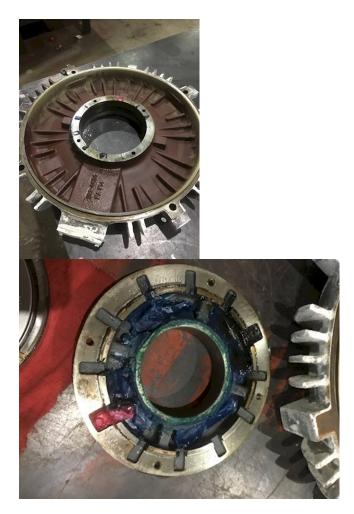
3. Photos of all six sides of the machine.

Describe the Overall Condition of the Equipment as Received Dirty

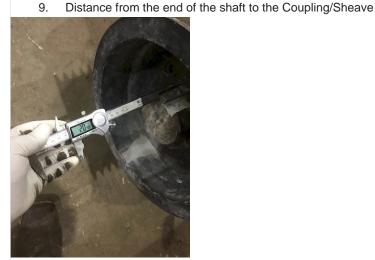
In	itial	Mechanical/Electrical	6
	5.	Does Shaft Turn Freely?	(Y) Yes
	6.	Does the shaft require T.I.R in Lathe to identify additional repairs?	(No) No
	7.	Does Shaft Have Visible Damage?	(Yes) Yes P26

8. Assembled Shaft Runout0.001 Inches

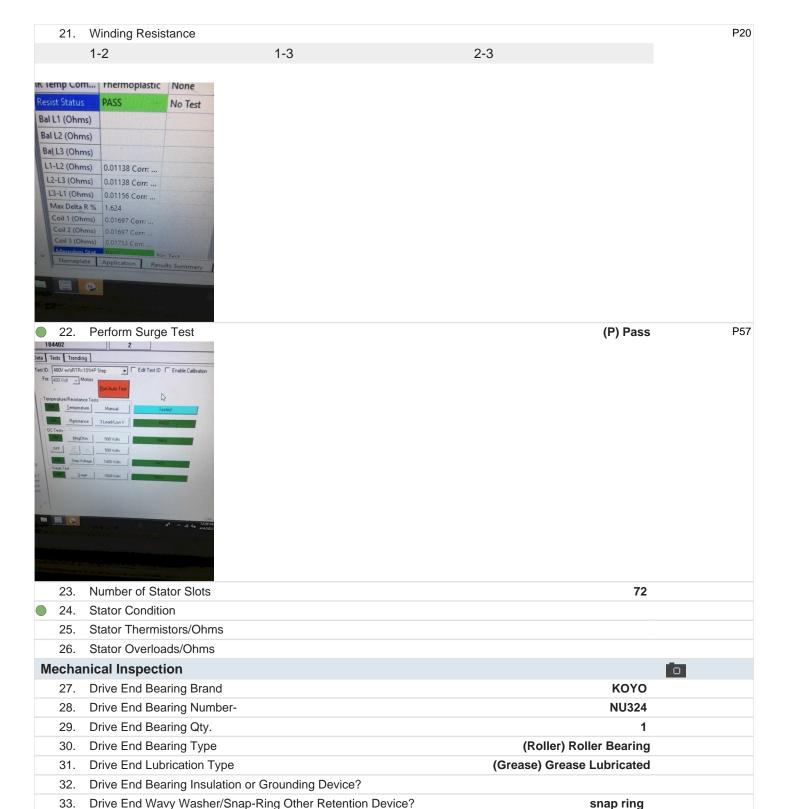
Insulation Resistance/Megger

Contamination
