AC Inspection as Found

Sage V Foods

Description: 20 HP BALDOR

Hi-Speed Job Number: 104421

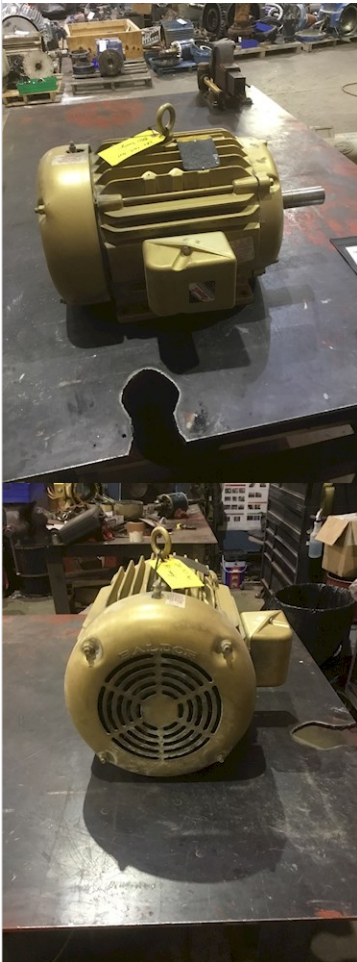
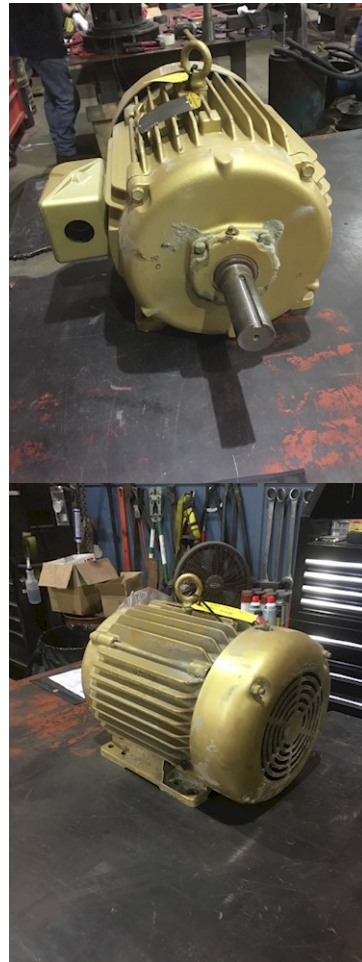
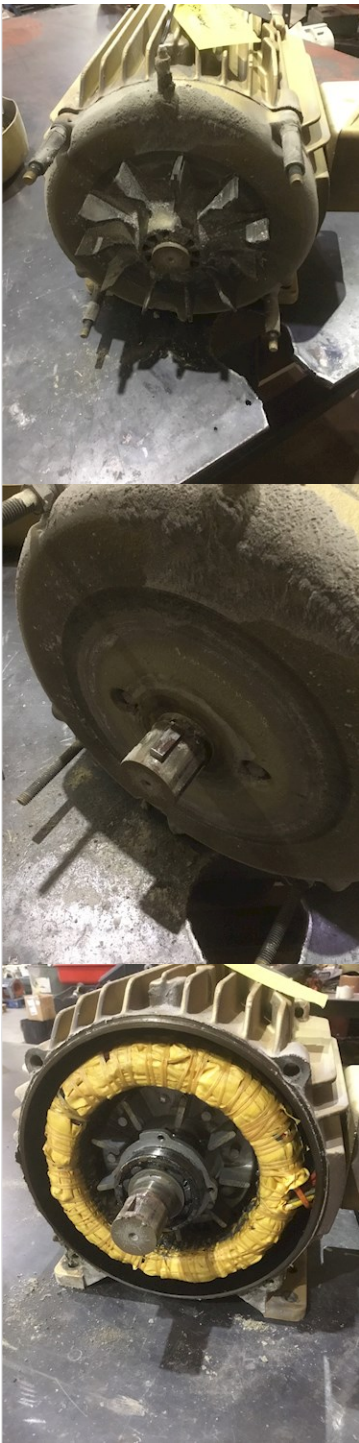
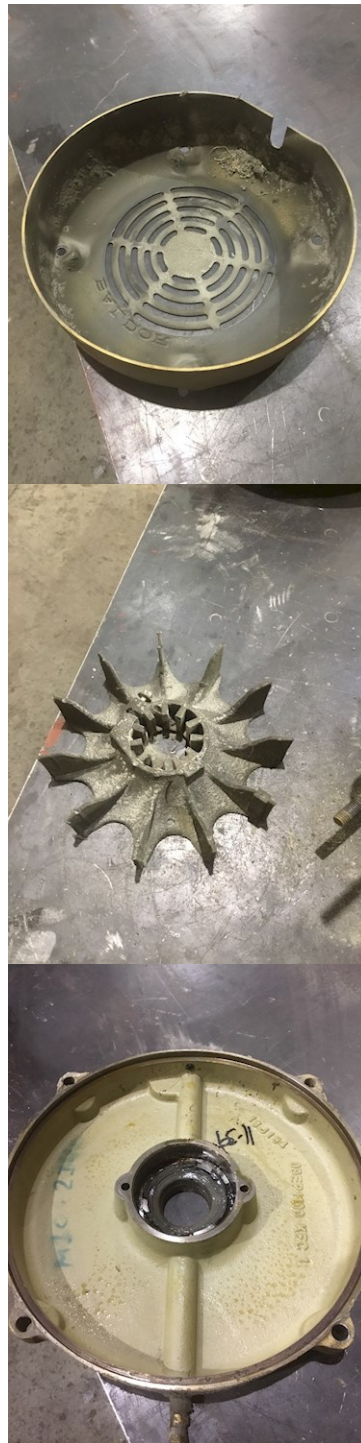
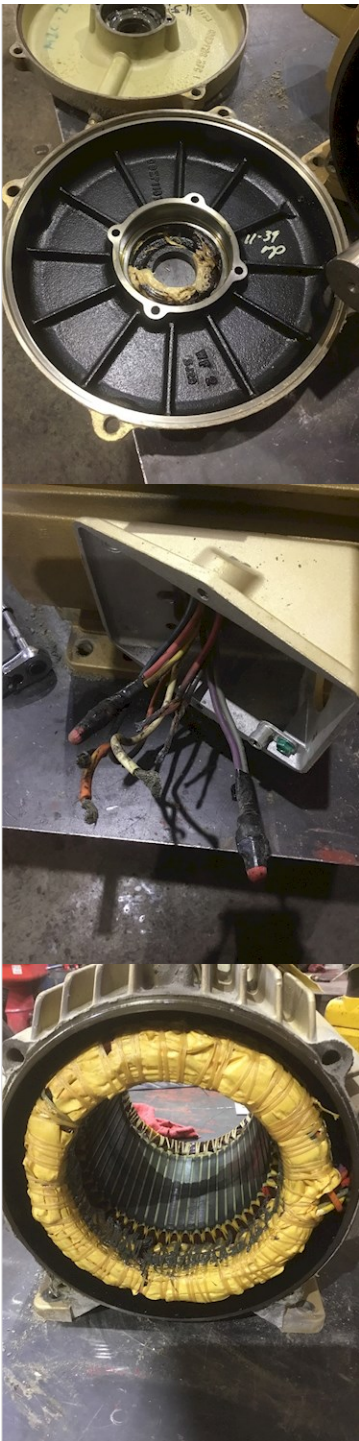
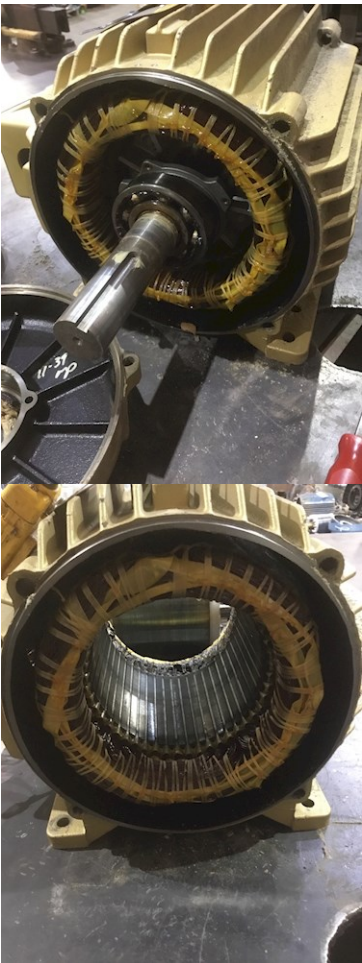
3. Photos of all six sides of the machine.

4.	Describe the Overall Condition of the Equipment as Received	
	<i>Dirty</i>	
5.	Is this a UL Listed Motor	(No) No
6.	Is the motor water cooled or can be pressure checked before teardown	(No) No
Initial Mechanical/Electrical

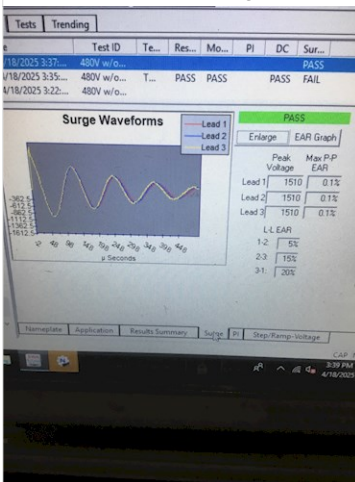
24. Perform Surge Test

(P) Pass

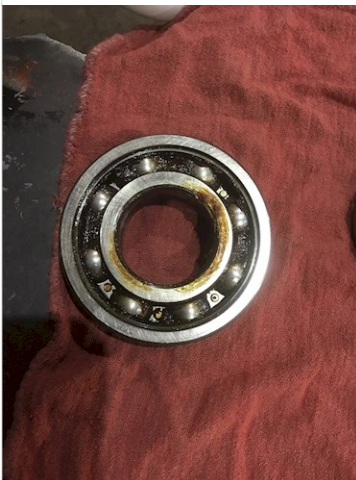
31.	Drive End Bearing Qty.	1	
32.	Drive End Bearing Type	(Ball) Ball Bearing	
33.	Drive End Lubrication Type	(Grease) Grease Lubricated	
34.	Drive End Bearing Insulation or Grounding Device?		
35.	Drive End Wavy Washer/Snap-Ring Other Retention Device?		
36.	Drive End Bearing Condition		P83

<div> <div></div> Co sign: DM </div>		
Root Cause of Failure			
70.	Failure locations <i>Bearings and lead connections</i>

71.	Root cause of failure <i>Loose connection and fluting</i>		
Dynamic Balance Report

45.	Drive End Seal	
	<i>Slinger</i>	
46.	Opposite Drive End Seal	
Rotor Inspection		
47.	Rotor Type/Material	(Squirrel Aluminum) Squirrel Cage Aluminum Die Cast
48.	Growler Test	(Pass) Pass
49.	Number of Rotor Bars	40
50.	Rotor Condition	
51.	List the Parts needed for the Repair Below 6309 6208 New leads Aegis ring: 2.2272	
52.	Signature of Technician that Disassembled Motor	Cw

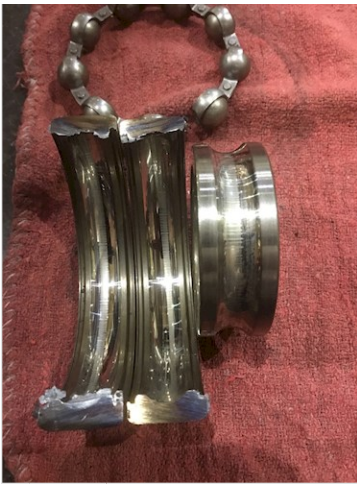
39.	Opposite Drive End Bearing Qty.	1	
40.	Opposite Drive End Bearing Type	(Ball) Ball Bearing	
41.	Opposite Drive End Lubrication Type	(Grease) Grease Lubricated	
42.	Opposite Drive End Bearing Insulation or Grounding Device?		
43.	Opposite Drive End Wavy Washer/Snap-Ring Other Retention Device?	wavy washer	
44.	Opposite Drive End Bearing Condition		P120
