AC Inspection as Found

Beasley Flooring (12083)

AC Inspection - Rev. 2

Description: 60 HP WEG

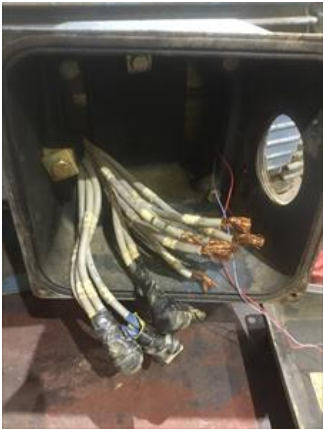
4.	Describe the Overall Condition of the Equipment as Received <i>Serviceable</i>	
5.	Is this a UL Listed Motor	(No) No
6.	Is the motor water cooled or can be pressure checked before teardown	(No) No
Initial Mechanical/Electrical		<input type="checkbox"/>
7.	Does Shaft Turn Freely?	(Y) Yes
8.	Does the shaft require T.I.R in Lathe to identify additional repairs?	(No) No
9.	Does Shaft Have Visible Damage?	(No) No
10.	Assembled Shaft Runout	0.001 Inches
11.	Assembled Shaft End Play	0 inches
12.	Air Gap Variation <10%

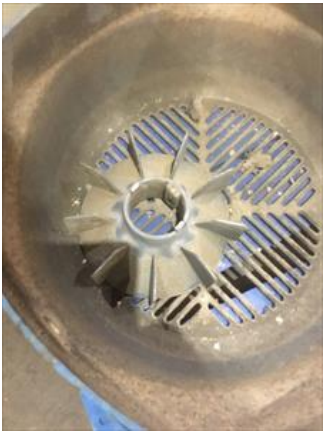
14.	Lead Length	8 Inches	
15.	Does it have Lugs?, If so what is the Stud Size?	(No) No	
16.	Lead Numbers	1-12	
17.	Are the Leads insulated with Chico or other material	(No) No	
18.	Frame Condition	pass	
19.	Fan Condition	(P) Pass	P119

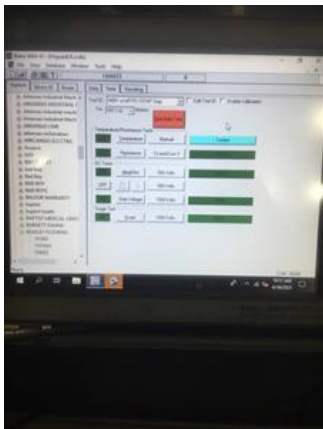
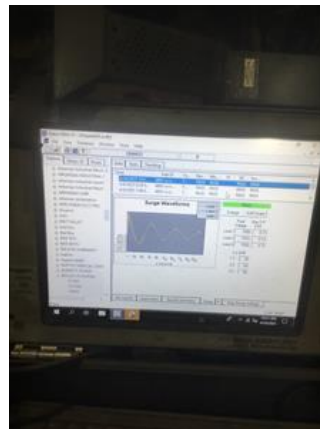
24. Perform Surge Test

(P) Pass

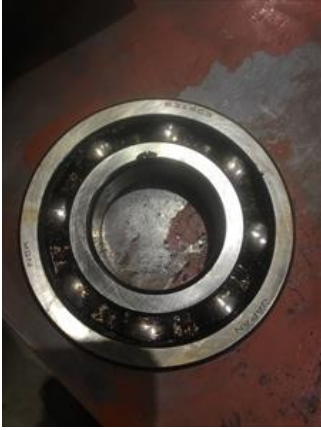
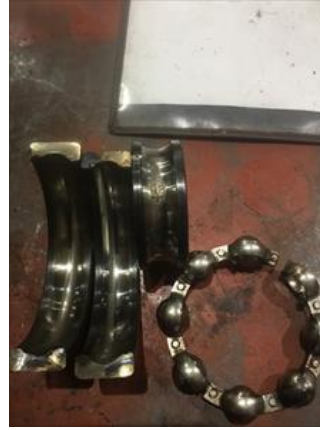
30. Drive End Bearing Number-	6314 C3
31. Drive End Bearing Qty.	1
32. Drive End Bearing Type	(Ball) Ball Bearing
33. Drive End Lubrication Type	(Grease) Grease Lubricated
34. Drive End Bearing Insulation or Grounding Device?	none
35. Drive End Wavy Washer/Snap-Ring Other Retention Device?	snap ring
36. Drive End Bearing Condition	worn
37. Opposite Drive End Bearing Brand	NSK

51. List the Parts needed for the Repair Below
2) 6314 C3 bearings

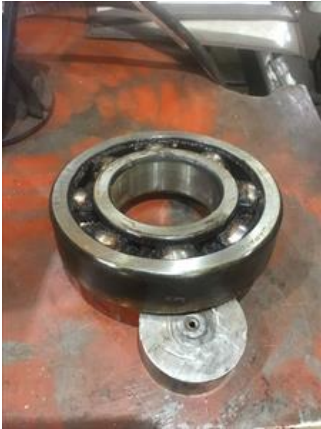
40. Opposite Drive End Bearing Type	(Ball) Ball Bearing	
41. Opposite Drive End Lubrication Type	(Grease) Grease Lubricated	
42. Opposite Drive End Bearing Insulation or Grounding Device?	none	
43. Opposite Drive End Wavy Washer/Snap-Ring Other Retention Device?	spring loaded cap	
44. Opposite Drive End Bearing Condition		P120

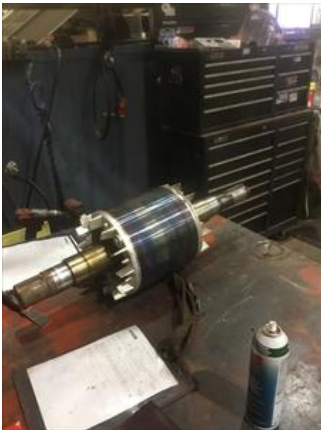
48. Growler Test **(Pass) Pass**
49. Number of Rotor Bars **58**
50. Rotor Condition **pass**

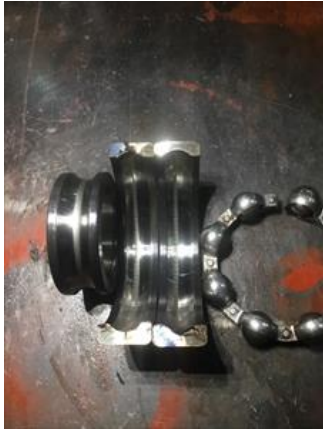
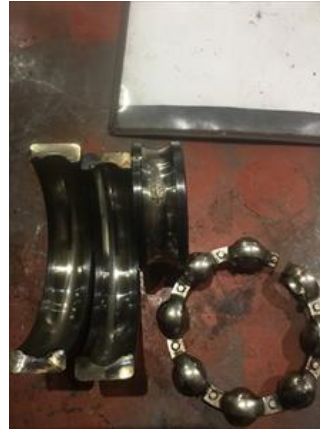
70. Failure locations	<i>Both bearings</i>

Electrical fluting in ODE bearing

Sub surface initiated fatigue in DE bearing & contaminated grease.
