AC Inspection as Found

American Kraft Paper

AC Inspection - Rev. 2

Description: 125 HP
NAMEPLATE NOT READABLE FOR SOME
SPECS

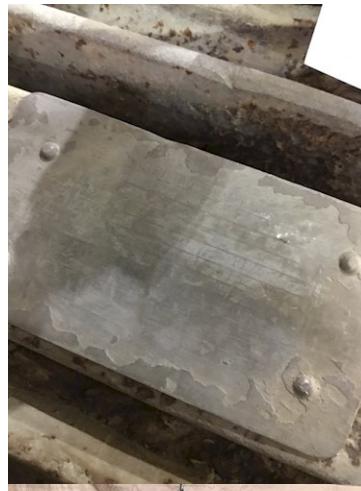
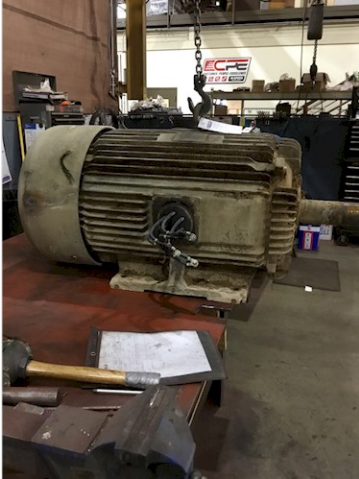
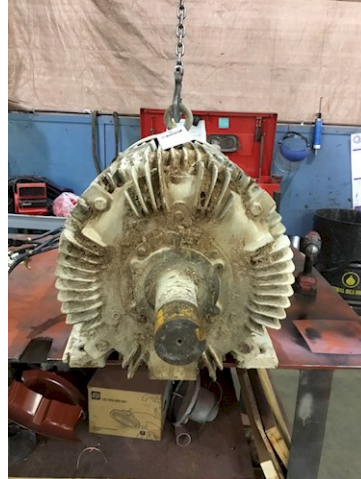
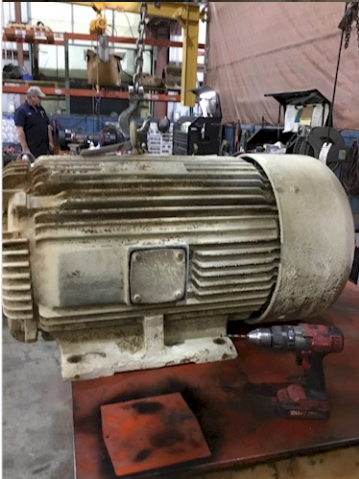
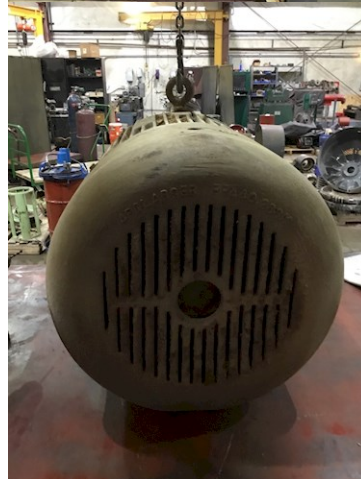
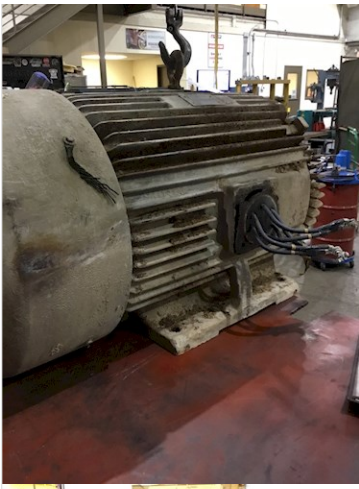
3.	Photos of all six sides of the machine.	
4.	Describe the Overall Condition of the Equipment as Received <i>Dirty</i>	
5.	Is this a UL Listed Motor	(No) No

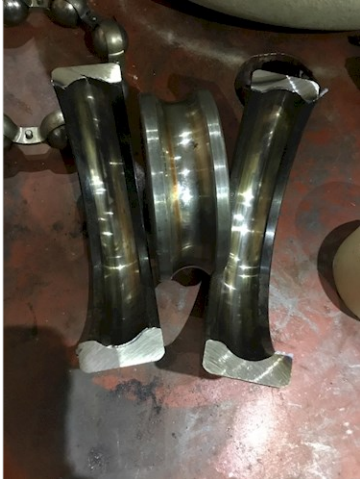
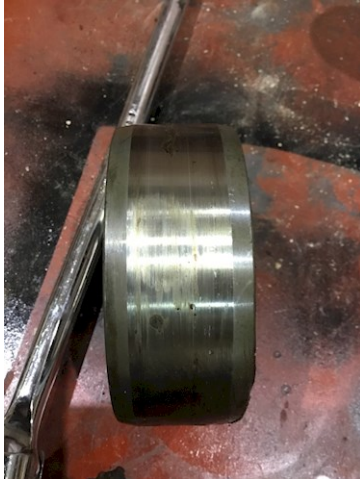
27.	Stator Thermistors/Ohms	
28.	Stator Overloads/Ohms	
Mechanical Inspection		
29.	Drive End Bearing Brand	NTN P12
<div style="display: flex; justify-content: space-around;">

34.	Drive End Bearing Insulation or Grounding Device?	none
35.	Drive End Wavy Washer/Snap-Ring Other Retention Device?	none
36.	Drive End Bearing Condition	normal wear

44.	Opposite Drive End Bearing Condition	fatigue
45.	Drive End Seal	
46.	Opposite Drive End Seal	
Rotor Inspection		
47.	Rotor Type/Material	(Squirrel Aluminum) Squirrel Cage Aluminum Die Cast

48.	Growler Test	(Pass) Pass
49.	Number of Rotor Bars	55
50.	Rotor Condition	good
51.	List the Parts needed for the Repair Below	
	NU318, 6318 2Z

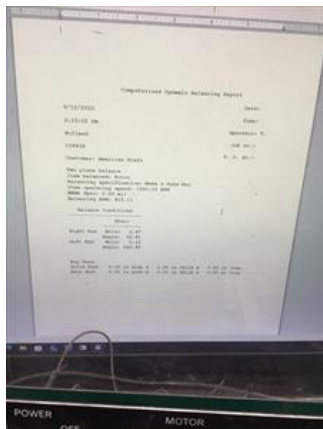
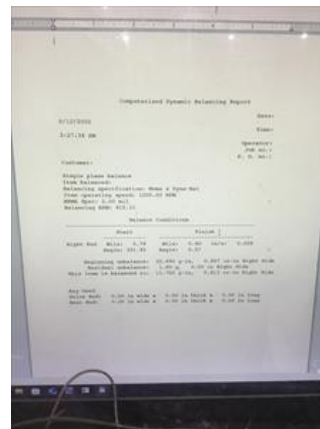
P27

Rotor

Rotor and fan

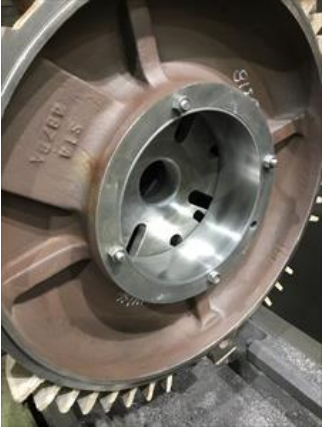
(F) Fail

Sleeve ODE end bell bearing fit

86. Bearing Cap Condition Post Repair		
Drive End Bearing Cap	Opposite Drive End Bearing Cap	
87. End Bell Air Seal Fits Post Repair		
Drive End Air Seal	Opposite Drive End Air Seal	
88. End Bell Repair Sign-off	RW

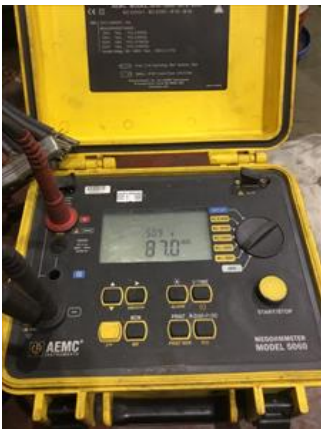
P31

91. Final Insulation Resistance Test

87 Gigohms

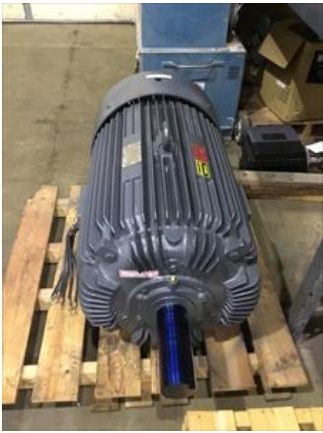
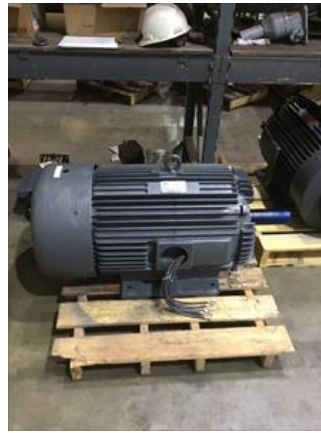
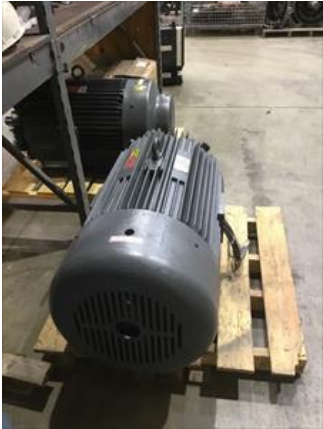
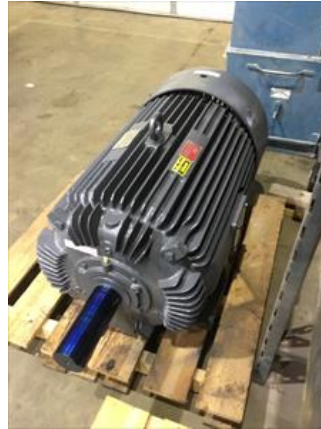
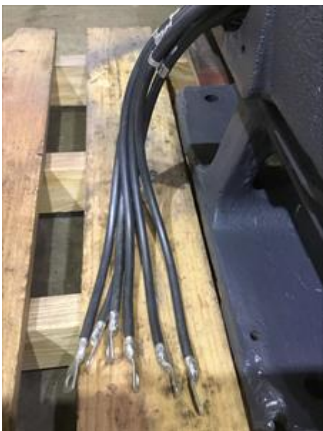
P135

101. Document Final Condition with Pictures after paint
