AC Inspection as Found

Welspun Tubular (11685)

AC Inspection - Rev. 2

Description: 18.6 KW NEMA

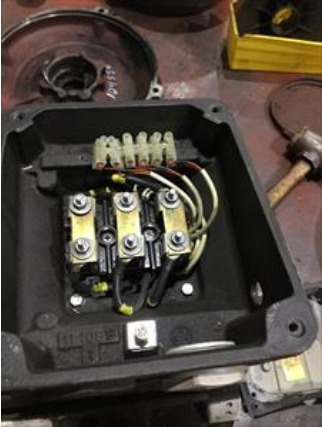
●	13. Lead Condition	(P) Pass	P69

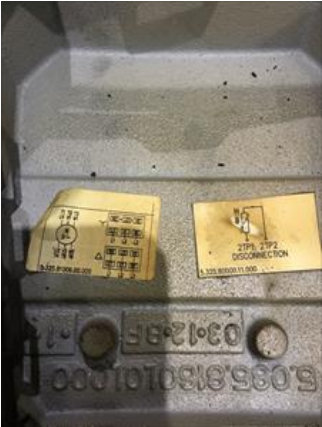
●	14. Lead Length	8 Inches	
●	15. Does it have Lugs?, If so what is the Stud Size?	(Yes) Yes	
■	Connection block installed.		
●	16. Lead Numbers	1-6	P99
■	U1-V1-W1 U2-V2-W2

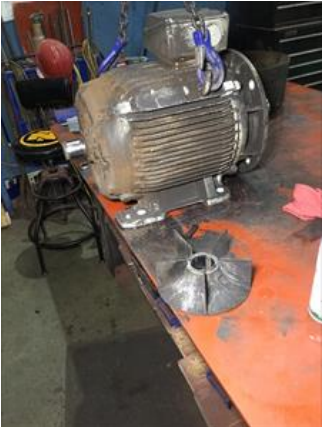
●	17. Are the Leads insulated with Chico or other material	(No) No	
●	18. Frame Condition	pass	
●	19. Fan Condition	(P) Pass	P119

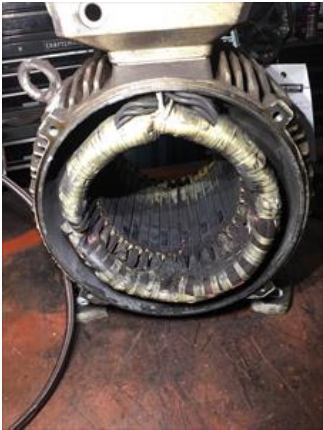
22. Insulation Resistance/Megger	Megohms		
23. Winding Resistance			P20
1-2	1-3	2-3

<i>Motor windings blown in slot.</i>

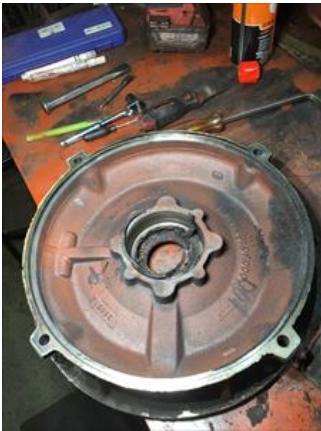
Wavy washer broken

worn

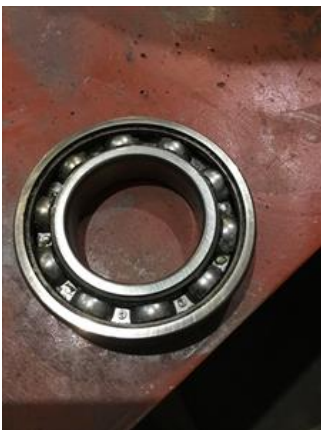
42.	Opposite Drive End Bearing Insulation or Grounding Device?	none
43.	Opposite Drive End Wavy Washer/Snap-Ring Other Retention Device?	two snap rings
44.	Opposite Drive End Bearing Condition	worn

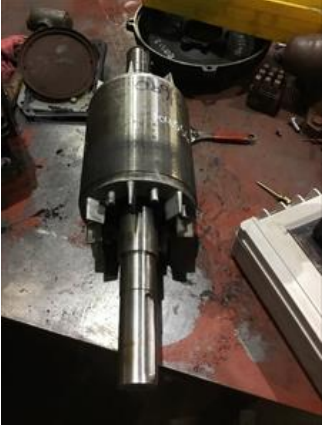
47.	Rotor Type/Material	(Squirrel Aluminum) Squirrel Cage Aluminum Die Cast P3

48.	Growler Test	(Pass) Pass
49.	Number of Rotor Bars	28
50.	Rotor Condition	pass
51.	List the Parts needed for the Repair Below 2) 6210 C3 bearings	
52.	Signature of Technician that Disassembled Motor	Terrence Holland

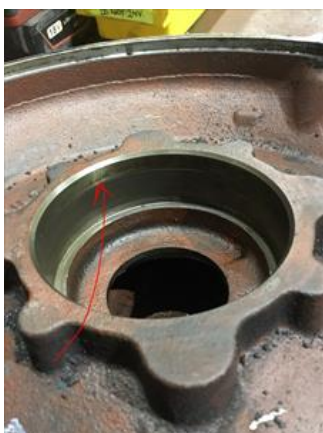
63.	Drive End - Endbell Bearing Fit Condition (F) Fail		
	Lip worn in.

D.E. Housing fit has lip worn in allowing the rotor to impact the stator iron causing a electrical grounding to the iron. Contaminated grease I both bearings was a contributing factor to premature bearing failure.

Sleeve both end bell housing fits.

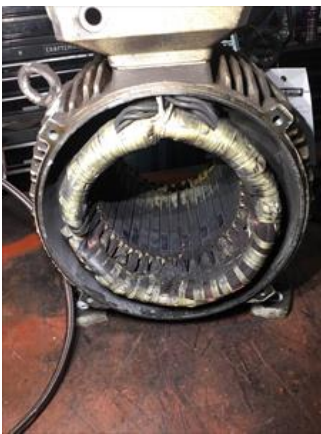
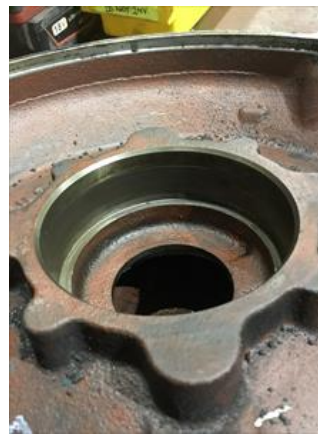
Both housing fits bad. Rewind stator. Windings blown in slot
