Submersible Pump Repair Report

FolderID: 104590  
FormID: 24403102

HOT SPRINGS VILLAGE  
895 DESOTO DR  
HOT SPRINGS VILLAGE, AR 71909  
LR MOTOR SHOP

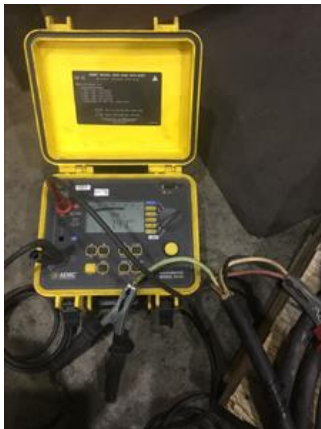
6.	Power Cord Length	26 ft	
7.	Power Cord Condition	(P) Pass	P37

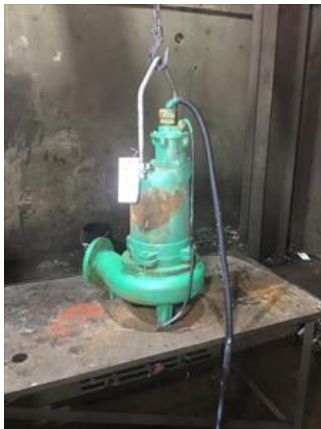
8.	Sensor Cord Wire Size	14 AWG	
9.	Sensor Cord # of Conductors	4	
10.	Sensor Cord Length	4 ft	P58
	<i>Need at least 25' as replacement</i>

11.	Sensor Cord Condition	(F) Fail	
12.	Sensor Cord for Thermal Protection?	(Y) Yes	
13.	Sensor Cord for Water Protection	(Y) Yes	
14.	Bowl Condition	(P) Pass

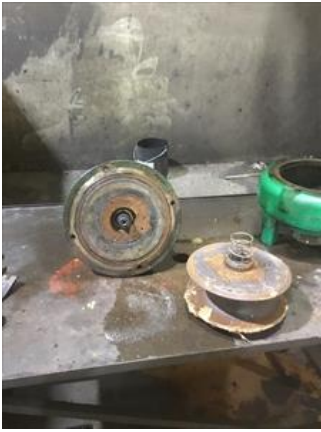
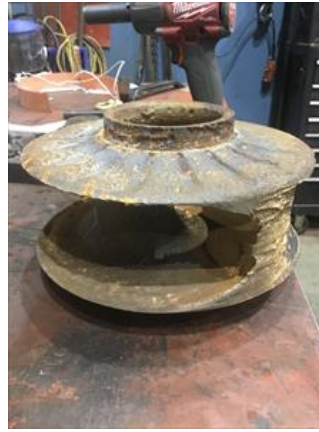
15. Impeller Condition

(F) Fail

84.	Component Failure	seals
85.	Cause of Failure	<i>Seals failed and impeller had rag like material wrapped around it.</i>
86.	Comments	
87.	Service Technician	Terrence Holland

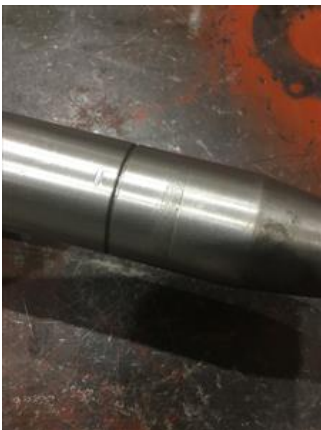
21. Seal Surfaces Condition

(F) Fail

Outer seal surface worn

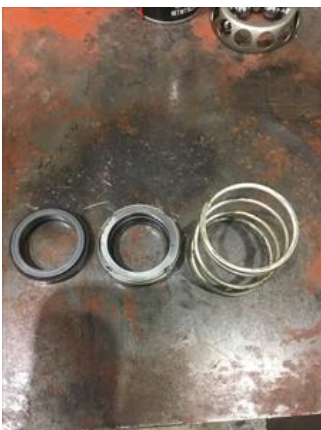
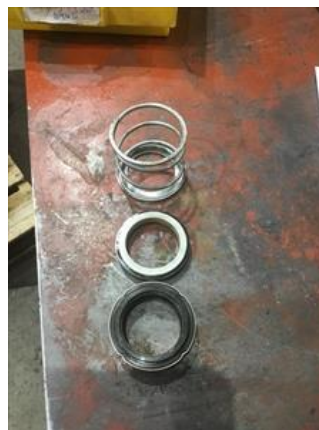
Outer seal, Tungsten, seat and rotary face

Inner seal, carbon, ceramic.

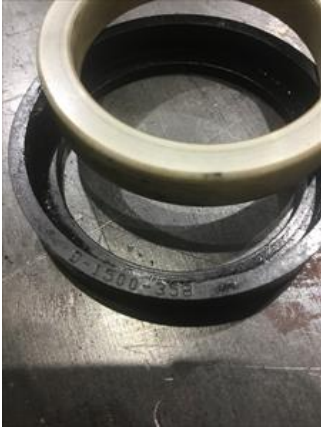
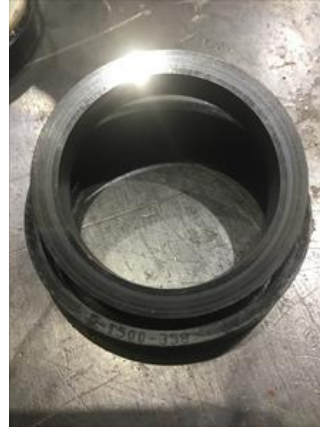
D-1500-358  
54.01 mm or 2.1245

D-1500-358  
54.06 mm or 2.1275in

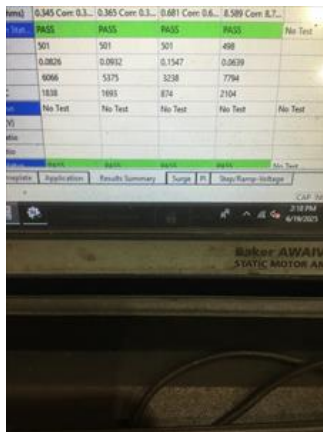
53. Resistance to Ground

0.11 Mohm

After wash and bake.
