AC Inspection as Found
Green Bay Packaging, Pinecrest (11362)
3610 Hwy 64 East
Plummerville, AR 72127

AC Inspection - Rev. 2

Description: MOTOR -NO NAMEPLATE DATA

Hi-Speed Job Number: 104598

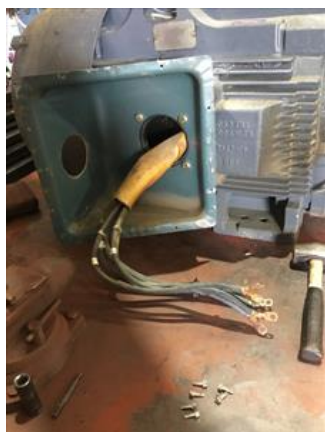
13.	Lead Condition	(P) Pass	
14.	Lead Length	26 Inches	
15.	Does it have Lugs?, If so what is the Stud Size?	(Yes) Yes	P95

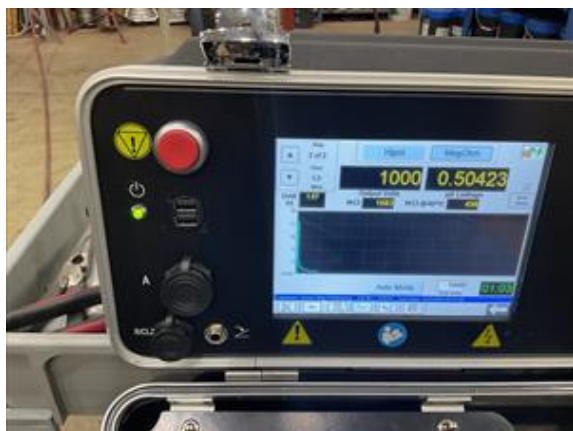
22.	Insulation Resistance/Megger	496 Megohms	P8
-----	------------------------------	-------------	----

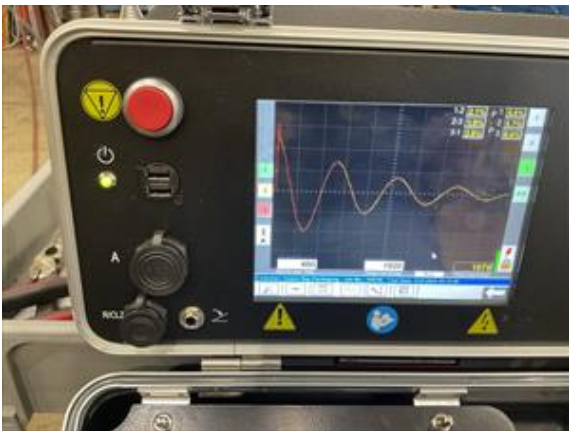
24. Perform Surge Test

(P) Pass

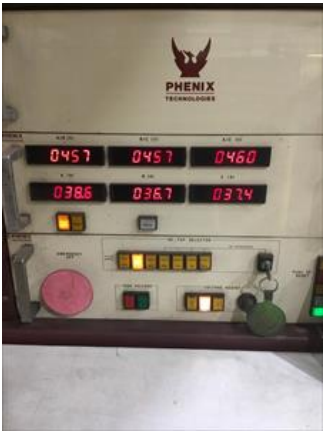
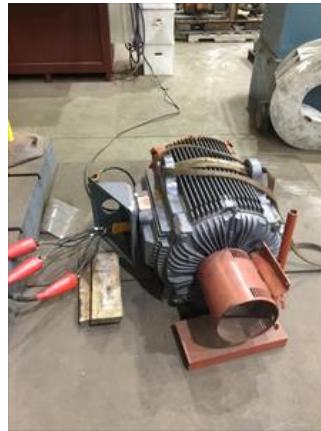
89. Test Run Voltage P55

Volts	Volts	Volts
457	457	480

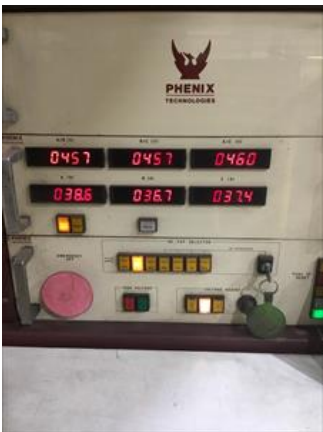
90. Test Run Amperage P65

Amps	Amps	Amps
38.6	35.7	37.4
