**AC Inspection as Found**  
**Saint Jean Industries, Inc. (11653)**  
424 Industrial Park Road  
Heber Springs, AR 72543

**AC Inspection - Rev. 2**

**Location:** LR MOTOR SHOP

**Description:** 300 HP NEMA

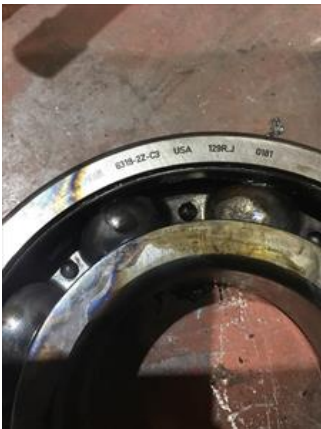
P32

29. Drive End Bearing Brand

30. Drive End Bearing Number-

6319 2Z/C3

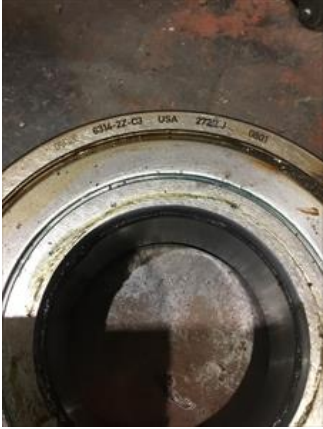
36. Drive End Bearing Condition	<b>worn</b>	
37. Opposite Drive End Bearing Brand	<b>Fag</b>	
38. Opposite Drive End Bearing Number-	<b>6314 2Z/C3</b>	P101

- 1.) 6314 2Z/C3 bearing  
1.) 6319 2Z/C3 bearing

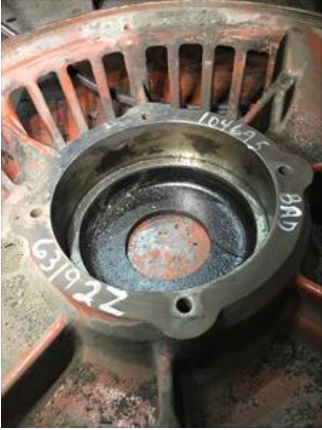
<div>61. Shaft Air Seal Fits</div> <div> <div>Drive End Air Seal</div> <div>Opposite Drive End Air Seal</div> </div>	<div>Mechanical Fits- Bearing Housings</div> <div>62. Drive End - Endbell Bearing Fit</div> <div> <div>0 Degrees</div> <div>60 Degrees</div> <div>120 Degrees</div> </div> <div>Bad</div>		
<div>63. Drive End - Endbell Bearing Fit Condition</div> <div>Excessive wear. See photo below</div> <div>

</div>	<div>(F) Fail</div> <div>P15</div>		
<div>64. Opposite Drive End - Endbell Bearing Fit</div> <div> <div>0 Degrees</div> <div>60 Degrees</div> <div>120 Degrees</div> </div> <div>Bad</div>	<div>65. Opposite Drive End - Endbell Bearing Fit Condition</div> <div>Excessive wear. See photo below.</div> <div>

*Both end bell housings are bad.*
