AC Inspection as Found

Riceland Foods (11100-RLF)

AC Inspection - Rev. 2

Description: 100 HP EMERSON

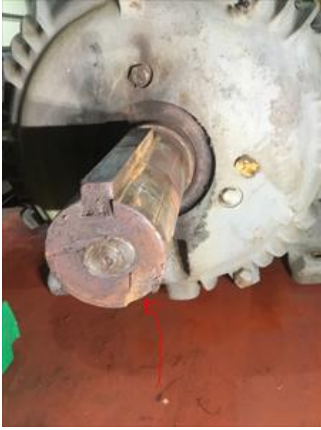
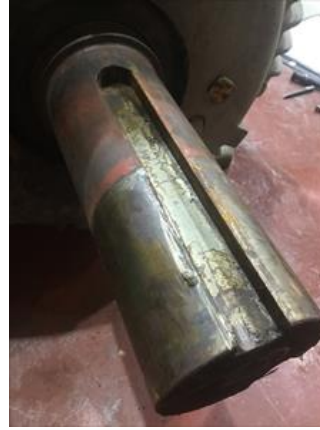
9. Does Shaft Have Visible Damage?

(Yes) Yes

Unable to perform due to locked shaft.

*Possible new shaft and new DE bearing cap.
Machine shaft opening on DE housing
Both end bell housing fits bad.*

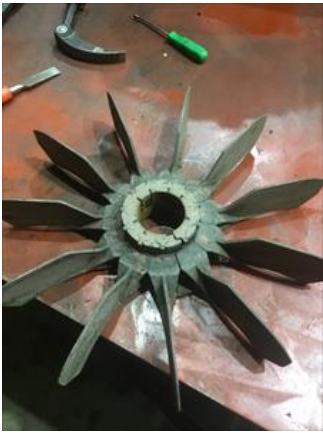
19. Fan Condition

(P) Pass

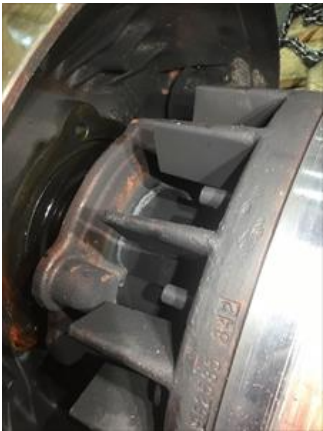
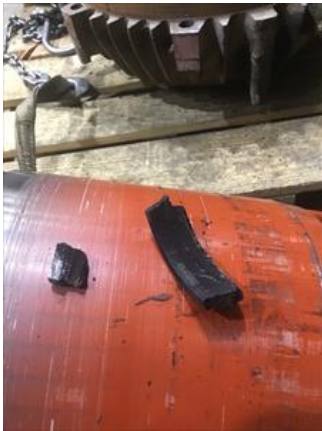
| 21. Broken or Missing Components | DE bearing cap broken | P128 |

<div> <div></div> <div>Co sign: RRW</div> </div>		
Root Cause of Failure			
70.	Failure locations		
	<i>Windings shorted on coil head.</i> <i>Both housing fits bad</i> <i>D.E cap broken.</i>		
71.	Root cause of failure		
	<i>Bearing cap fragments impacted the windings causing a short circuit.</i>		
Dynamic Balance Report			
72.	Rotor Weight and Balance Grade		
	Rotor Weight	Balance Grade	
73.	Initial Balance Readings		
	Drive End	Opposite Drive End	
74.	Final Balance Readings		
	Drive End	Opposite Drive End	
75.	Technician		
Rewind			
76.	Core Test Results - Watts loss per Pound		
	Pre-Burnout	Post Burnout	
77.	Core Hot Spot Test		
	Pre-Burnout	Post-Burnout	
78.	Post Rewind Electrical Test- Insulation Resistance

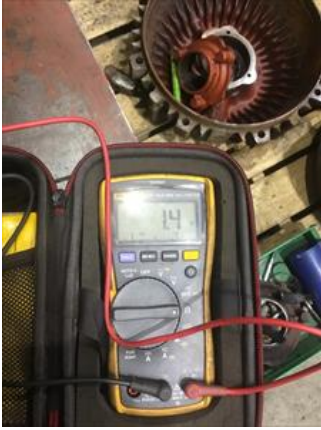
| 26. Stator Condition | rewind |

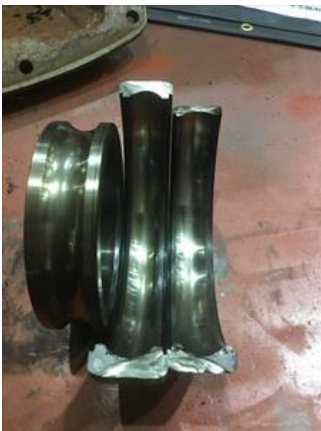
32. Drive End Bearing Type	(Ball) Ball Bearing	
33. Drive End Lubrication Type	(Grease) Grease Lubricated	
34. Drive End Bearing Insulation or Grounding Device?	none	
35. Drive End Wavy Washer/Snap-Ring Other Retention Device?	snap ring	
36. Drive End Bearing Condition	excessive wear	P82

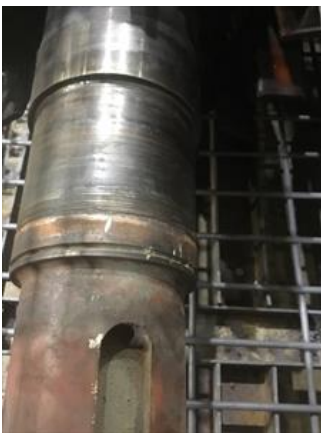
57. Drive End Bearing Shaft Fit

● 58. Drive End Bearing Shaft Fit Condition **(F) Fail**
