## AC Inspection as Found

Johnson Controls Inc

### AC Inspection - Rev. 2

Description: 75 HP RELIANCE  
RUSH

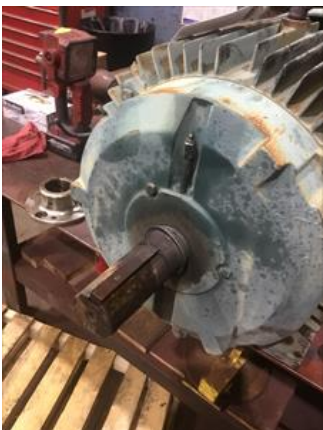
10. Does Shaft Have Visible Damage?

**(No) No**

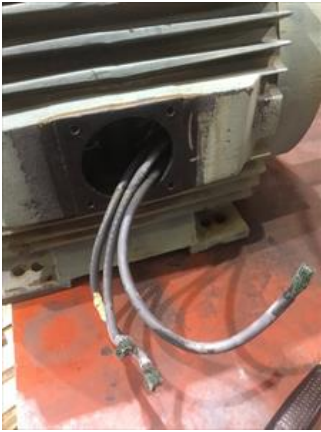
14. Lead Condition

(P) Pass

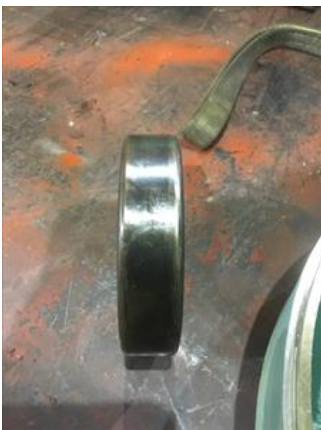
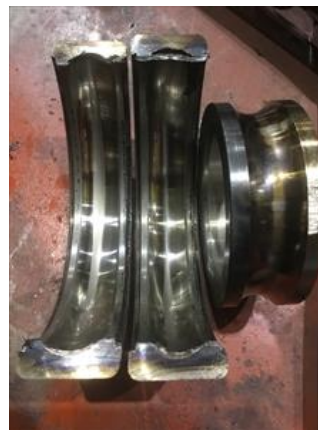
32. Drive End Bearing Qty.	1
33. Drive End Bearing Type	(Ball) Ball Bearing
34. Drive End Lubrication Type	(Grease) Grease Lubricated
35. Drive End Bearing Insulation or Grounding Device?	none
36. Drive End Wavy Washer/Snap-Ring Other Retention Device?	none
37. Drive End Bearing Condition	fluting on inner and outer races.

72. Root cause of failure  
*Bearings worn*

52. List the Parts needed for the Repair Below  
 2) 6313 2Z/C3 bearings.  
 Recondition stator.

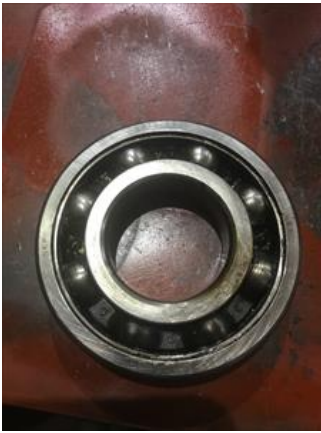
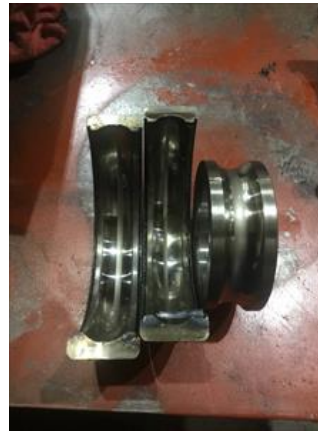
40. Opposite Drive End Bearing Qty.	1
41. Opposite Drive End Bearing Type	(Ball) Ball Bearing
42. Opposite Drive End Lubrication Type	(Grease) Grease Lubricated
43. Opposite Drive End Bearing Insulation or Grounding Device?	none
44. Opposite Drive End Wavy Washer/Snap-Ring Other Retention Device?	wavy washer
45. Opposite Drive End Bearing Condition	frosting on inner and outer races
46. Drive End Seal	dust seal
47. Opposite Drive End Seal	dust seal

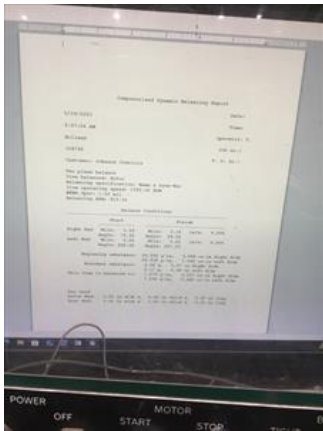
74. Initial Balance Readings

Drive End

Opposite Drive End

.65

..85

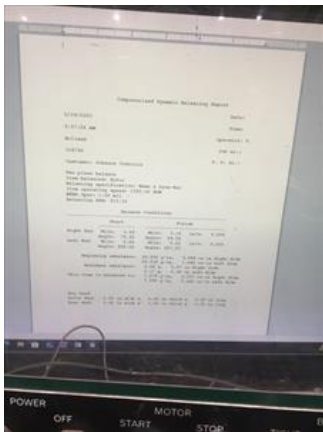
75. Final Balance Readings

Drive End

Opposite Drive End

.18

.22
