## AC Inspection as Found

American Kraft Paper

### AC Inspection - Rev. 2

Description: 350 HP GENERAL ELECTRIC

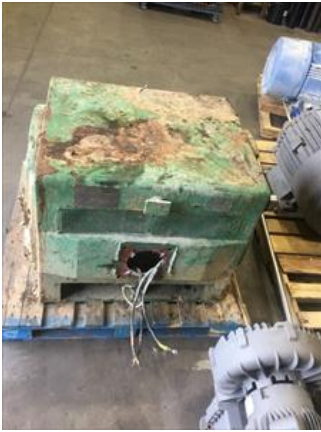
P70

13. Lead Condition

(P) Pass

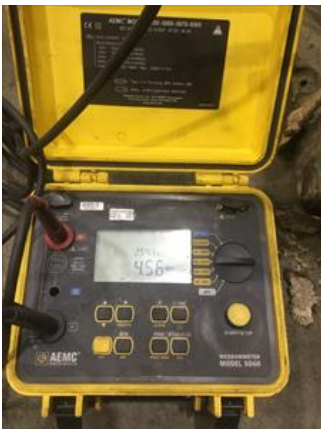
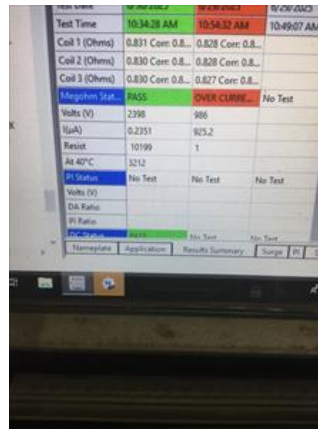
P8

23. Insulation Resistance/Megger

Megohms

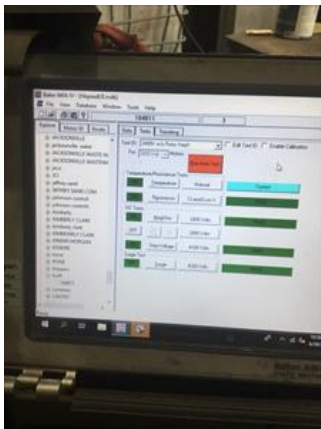
P59

## 25. Perform Surge Test

(P) Pass

I(μA)	0.3396
Resist	12075
At 40°C	3803
Surge Status	PASS No Test
Peak Volt(V) L1	4240
Peak Volt(V) L2	4200
Peak Volt(V) L3	4280
Max P-P EAR[...	0.1/0.1/0.1
EAR 1-2/2-3/...	2/2/0

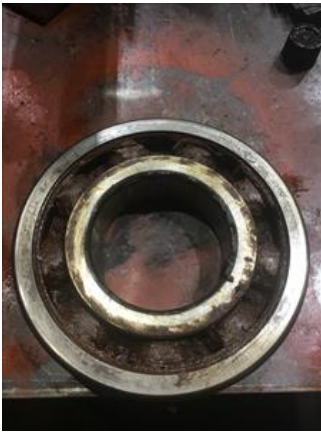
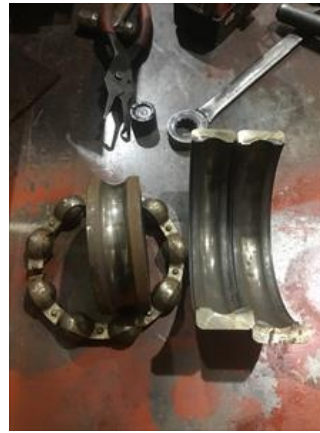
34. Drive End Lubrication Type	(Grease) Grease Lubricated	
35. Drive End Bearing Insulation or Grounding Device?	none	
36. Drive End Wavy Washer/Snap-Ring Other Retention Device?	none	
37. Drive End Bearing Condition	filled with contaminated grease	P82

42. Opposite Drive End Lubrication Type	(Grease) Grease Lubricated
43. Opposite Drive End Bearing Insulation or Grounding Device?	none
44. Opposite Drive End Wavy Washer/Snap-Ring Other Retention Device?	none
45. Opposite Drive End Bearing Condition	filled with contaminated grease
46. Drive End Seal	
47. Opposite Drive End Seal

*Both bearings filled with water logged contaminated grease.  
DE end shaft bearing journal way out of tolerance.  
Stator megged low. Placed in oven to re-evaluate.*

*Water contamination in stator and bearings.*

68.	End Bell Air Seal Fits		
	Drive End Air Seal	Opposite Drive End Air Seal	
69.	List Machine Work Needed Below Sleeve both end bell housing fits. Repair DE shaft bearing journal

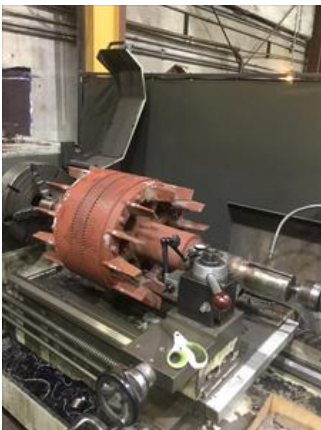
P40

48. Rotor Type/Material	(Aluminum Bar) Aluminum Barred Rotor
49. Growler Test	(Pass) Pass
50. Number of Rotor Bars	118
51. Rotor Condition	pass

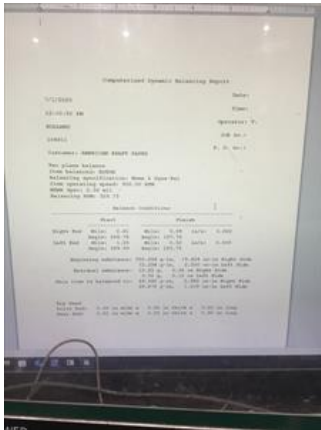
P11

## 74. Initial Balance Readings

Drive End	Opposite Drive End
.61	1.25

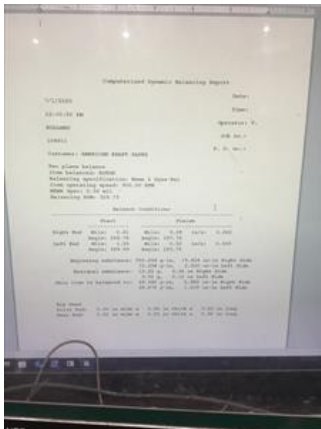
P27

## 75. Final Balance Readings

Drive End	Opposite Drive End
.09	.50

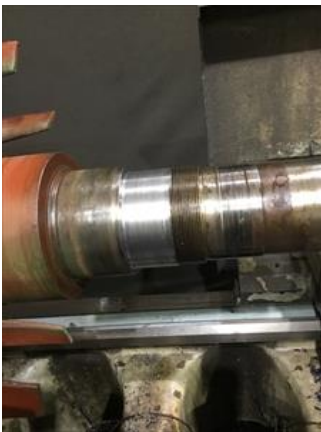
P49

82. Drive End Bearing Shaft Fit Post Repair

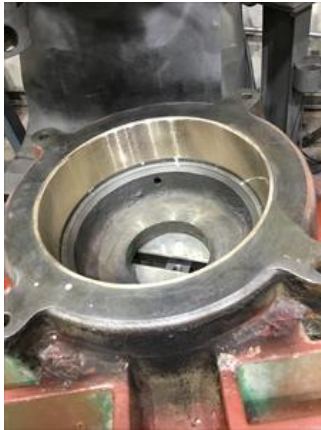
86.	Drive End - Endbell Bearing Fit Post Repair			P5
	0 Degrees	60 Degrees	120 Degrees	
	7.8745	7.8745	7.8745

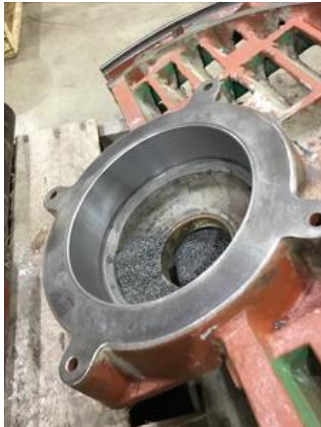
87.	Opposite Drive End - Endbell Bearing Fit Post Repair			P19
	0 Degrees	60 Degrees	120 Degrees	
	7.8751	7.8751	7.8751

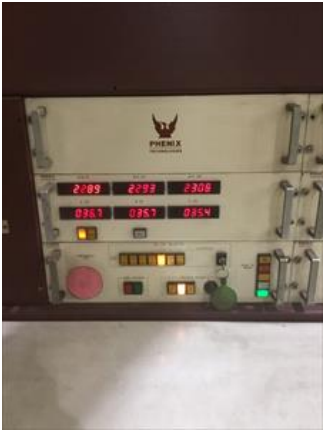
93.	Was a Insulated bearing or end bell tested?	(P) Pass		
94.	Final Insulation Resistance Test	10 Gigohms		
95.	Assembled Shaft Endplay	0 inches		
96.	Assembled Shaft Runout	0.002 inches		
97.	Test Run Voltage			P54
	Volts	Volts	Volts

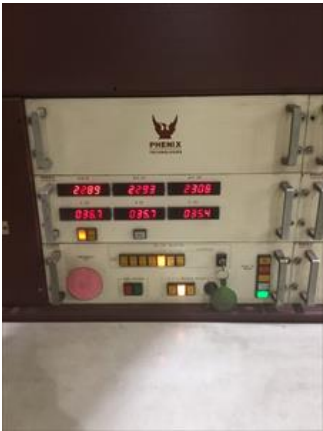
98.	Test Run Amperage				P65
	Amps	Amps	Amps
