AC Inspection as Found

Sage V Foods

AC Inspection - Rev. 2

Description: .90 KW BECKER

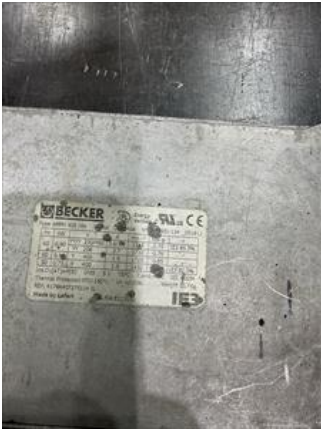
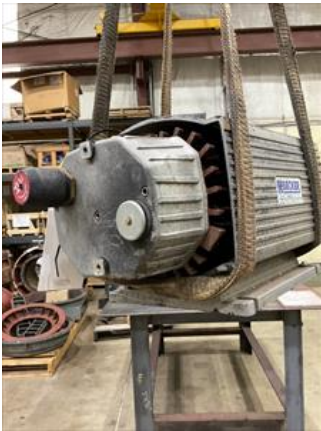
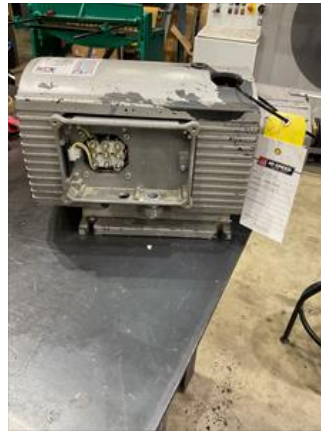
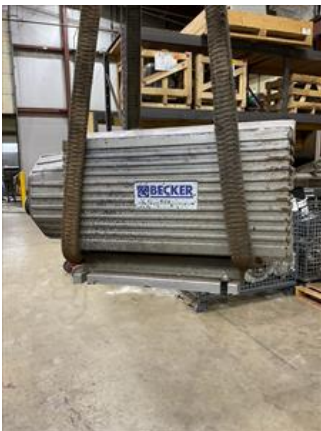
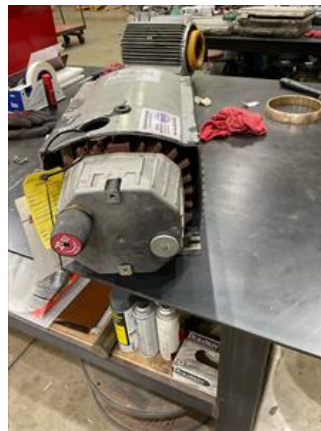
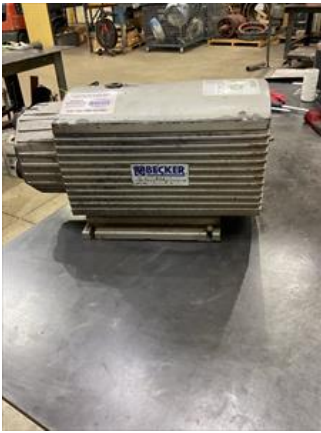
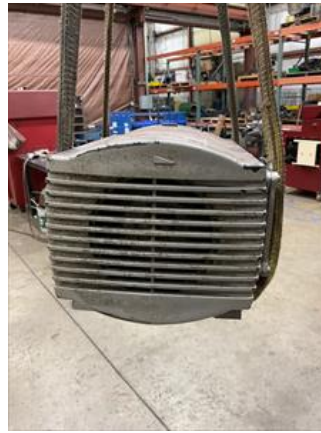
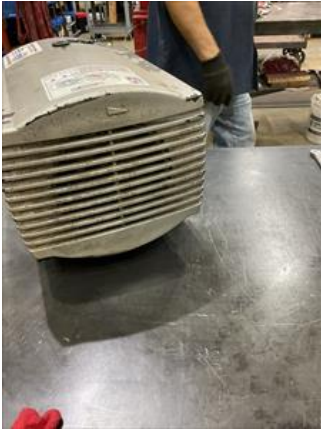
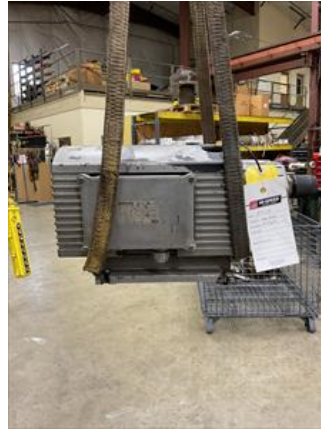
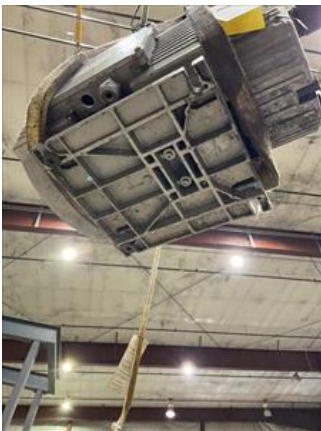
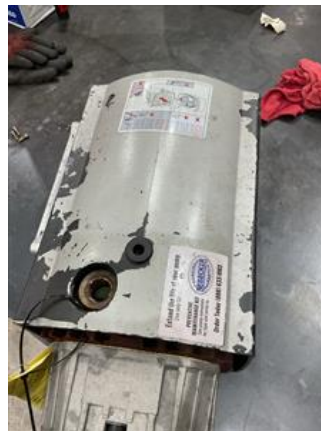
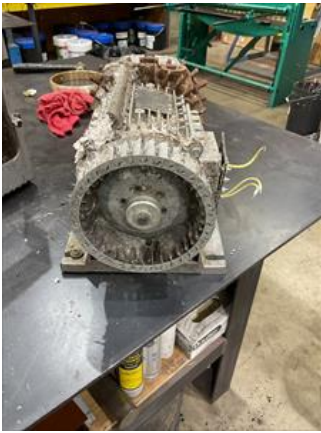
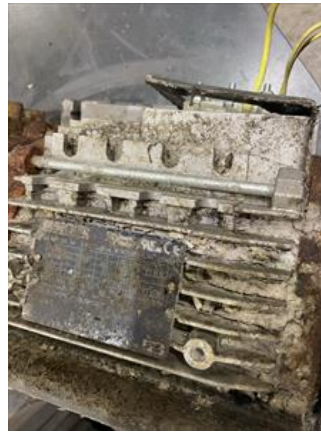
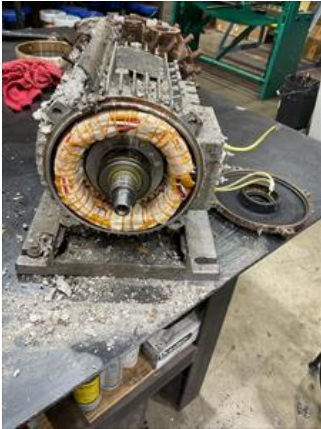
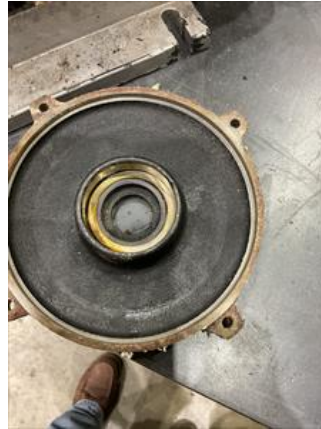
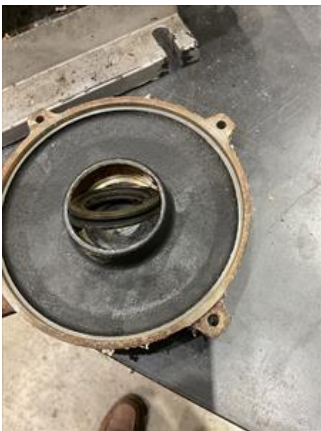
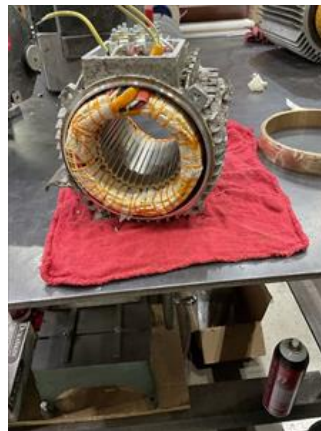
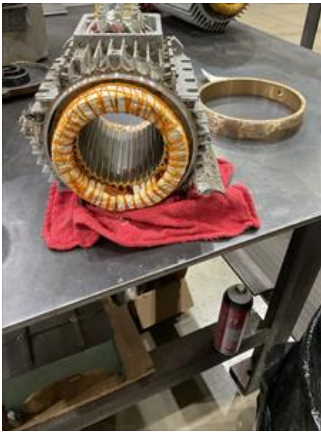
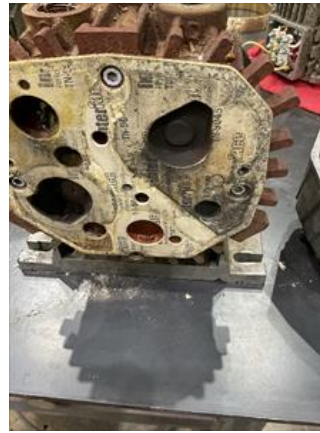
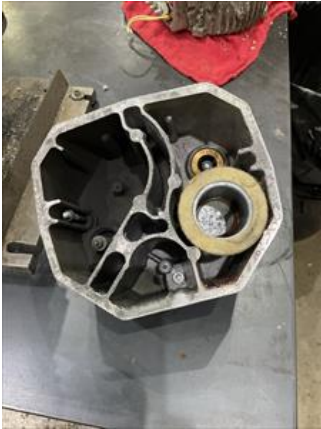
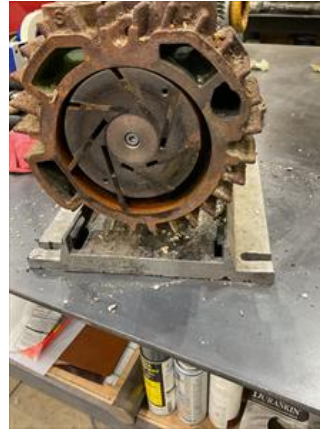
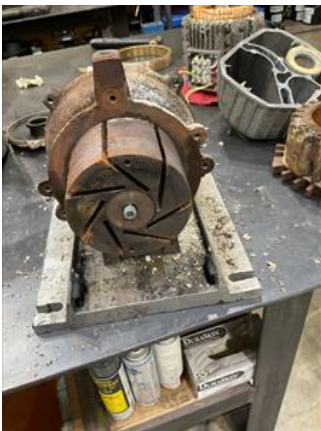
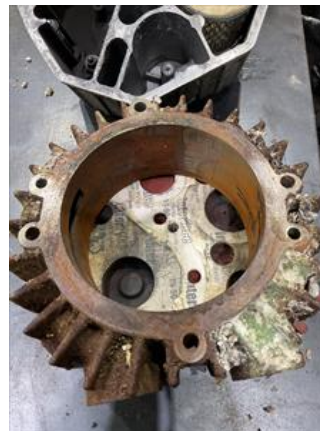
4.	Describe the Overall Condition of the Equipment as Received	
	<i>Acceptable</i>	
5.	Is this a UL Listed Motor	(NO) NO
6.	Is the motor water cooled or can be pressure checked before teardown	(NO) NO
Initial Mechanical/Electrical		
7.	Does Shaft Turn Freely?	(N) No
8.	Does the shaft require T.I.R in Lathe to identify additional repairs?	(NO) NO
9.	Does Shaft Have Visible Damage?	(No) No
10.	Assembled Shaft Runout	0 Inches
11.	Assembled Shaft End Play	inches
	<i>None</i>

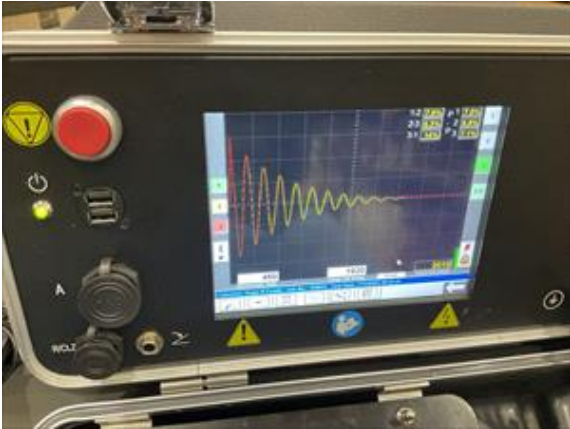
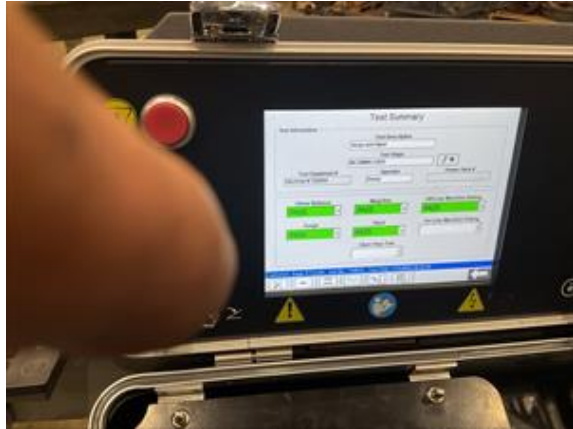
24.	Perform Surge Test		(P) Pass
			P57

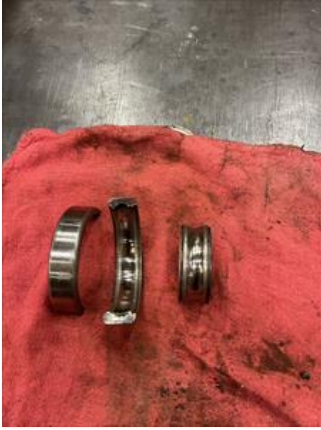
34.	Drive End Bearing Insulation or Grounding Device?		
35.	Drive End Wavy Washer/Snap-Ring Other Retention Device?

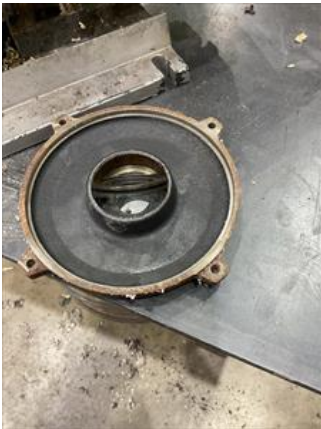
| 43. Opposite Drive End Wavy Washer/Snap-Ring Other Retention Device? | P115 |

Flat washers

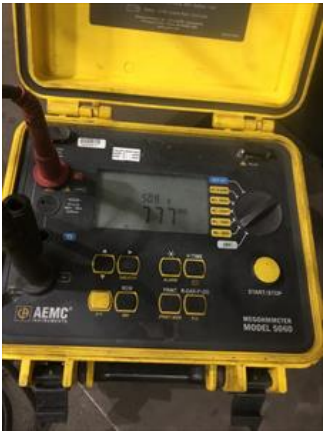
80. Final Insulation Resistance Test

P37

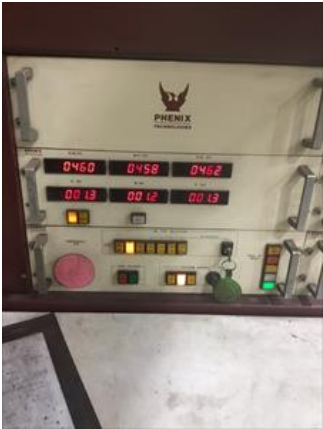
81. Assembled Shaft Endplay	0 inches	
82. Assembled Shaft Runout	0.001 inches	
83. Test Run Voltage

Volts	Volts	Volts
460	458	462

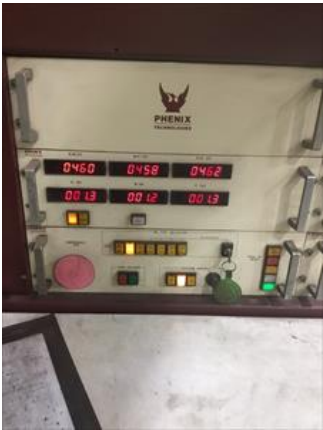
84. Test Run Amperage		
-----------------------	--	--

Amps	Amps	Amps
1.3	1.2	1.3
