AC Inspection as Found
Arkansas Electric Coop. (11681)
17400 highway 365 south
Little Rock, AR 72206

AC Inspection - Rev. 2

Location: MOTOR SHOP LR

Description: 4.3 HP AMATEK

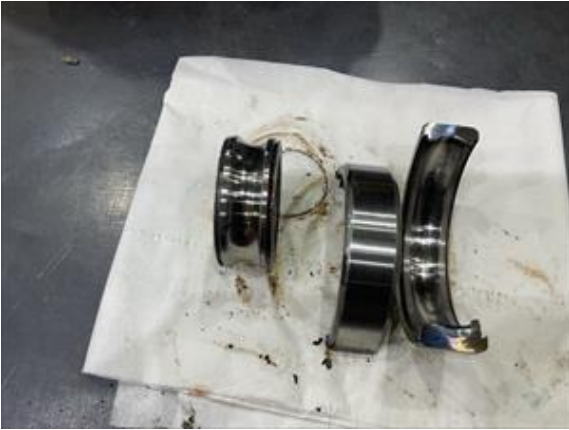
35.	Drive End Wavy Washer/Snap-Ring Other Retention Device?		
36.	Drive End Bearing Condition	good	P82

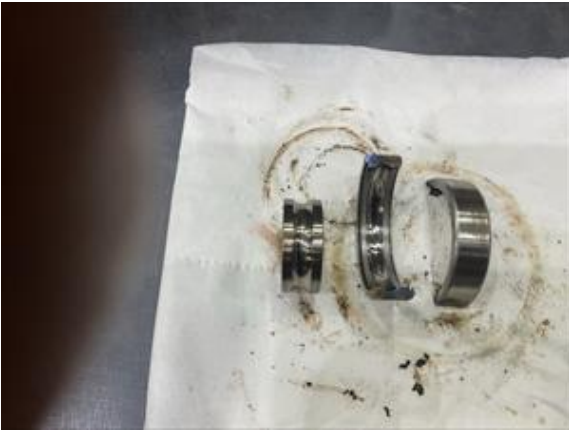
42.	Opposite Drive End Bearing Insulation or Grounding Device?		
43.	Opposite Drive End Wavy Washer/Snap-Ring Other Retention Device?	washers	
44.	Opposite Drive End Bearing Condition	good	P120

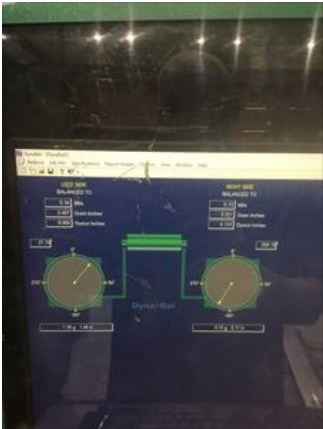
74. Final Balance Readings	P28	
Drive End	Opposite Drive End	
.34	.13
