AC Inspection as Found
ARKANSAS INDUSTRIAL MACHINERY
3804 N. NONA ST
NORTH LITTLE ROCK, AR 72118

AC Inspection - Rev. 2

Location: LR MOTOR SHOP

Description: 200 HP QUINCY COMPRESSOR
PREVENTATIVE MAINTENANCE

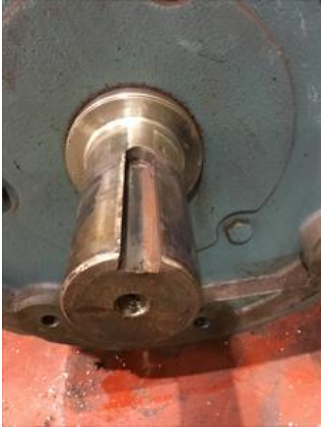
9. Does Shaft Have Visible Damage?

(No) No

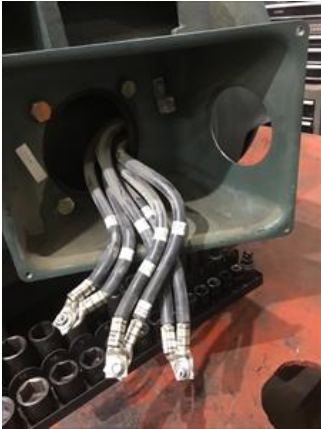
13. Lead Condition **(P) Pass**

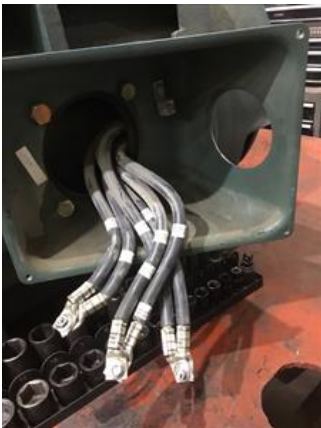
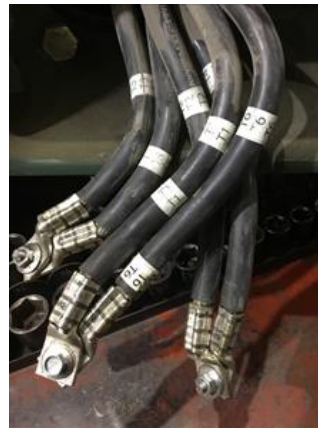
16. Lead Numbers **T1-T6**

Connection: (1-6) (2-4) (3-5)

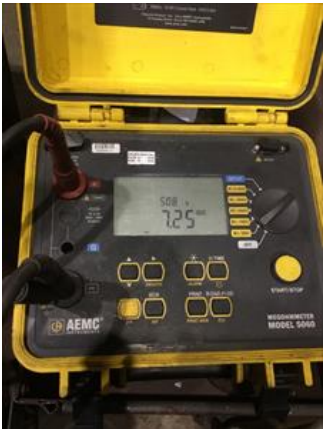
22. Insulation Resistance/Megger	7.25 Gigohms	P8
----------------------------------	--------------	----

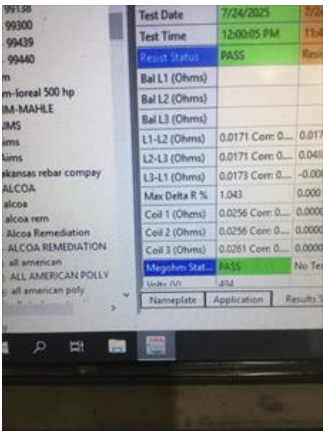
23. Winding Resistance			P16
1-2	1-3	2-3	
.0171	.0173	.0171

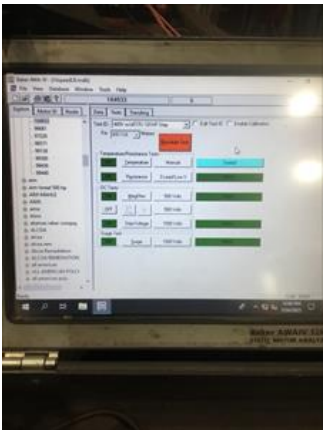
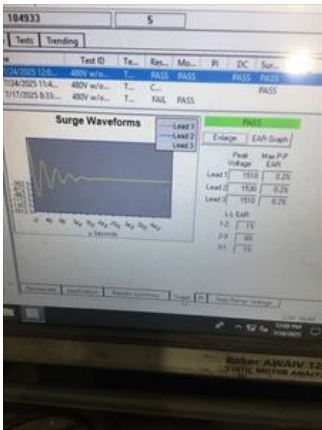
24. Perform Surge Test	(P) Pass	P57
------------------------	----------	-----

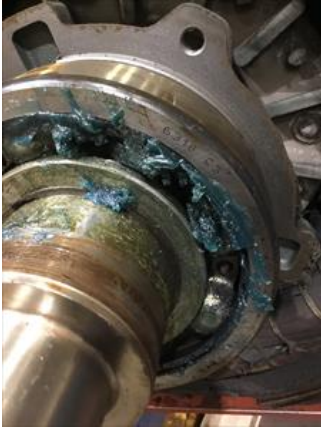
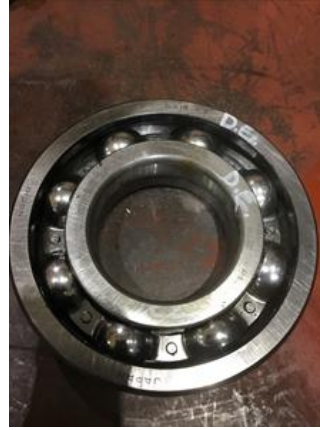
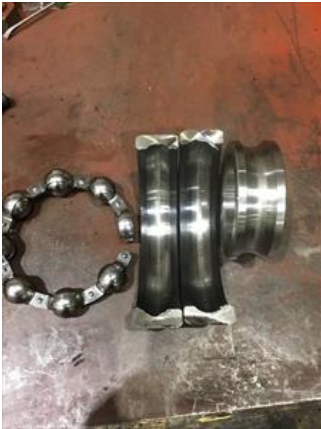
31. Drive End Bearing Qty.	1
32. Drive End Bearing Type	(Ball) Ball Bearing
33. Drive End Lubrication Type	(Grease) Grease Lubricated
34. Drive End Bearing Insulation or Grounding Device?	none
35. Drive End Wavy Washer/Snap-Ring Other Retention Device?	snap ring
36. Drive End Bearing Condition	replace

Contaminated grease.	
37. Opposite Drive End Bearing Brand	nachi

51. List the Parts needed for the Repair Below 2) 6318 2Z/C3 bearings 1) 318 sleeve for ODE housing fit			
52. Signature of Technician that Disassembled Motor	Terrence Holland

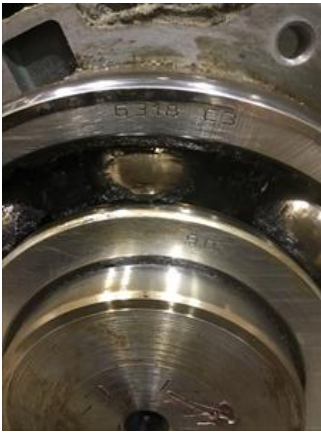
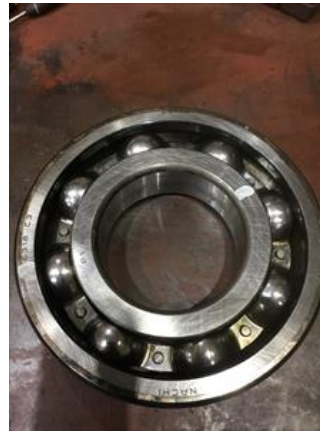
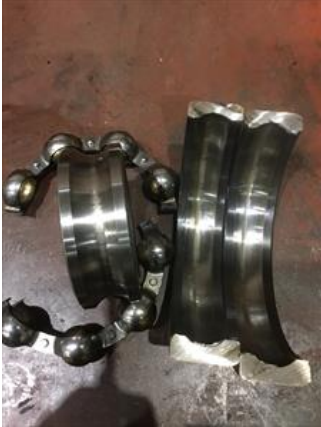
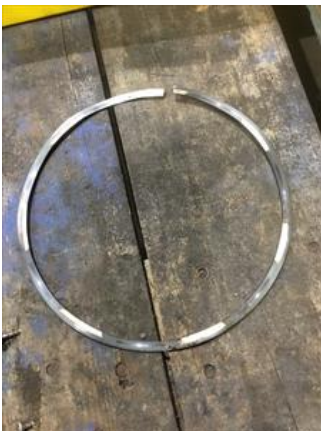
44.	Opposite Drive End Bearing Condition	replace
	Contaminated grease	
45.	Drive End Seal	
46.	Opposite Drive End Seal

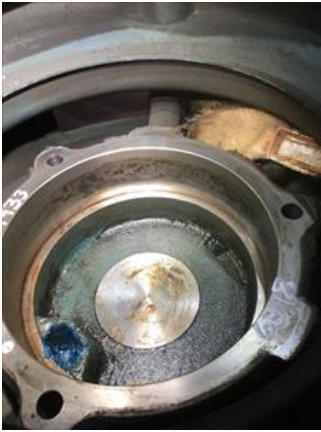
Fail

Excessive wear. Lip worn in housing.

Contaminated grease, and fluting

Sleeve ODE housing fit.
