Hi-Speed Industrial Service
7030 Ryburn Dr
Millington, Tn 38053
901-873-5300

AC Inspection as Found

REMURIAE

Location: MLMR
Serial Number: LSFT322U039
Description: 500 HP AC

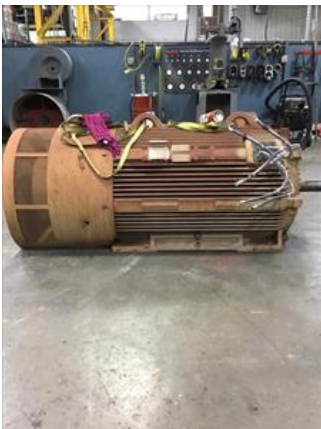
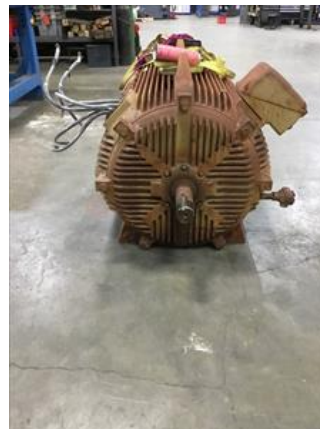
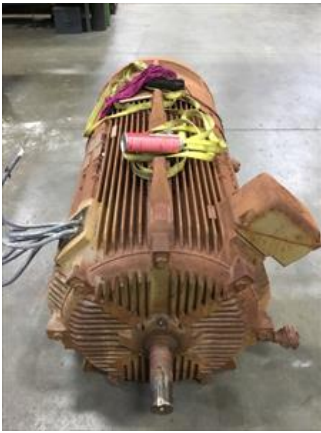
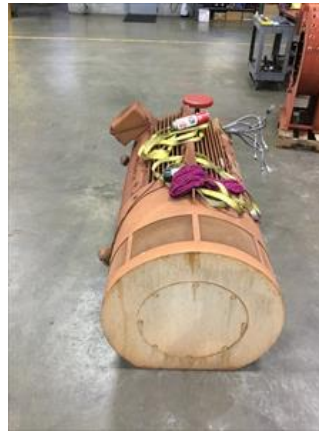
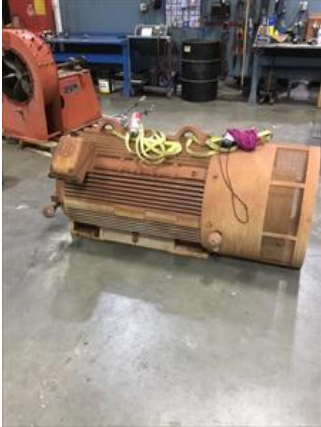
Passed all electrical tests. Shaft is bent and requires repair. Stator passed all electrical tests. Shaft is bent and requires repair as well as machine work to both end bells. Drive end bearing shows electrical fluting.? Recommend adding aegis ring to drive end and insulated bearing on opposite drive end.

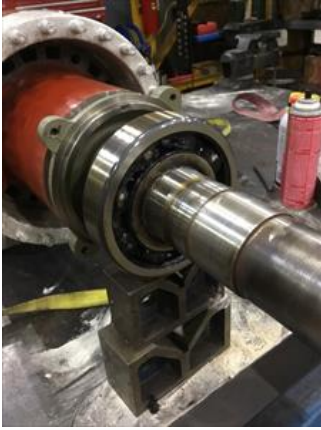
33. Drive End Bearing Number-	6315 zC3
34. Drive End Bearing Qty.	1
35. Drive End Bearing Type	(Ball) Ball Bearing
36. Drive End Lubrication Type	(Grease) Grease Lubricated
37. Drive End Bearing Insulation or Grounding Device?	None
38. Drive End Wavy Washer/Snap-Ring Other Retention Device?	None
39. Drive End Bearing Condition	fluted

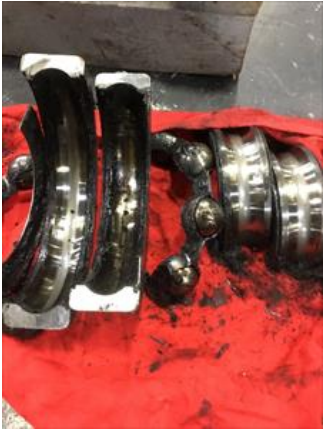
43.	Opposite Drive End Bearing Type	(Ball) Ball Bearing	
44.	Opposite Drive End Lubrication Type	(Grease) Grease Lubricated	
45.	Opposite Drive End Bearing Insulation or Grounding Device?	None	
46.	Opposite Drive End Wavy Washer/Snap-Ring Other Retention Device?	Wavy Washer	
47.	Opposite Drive End Bearing Condition	Fluting	P47

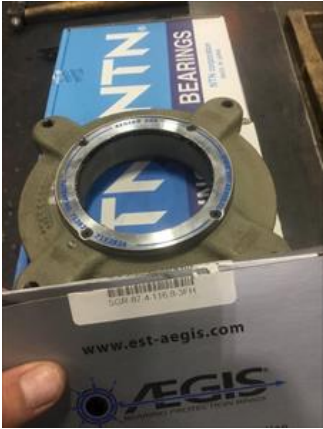
50.	Rotor Type/Material	(Squirrel Aluminum) Squirrel Cage Aluminum Die Cast	
51.	Growler Test	(Pass) Pass	
52.	Number of Rotor Bars	40	
53.	Rotor Condition	Pass	
54.	List the Parts needed for the Repair Below		P54
<i>Aegis ring see picture for part #</i> 6315 C3 6315 C3 insulated

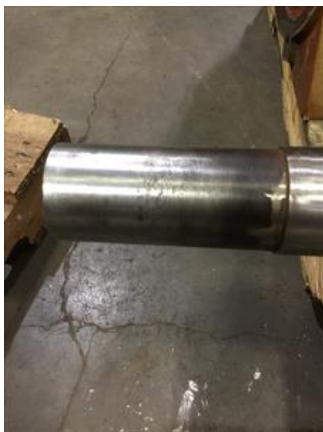
56.	Shaft Runout	0.008 inches		
57.	Rotor Runout			
	Drive End Bearing Fit	Rotor Body	Opposite Drive End Bearing	
	0.001	0.001	0.001	
58.	Coupling Fit Closest to Bearing Housing	P58		
	0 Degrees	90 Degrees	120 Degrees	
	2.625	2.625	2.625

*Bore and install bushings in both end bells.**Clean up shaft at seal fit.**Shaft is bend from seal fit to end of shaft .008". Shaft material needs to be tested to see if it can be weld repaired. Is so, shaft needs turned, welded, turned and new keyway milled.*

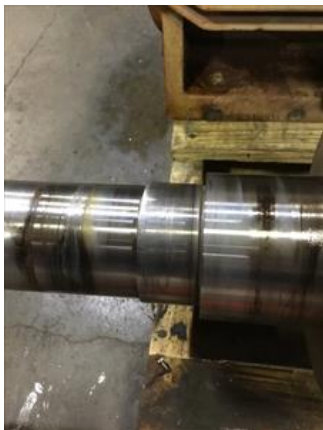
59.	Coupling Fit Closest to the end of the Shaft			
	0 Degrees	60 Degrees	120 Degrees	
	2.625	2.625	2.625	
60.	Drive End Bearing Shaft Fit	P60		
	0 Degrees	60 Degrees	120 Degrees	
	2.9529	2.9529	2.9529	
	Tolerance is 2.9529-2.9534

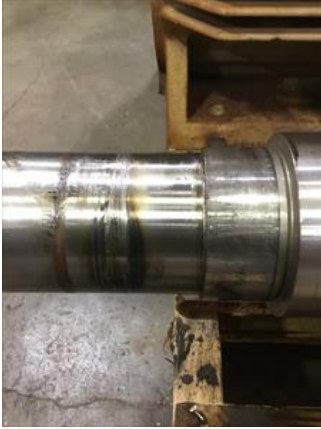
61.	Drive End Bearing Shaft Fit Condition	(P) Pass		
62.	Opposite Drive End Bearing Shaft Fit			
	0 Degrees	60 Degrees	120 Degrees	
	2.9528	2.9528	2.9528	
	Tolerance is 2.9529-2.9534			
63.	Opposite Drive End Bearing Shaft Fit Condition	(P) Pass

Drive End Air Seal
Needs Repaired

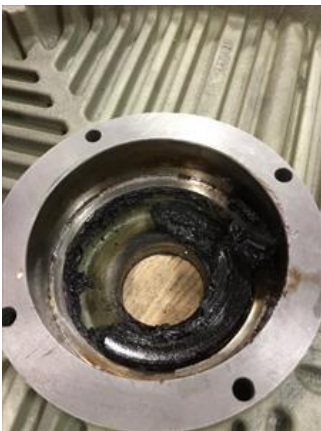
P65

65. Drive End - Endbell Bearing Fit

6.3021

Tolerance is 6.2992-6.3002

(F) Fail

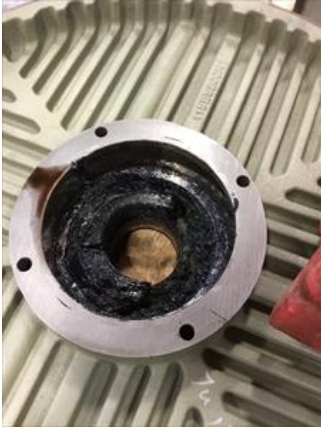
67. Opposite Drive End - Endbell Bearing Fit

6.3018

Tolerance is 6.2992-6.3002
