Hi-Speed Industrial Service
7030 Ryburn Dr
Millington, Tn 38053
901-873-5300

AC Inspection as Found
MOTOR - KTG USA
400 Mahannah
Memphis, TN 38107

AC Inspection - Rev. 2

Location: MLMR
Serial Number: Q2 G14T0326NPI
Description: 100HP AC

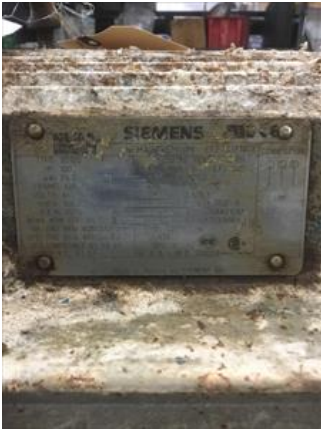
P2

2. Nameplate Picture

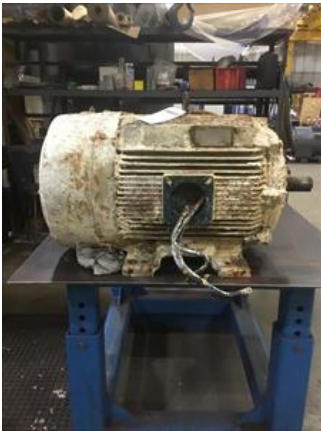
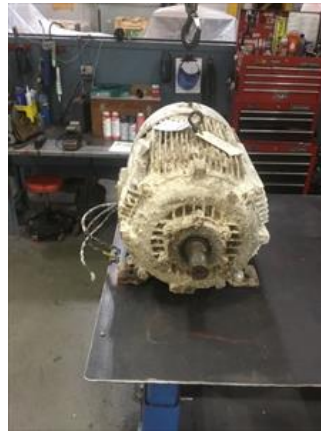
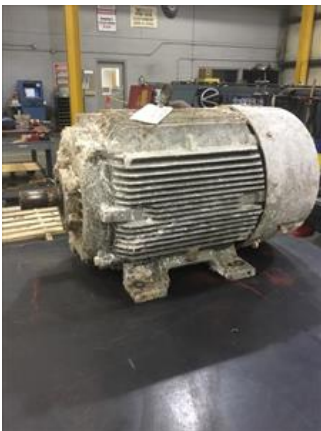
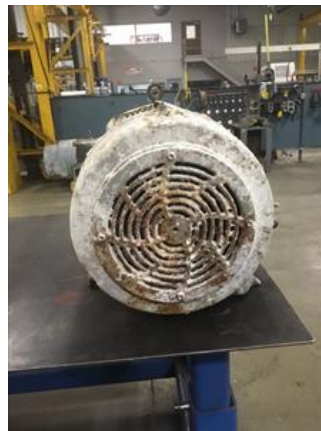
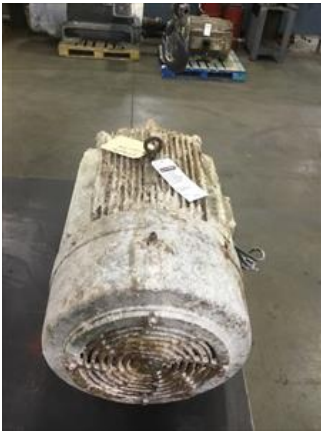
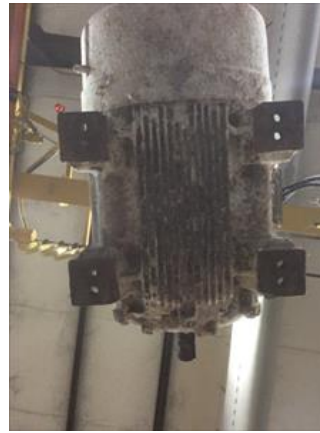
P3

4. Describe the Overall Condition of the Equipment as Received
Passed all electrical tests. Requires bore and bushing installed in both end bells.

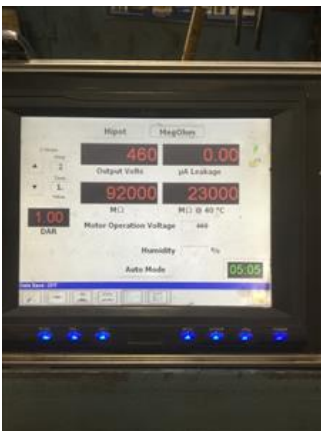
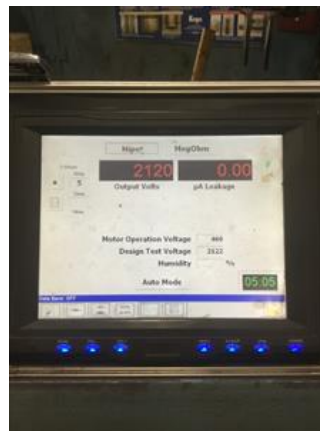
P19

19. Insulation Resistance/Megger 92000 Megohms

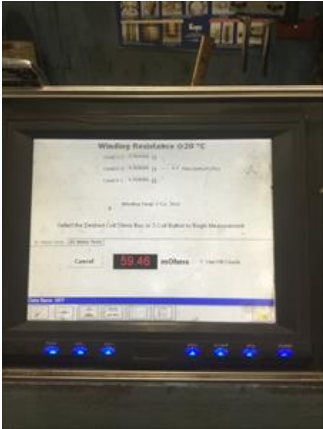
20. Winding Resistance			P20
1-2	1-3	2-3	
.05948	.05956	.05946

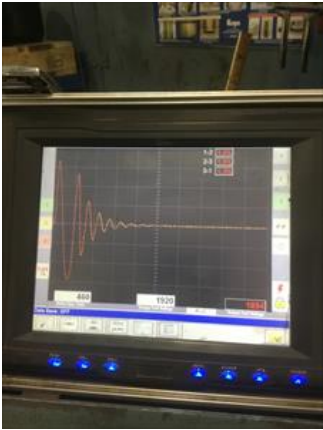
21. Perform Surge Test	(P) Pass	P21

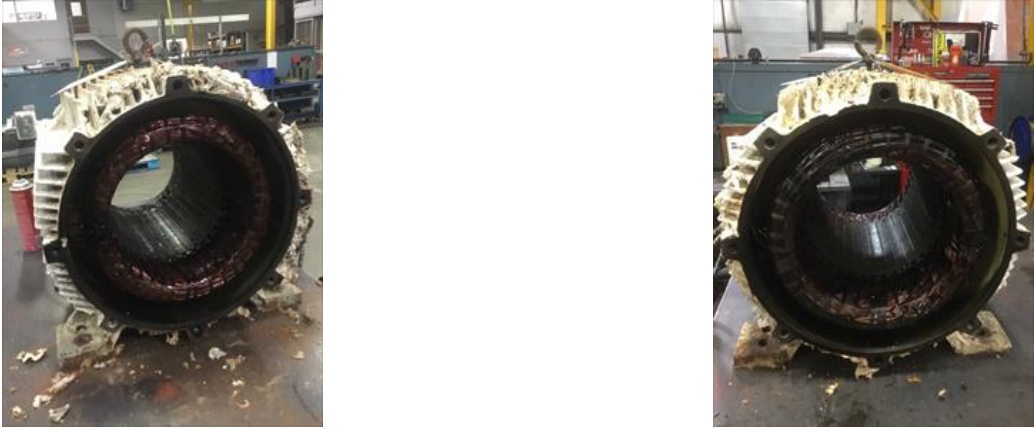
22. Number of Stator Slots	36		
23. Stator Condition		P23

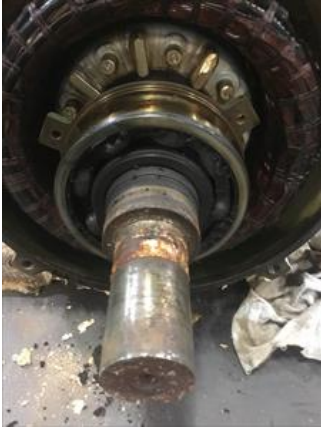
27. Drive End Bearing Number-	6316 C3
28. Drive End Bearing Qty.	1
29. Drive End Bearing Type	(Ball) Ball Bearing
30. Drive End Lubrication Type	(Grease) Grease Lubricated
31. Drive End Bearing Insulation or Grounding Device?	None
32. Drive End Wavy Washer/Snap-Ring Other Retention Device?	None
33. Drive End Bearing Condition	Destroyed from old grease and heat
34. Opposite Drive End Bearing Brand	ORS

Old grease and heat

46.	Number of Rotor Bars	28	
47.	Rotor Condition	Pass	
48.	List the Parts needed for the Repair Below Va75 x2 2-6316		
49.	Signature of Technician that Disassembled Motor	Brandon Woodard

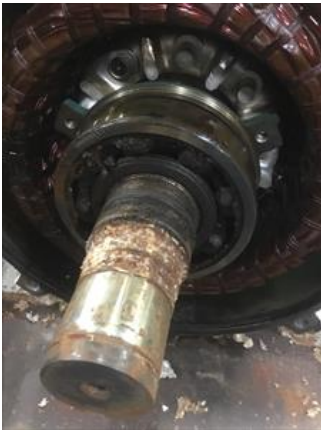
35. Opposite Drive End Bearing Number-	6316 C3
36. Opposite Drive End Bearing Qty.	1
37. Opposite Drive End Bearing Type	(Ball) Ball Bearing
38. Opposite Drive End Lubrication Type	(Grease) Grease Lubricated
39. Opposite Drive End Bearing Insulation or Grounding Device?	None
40. Opposite Drive End Wavy Washer/Snap-Ring Other Retention Device?	Wavy Washer
41. Opposite Drive End Bearing Condition	Destroyed from old grease and heat
42. Drive End Seal	VA75
43. Opposite Drive End Seal	VA75

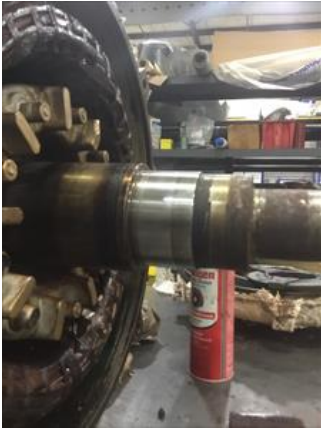
P54

0 Degrees	60 Degrees	120 Degrees
3.1501	3.1501	3.1501

Tolerance is 3.1497-3.1502

(P) Pass

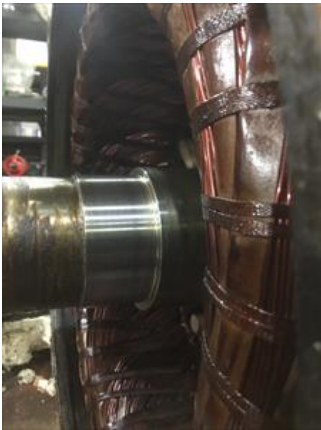
P56

0 Degrees	60 Degrees	120 Degrees
3.15	3.15	3.15

Tolerance is 3.1497-3.1502

(P) Pass

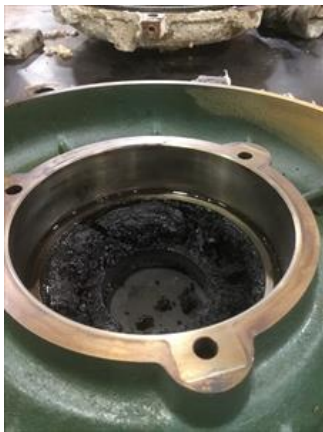
59.	Drive End - Endbell Bearing Fit			P59
	0 Degrees	60 Degrees	120 Degrees	
	6.6948	6.6947	6.6948	
	Tolerance is 6.6929-6.6939

60.	Drive End - Endbell Bearing Fit Condition			(F) Fail
61.	Opposite Drive End - Endbell Bearing Fit			P61
	0 Degrees	60 Degrees	120 Degrees	
	6.6947	6.6948	6.6947	
	Tolerance is 6.6929-6.6939

62.	Opposite Drive End - Endbell Bearing Fit Condition			(F) Fail
63.	Bearing Cap Condition			
	Drive End Bearing Cap	Opposite Drive End Bearing Cap		
	Pass	Pass		
64.	End Bell Air Seal Fits			
	Drive End Air Seal	Opposite Drive End Air Seal		
	Pass	Pass		
65.	List Machine Work Needed Below			
	Bore and bush both end bells.			
66.	Technician			Brandon Woodard
