AC Inspection as Found
UNITED SOLUTIONS
 1052 INDUSTRIAL PARK RD
 SARDIS, MS 38666

AC Inspection - Rev. 2

Hi-Speed Job Number:	154620
Manufacturer:	Other
HP/kW:	115 (kW)
RPM:	2500 (RPM)
Voltage:	Other
Current:	205 (Amps)
Phase:	Three
Hz:	125 (Hz)
# of Leads:	3
J-box Included:	Complete
Coupling/Sheave:	None
Date Received:	02/03/2025
Bearing RTDs:	No
Stator RTDs:	Yes
Repair Stage:	Teardown Inspection
Heaters:	No
Winding Type :	Random Wound
Bearing Type:	Rolling Element

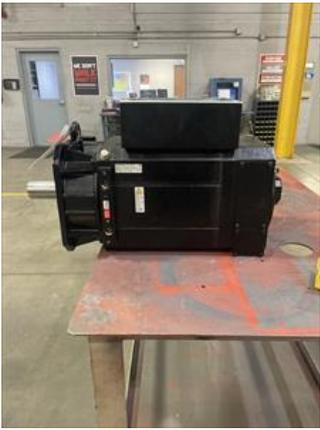
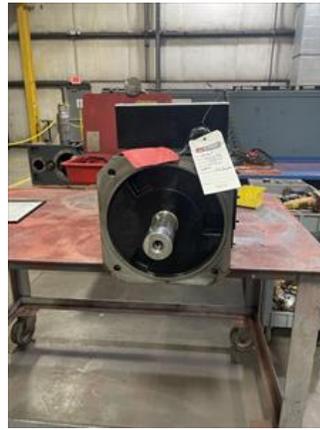
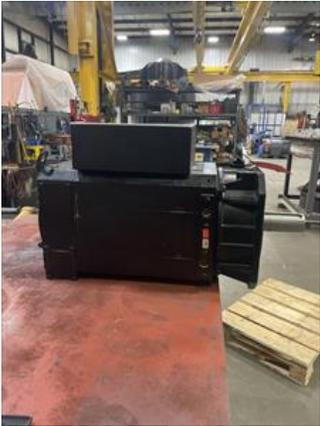
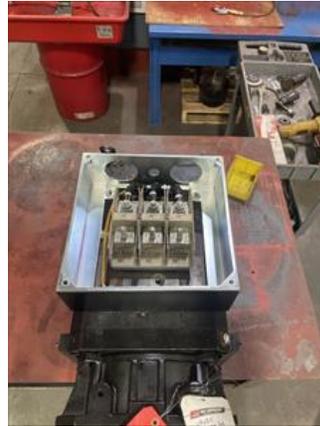
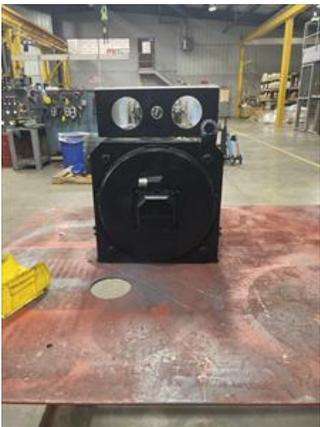
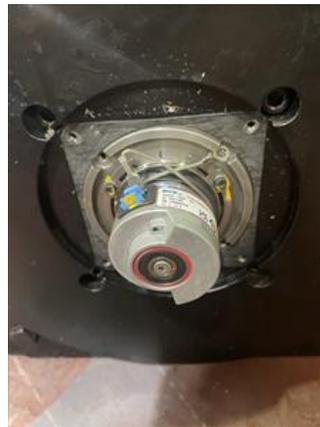
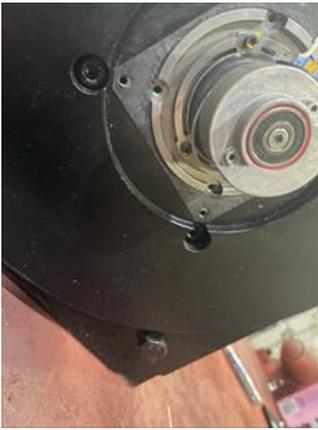
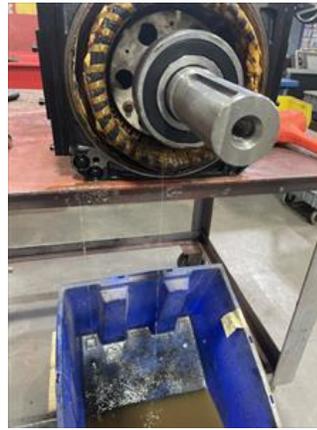
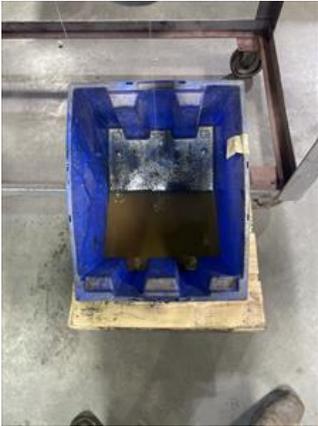
| 3. Photos of all six sides of the machine. | P3 |

*Motor was full of water and megged zero before initial tear down, bake and retest to determine if motor needs to be rewound or not
After baking motor it is in need of a rewind*

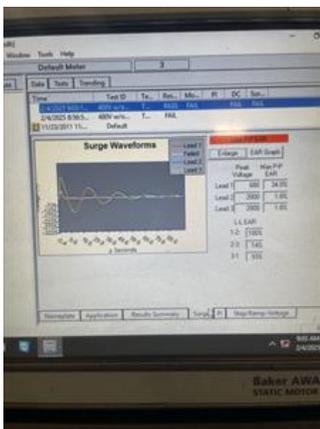
P25

20. Insulation Resistance/Megger	0 Megohms
----------------------------------	-----------

Winding resistance tripped out due to current overload

22. Perform Surge Test	(F) Fail
------------------------	----------

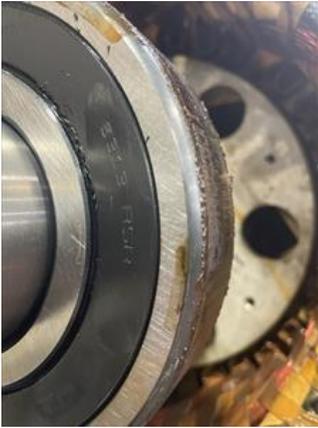
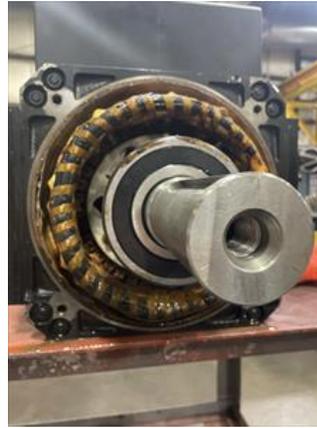
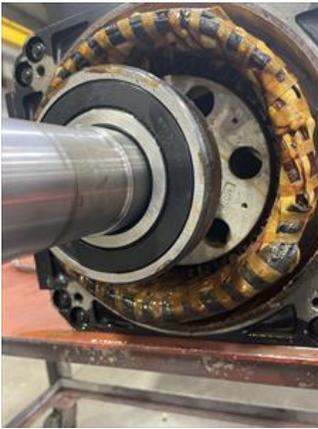
27. Drive End Bearing Brand	Fag
-----------------------------	-----

Sealed bearing

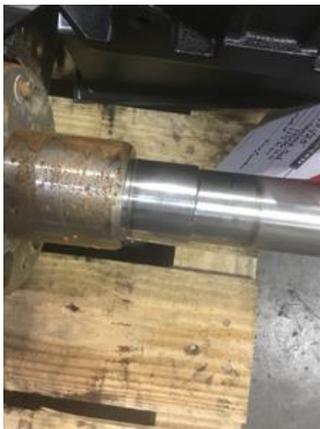
51. Shaft Runout			
52. Rotor Runout			
	Drive End Bearing Fit	Rotor Body	Opposite Drive End Bearing
53. Coupling Fit Closest to Bearing Housing			
	0 Degrees	90 Degrees	120 Degrees
54. Coupling Fit Closest to the end of the Shaft			
	0 Degrees	60 Degrees	120 Degrees
55. Drive End Bearing Shaft Fit			P66
	0 Degrees	60 Degrees	120 Degrees
	2.5592	2.5592	2.5592
	Tolerance is 2.5592-2.5597

56. Drive End Bearing Shaft Fit Condition	(P) Pass
---	----------

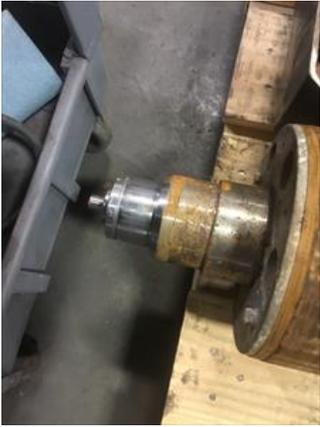
0 Degrees	60 Degrees	120 Degrees
2.1654	2.1654	2.1654

☐ *Tolerance is 2.1655-2.1660*

● 58. Opposite Drive End Bearing Shaft Fit Condition (P) Pass

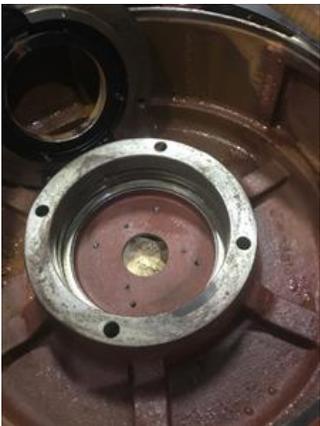
0 Degrees	60 Degrees	120 Degrees
4.7255	4.7255	4.7255

☐ *Tolerance is 4.7244-4.7253. .0002 over tolerance recommend no machine work*

● 63. Opposite Drive End - Endbell Bearing Fit Condition (P) Pass
