AC Inspection as Found

MOTOR - KTG USA

Description: 150 HP AC

Hi-Speed Job Number: 154703

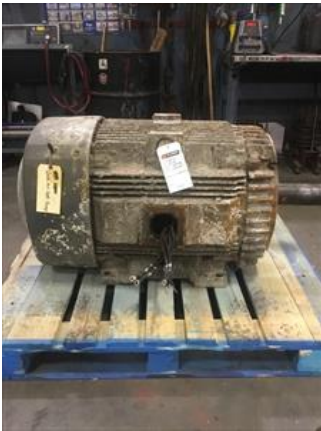
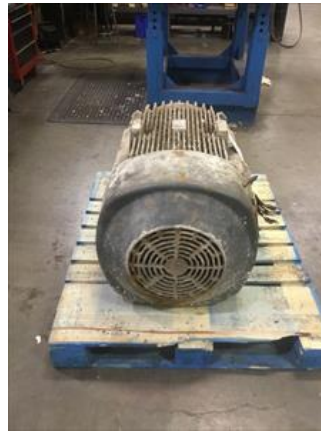
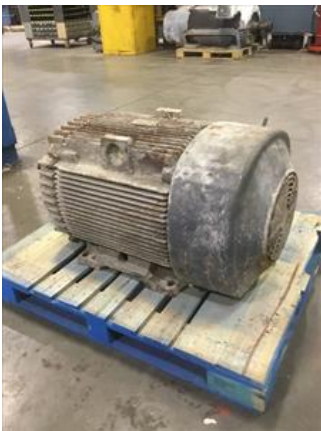
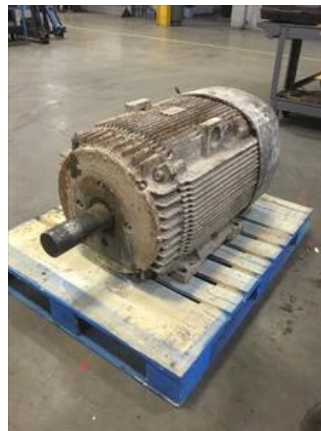
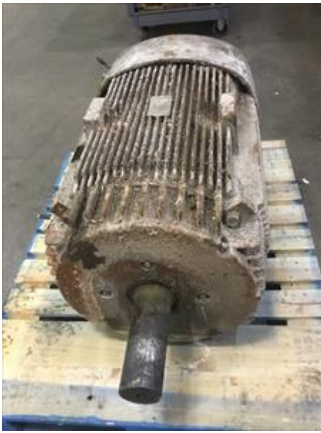
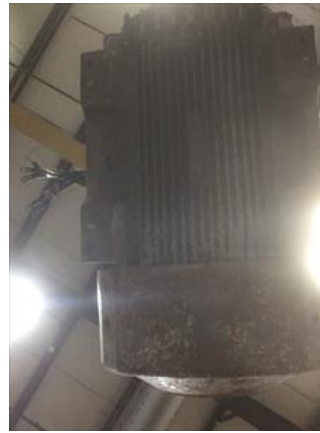
3. Photos of all six sides of the machine.

4. Describe the Overall Condition of the Equipment as Received
Stator windings blown and requires rewind . Requires machine work to drive end.

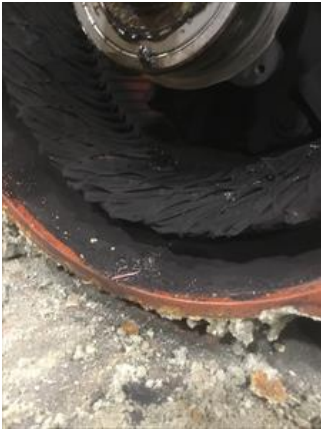
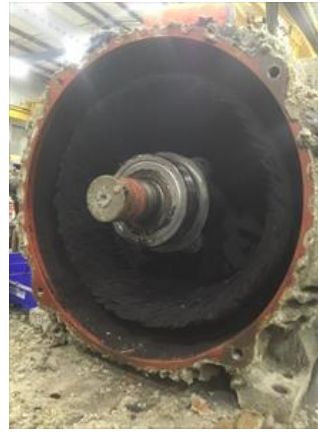
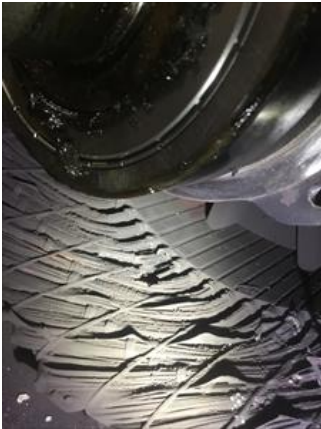
19.	Insulation Resistance/Megger	0 Megohms
20.	Winding Resistance	
	1-2	1-3
	0	0
21.	Perform Surge Test	(F) Fail
22.	Number of Stator Slots	72

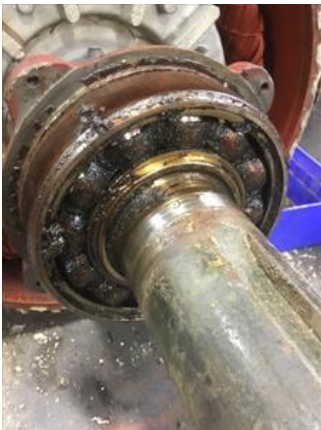
P26

33.	Drive End Bearing Condition	Normal wear	
34.	Opposite Drive End Bearing Brand	SKF	P34

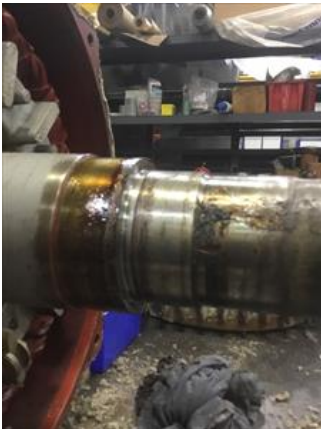
P54

0 Degrees	60 Degrees	120 Degrees
3.5437	3.5437	3.5437

Tolerance is 3.5434-3.5440

(P) Pass

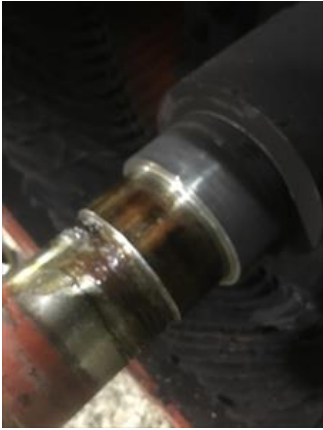
56. Opposite Drive End Bearing Shaft Fit

0 Degrees	60 Degrees	120 Degrees
2.7561	2.7561	2.7561

Tolerance is 2.7560-2.7565

57. Opposite Drive End Bearing Shaft Fit Condition (P) Pass

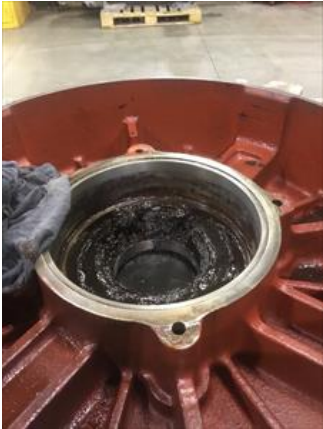
59. Drive End - Endbell Bearing Fit

0 Degrees	60 Degrees	120 Degrees
7.4825	7.482	7.4822

Tolerance is 7.4803-7.4814

60. Drive End - Endbell Bearing Fit Condition (F) Fail

65. List Machine Work Needed Below
Bore and bush Drive end.

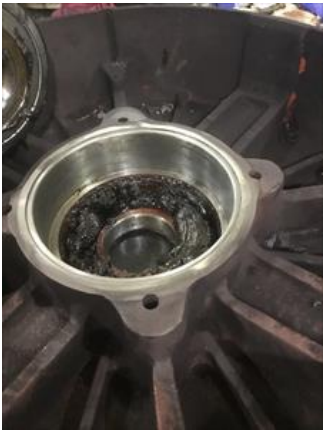
61. Opposite Drive End - Endbell Bearing Fit

0 Degrees	60 Degrees	120 Degrees
5.9058	5.9058	5.9058

Tolerance is 5.9055-5.9065

62. Opposite Drive End - Endbell Bearing Fit Condition (P) Pass
