Hi-Speed Industrial Service
7030 Ryburn Dr
Millington, Tn 38053
901-873-5300

AC Inspection as Found

USG Interiors
850 No Broadway
Greenville, MS 38701

Location: Millington Motorshop
Serial Number: S9027482-001005 AM
Description: 100 HP AC

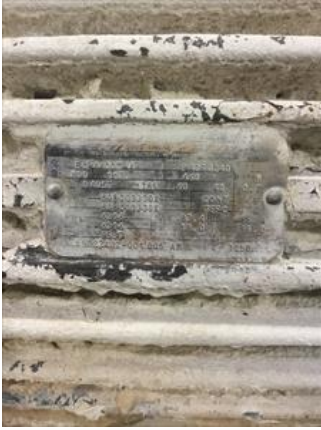
P2

2. Nameplate Picture

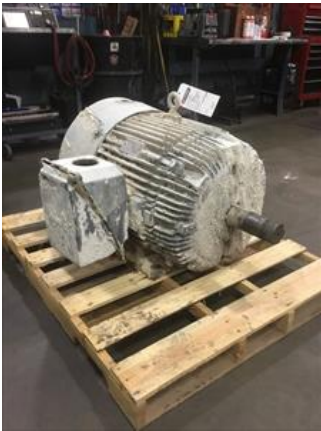
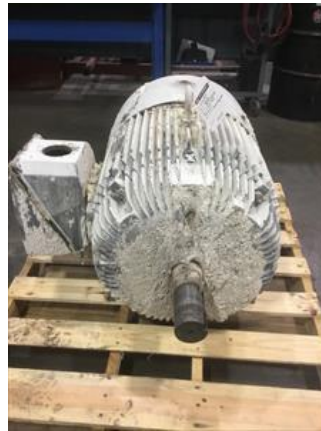
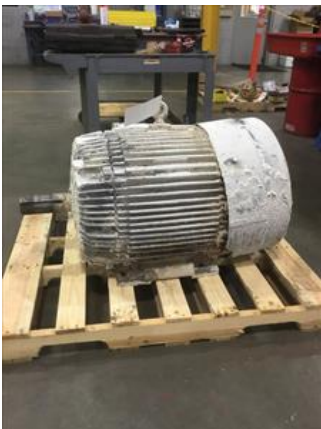
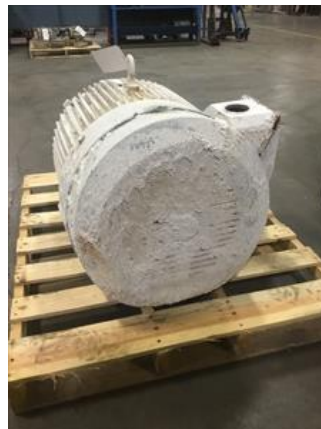
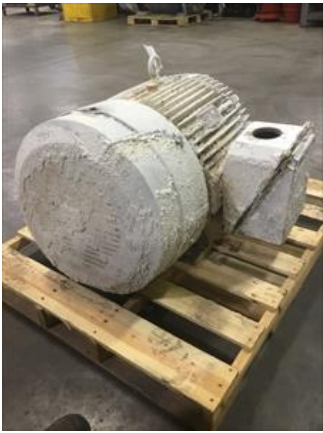
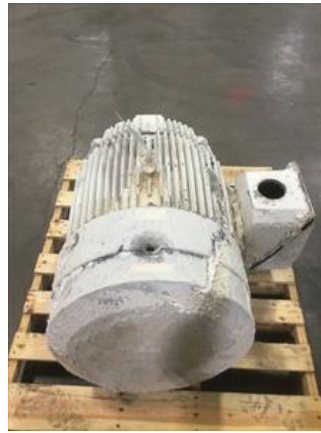
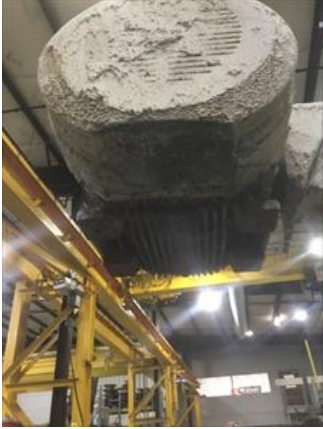
P3

3. Photos of all six sides of the machine.

Stator windings blown and requires rewind. No machine work required. Extra time involved with tear down due to bearings being stuck in end bells.

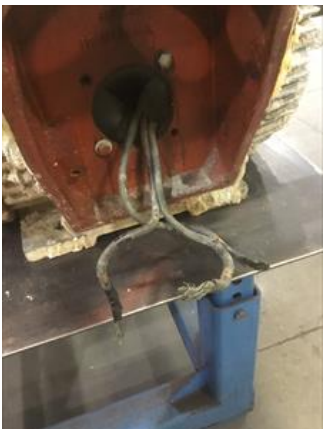
5. Does Shaft Turn Freely?	(Y) Yes	
6. Does the shaft require T.I.R in Lathe to identify additional repairs?	(No) No	
7. Does Shaft Have Visible Damage?	(No) No	
8. Assembled Shaft Runout	0.003 Inches	
9. Assembled Shaft End Play	0.002 inches	
10. Air Gap Variation <10%	No Provisions for Measurement	
11. Lead Condition	(P) Pass	P11

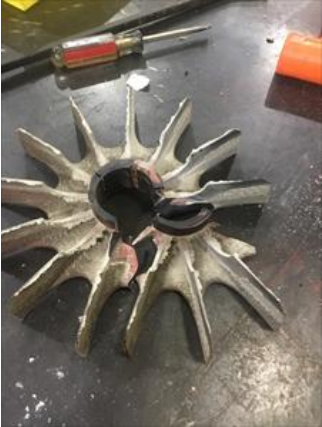
12.	Lead Length	14 Inches	
13.	Does it have Lugs?, If so what is the Stud Size?	(No) No	
14.	Lead Numbers	1-3	
15.	Frame Condition	Pass	
16.	Fan Condition	(F) Fail	P16
	<i>Cracked and broke.</i>

44. Rotor Type/Material	(Squirrel Aluminum) Squirrel Cage Aluminum Die Cast
45. Growler Test	(Pass) Pass
46. Number of Rotor Bars	46
47. Rotor Condition	Pass
48. List the Parts needed for the Repair Below <i>Fan</i>	
49. Signature of Technician that Disassembled Motor	Brandon Woodard

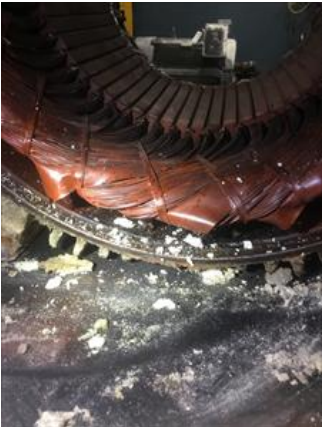
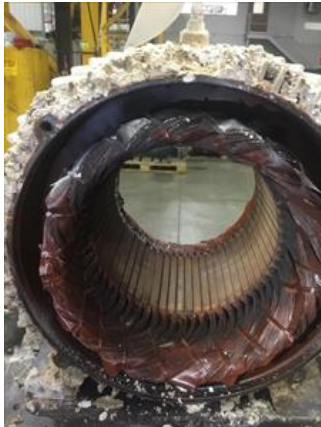
19.	Insulation Resistance/Megger	0 Megohms	
20.	Winding Resistance		
	1-2	1-3	2-3
	0	0	0
21.	Perform Surge Test	(F) Fail	
22.	Number of Stator Slots	60	
23.	Stator Condition	Requires rewind	P23
<div style="display: flex; justify-content: space-around;">

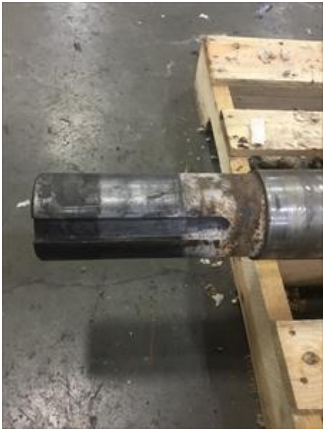
51. Rotor Runout			
Drive End Bearing Fit	Rotor Body	Opposite Drive End Bearing	
0.001	0.002	0.002	
52. Coupling Fit Closest to Bearing Housing			P52
0 Degrees	90 Degrees	120 Degrees	
2.875	2.875	2.875

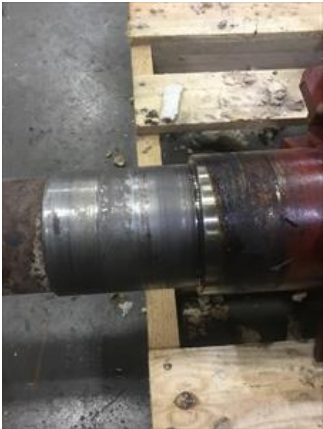
53. Coupling Fit Closest to the end of the Shaft			
0 Degrees	60 Degrees	120 Degrees	
2.875	2.875	2.875	
54. Drive End Bearing Shaft Fit			P54
0 Degrees	60 Degrees	120 Degrees	
3.1502	3.1502	3.1502

Tolerance is 3.1497-3.1502 </div>			
55. Drive End Bearing Shaft Fit Condition			(P) Pass

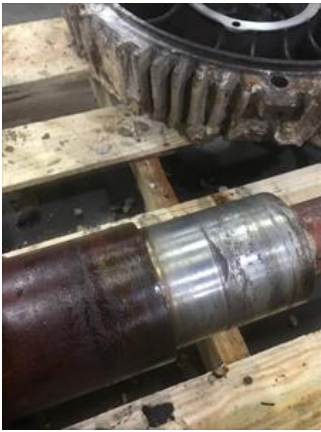
0 Degrees	60 Degrees	120 Degrees
3.1499	3.1499	3.1499

Tolerance is 3.1497-3.1502

57. Opposite Drive End Bearing Shaft Fit Condition (P) Pass
