AC Inspection as Found

Big River Steel (004767)

AC Inspection - Rev. 2

Location: Melt Shop

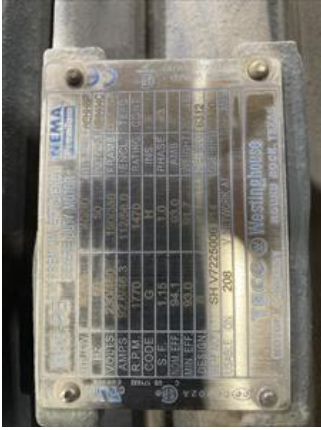
P2

2. Nameplate Picture

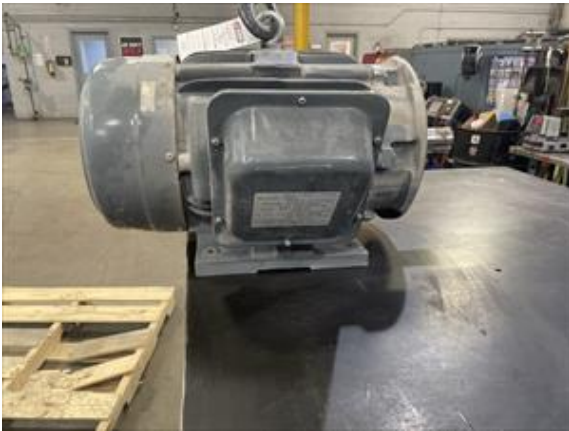
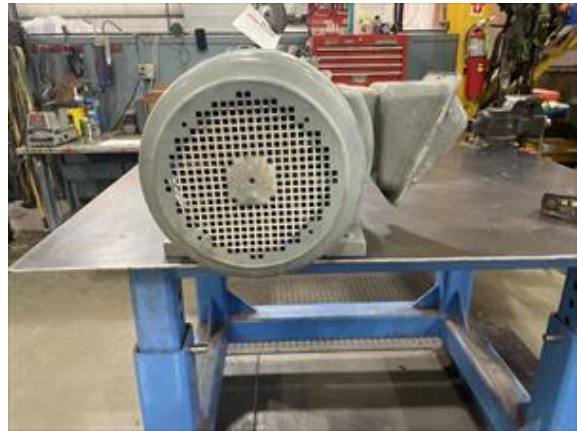
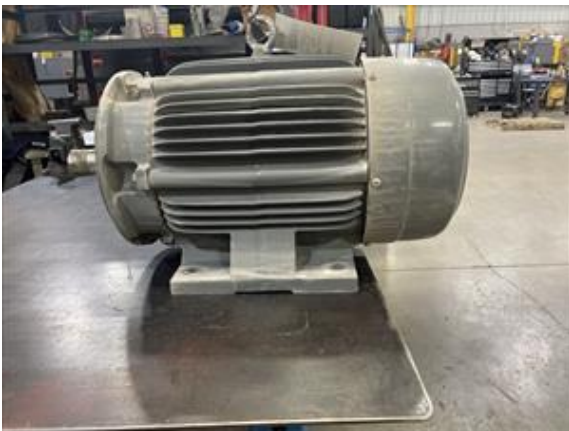
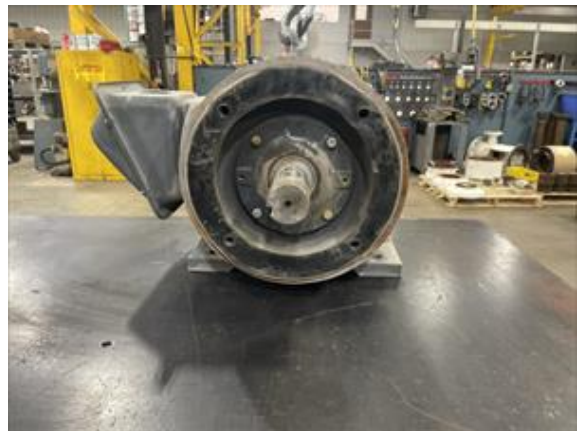
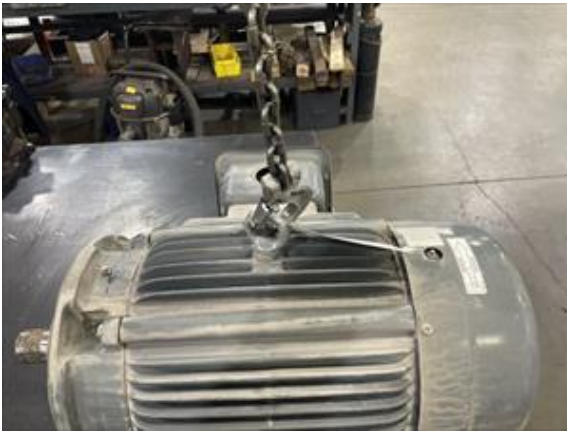
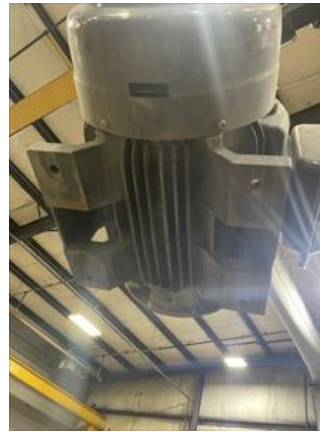
P3

3. Photos of all six sides of the machine.

4. Describe the Overall Condition of the Equipment as Received
Motor failed winding resistance and meg so it is in need of a rewind

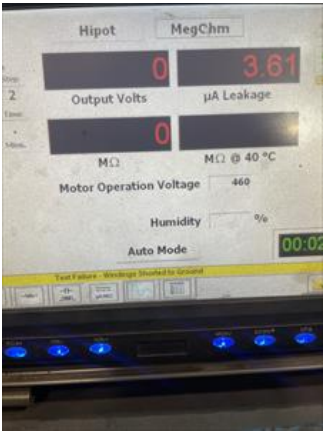
P19

19. Insulation Resistance/Megger

3.61 Megohms

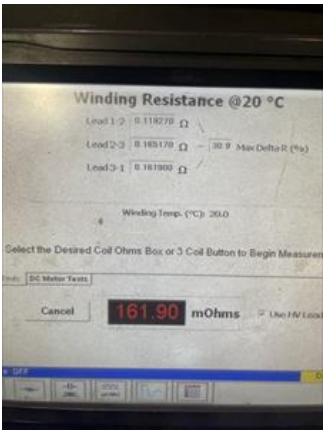
P20

20. Winding Resistance

1-2	1-3	2-3
.119	.161	.165

Failed winding resistance

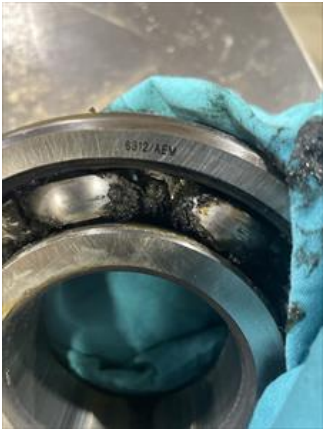
26.	Drive End Bearing Brand	skf	
27.	Drive End Bearing Number-	6312	P27

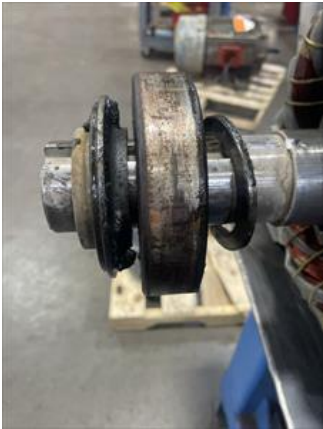
28.	Drive End Bearing Qty.	1	
29.	Drive End Bearing Type	(Ball) Ball Bearing	
30.	Drive End Lubrication Type	(Grease) Grease Lubricated	
31.	Drive End Bearing Insulation or Grounding Device?	none present	
32.	Drive End Wavy Washer/Snap-Ring Other Retention Device?	lock collar	P32
