**AC Inspection as Found**  
**MARS FOOD (0001269)**  
1098 N. Broadway  
Greenville, MS 38701

**AC Inspection - Rev. 2**

Description: 11KW AC

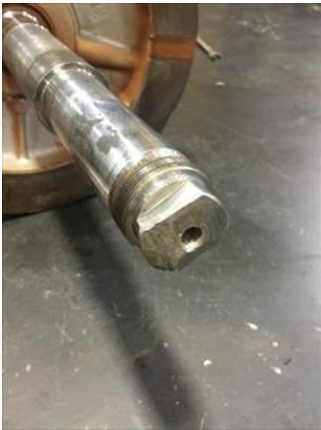
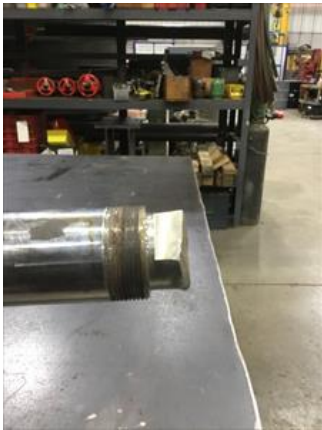
9. Does Shaft Have Visible Damage?	(Yes) Yes
<div style="display: flex; justify-content: space-around;">

4. Describe the Overall Condition of the Equipment as Received		
<i>Stator passed all electrical tests. Drive end bearing failed. Needs bore and bushing installed in opposite drive end and damaged end of shaft filed.</i>		
<input checked="" type="radio"/>	5. Is this a UL Listed Motor	(No) No
<input checked="" type="radio"/>	6. Is the motor water cooled or can be pressure checked before teardown	(No) No
<b>Initial Mechanical/Electrical</b>		<input type="checkbox"/>
<input checked="" type="radio"/>	7. Does Shaft Turn Freely?	(N) No
<input checked="" type="radio"/>	8. Does the shaft require T.I.R in Lathe to identify additional repairs?	(No) No

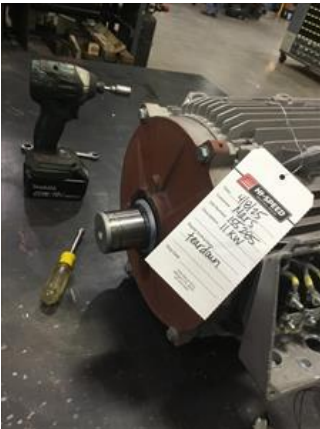
14. Lead Length	6 Inches	
15. Does it have Lugs?, If so what is the Stud Size?	(Yes) Yes	
#10		
16. Lead Numbers	UVW 1-2	
17. Are the Leads insulated with Chico or other material	(No) No	
18. Frame Condition	Pass	
19. Fan Condition	(N) NA	
20. Does motor have internal fan?	(No) No	
21. Broken or Missing Components	Yes	P21

Missing fan and fan shroud.

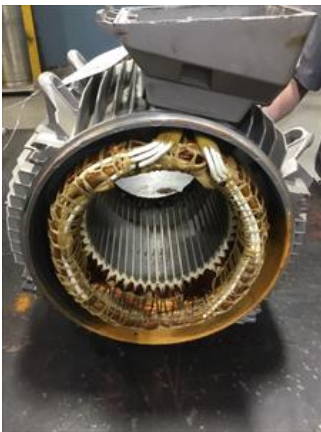
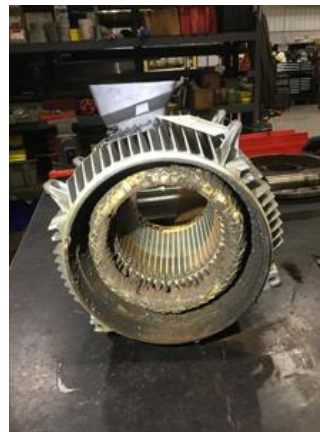
25. Number of Stator Slots	48	
26. Stator Condition	Pass	P26
<div>

<i>Stator had moisture present. Stator was dried out and retested.</i> </div>

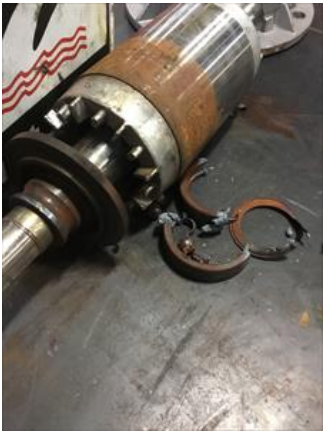
36. Drive End Bearing Condition	Destroyed	P36

*Drive end bearing.*

*No grease.*

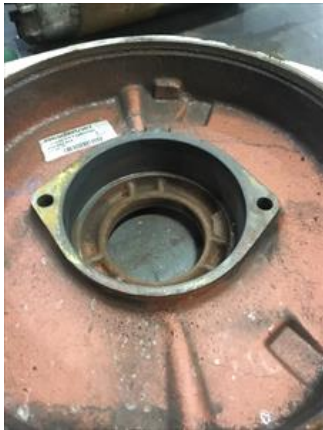
62.	Drive End - Endbell Bearing Fit			P62
	0 Degrees	60 Degrees	120 Degrees	
	3.9381	3.9381	3.9381	
	<div><div></div>Tolerance is 3.9370-3.9379. .0002 over tolerance recommend no machine work</div>

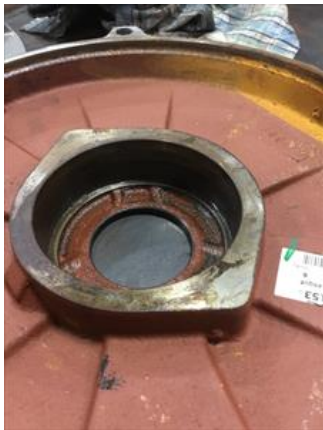
63.	Drive End - Endbell Bearing Fit Condition			(P) Pass
64.	Opposite Drive End - Endbell Bearing Fit			P64
	0 Degrees	60 Degrees	120 Degrees	
	3.5455	3.5452	3.5452	
	<div><div></div>Tolerance is 3.5433-3.5442</div>

65.	Opposite Drive End - Endbell Bearing Fit Condition			(F) Fail
66.	Bearing Cap Condition			
	Drive End Bearing Cap	Opposite Drive End Bearing Cap		
	Pass	N/A		
67.	End Bell Air Seal Fits			
	Drive End Air Seal	Opposite Drive End Air Seal		
	Pass	Pass		
68.	List Machine Work Needed Below			
	Bore and bush opposite driveend. Repair end of shaft.			
69.	Technician			Brandon Woodard
