AC Inspection as Found

MOTOR - KTG USA

AC Inspection - Rev. 2

Description: 50 HP AC

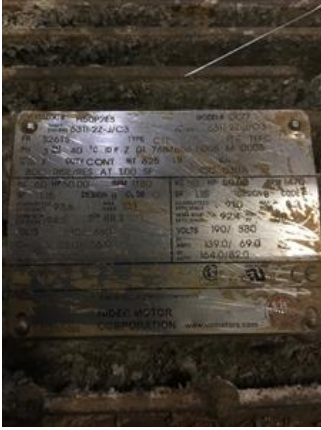
P2

2. Nameplate Picture

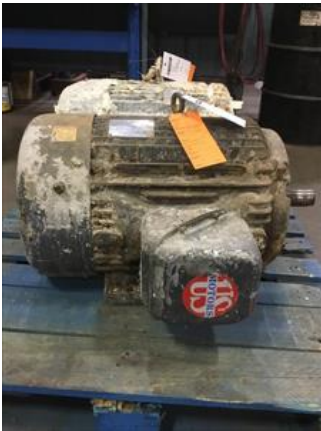
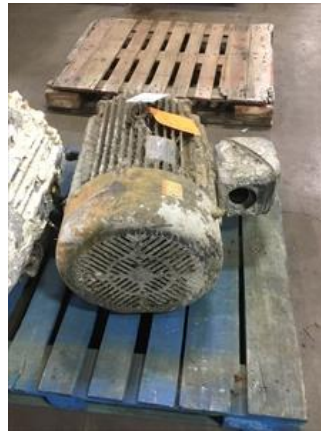
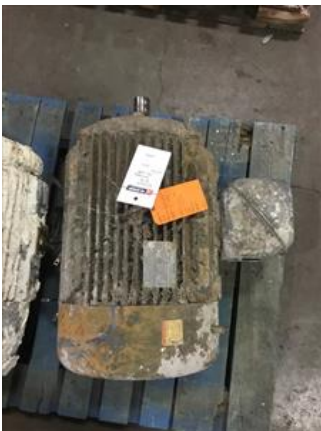
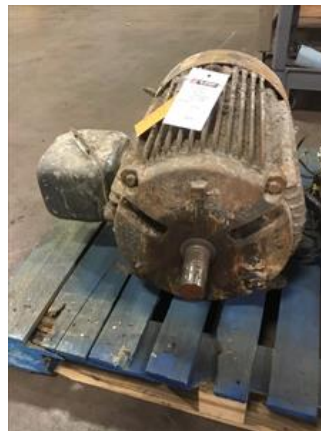
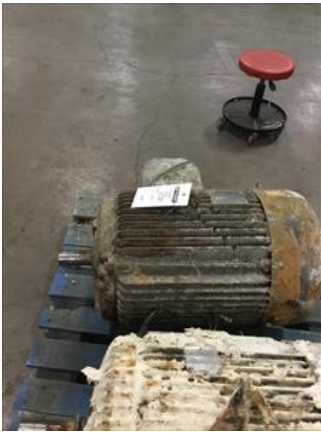
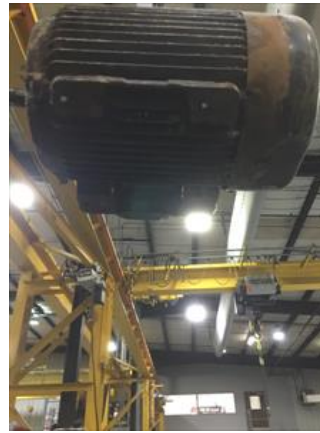
P3

3. Photos of all six sides of the machine.

4. Describe the Overall Condition of the Equipment as Received
Passed all electrical tests. Requires machine work to two bearing fits. Recommend recondition.

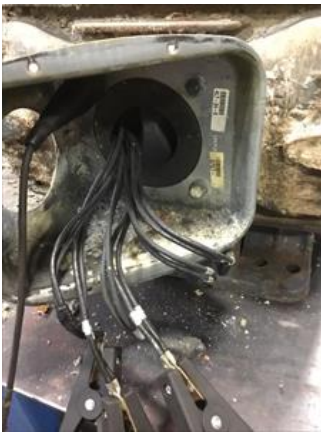
P13

| ● | 13. Lead Condition | (P) Pass |

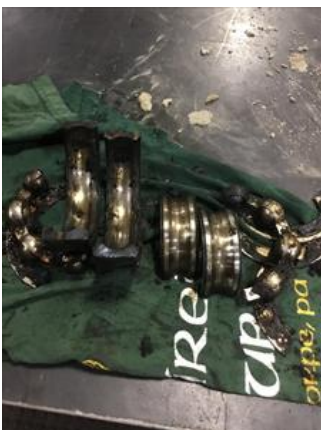
P36

36. Drive End Bearing Condition

Normal wear

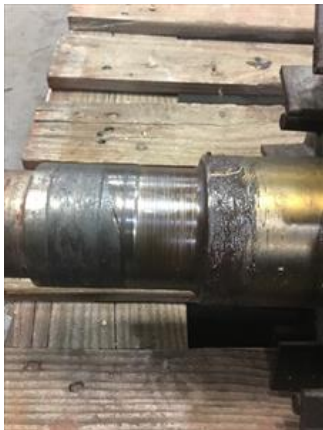
56.	Coupling Fit Closest to the end of the Shaft			
	0 Degrees	60 Degrees	120 Degrees	
	1.875	1.875	1.875	
57.	Drive End Bearing Shaft Fit			P57
	0 Degrees	60 Degrees	120 Degrees	
<div><div></div><div>Under cut and requires repair.</div></div>				
<div>

</div>				
<div></div> 58.	Drive End Bearing Shaft Fit Condition			(F) Fail
59.	Opposite Drive End Bearing Shaft Fit			P59
	0 Degrees	60 Degrees	120 Degrees	
	2.1653	2.1653	2.1653	
<div><div></div><div>Tolerance is 2.1655-2.1660. .0002 under tolerance recommend adding loctite during re assembly.</div></div>				
<div>

Repair Drive end shaft fit and opposite drive end end bell.

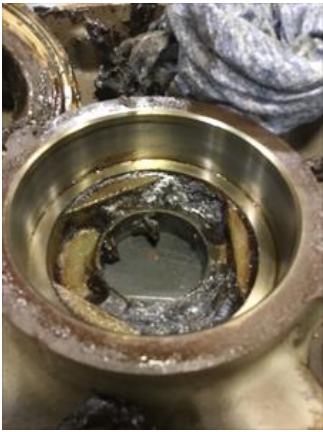
0 Degrees	60 Degrees	120 Degrees
4.7257	4.7258	4.7257

☐ Tolerance is 4.7244-4.7253. .0004 out of tolerance recommend no machine work.

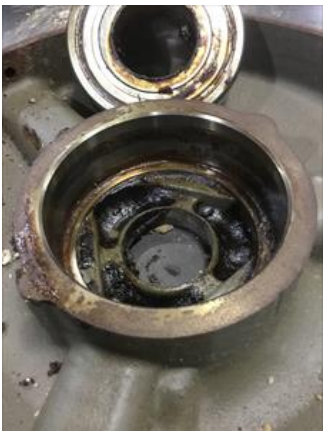
P65

64. Opposite Drive End - Endbell Bearing Fit

0 Degrees	60 Degrees	120 Degrees
4.7265	4.7263	4.7261

☐ Tolerance is 4.7244-4.7253. Out of tolerance and round. Requires repair

● 65. Opposite Drive End - Endbell Bearing Fit Condition (F) Fail
