AC Inspection as Found

Rich's Products (0003227)

AC Inspection - Rev. 2

Location: Shop
Serial Number: C2301031122
Description: 30 HP AC

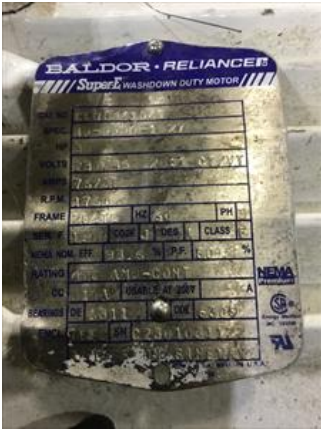
P2

2. Nameplate Picture

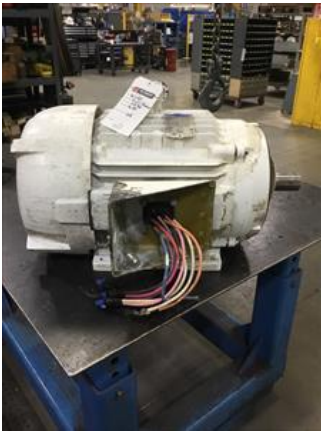
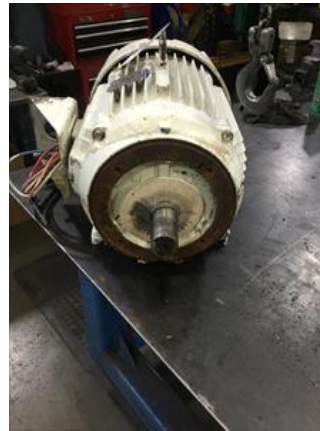
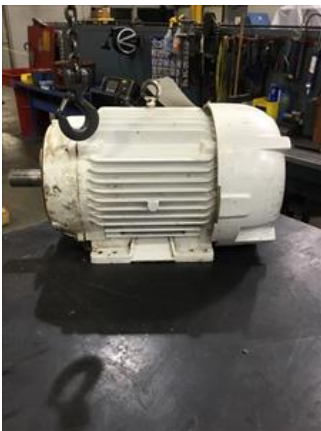
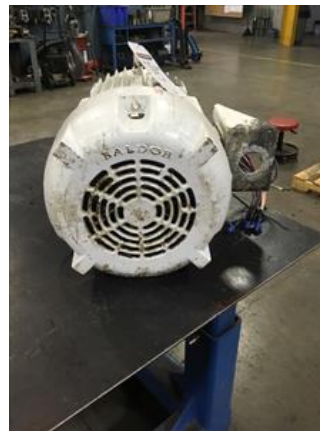
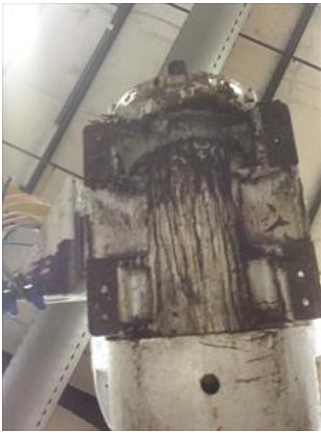
P3

3. Photos of all six sides of the machine.

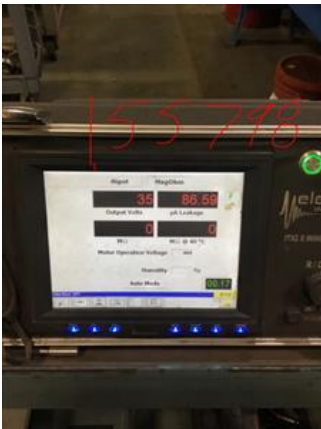
P22

| 22. Insulation Resistance/Megger | 0 Megohms |

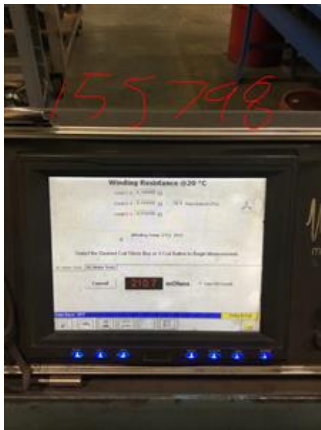
23. Winding Resistance		P23
1-2	1-3	2-3
<div>

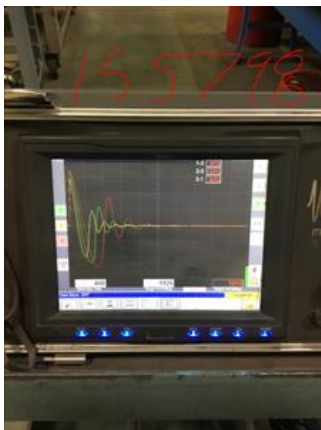
</div>		
24. Perform Surge Test	(F) Fail	P24
<div>

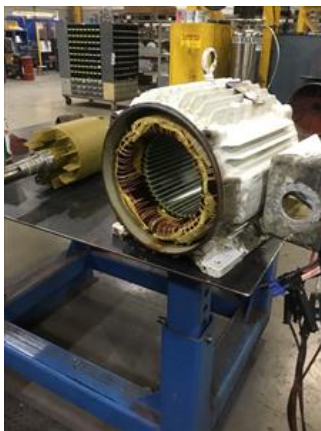
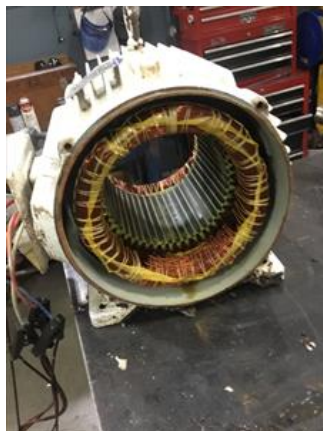
Failed electrical tests and requires rewind. No machine work.

</div>		
25. Number of Stator Slots	48	
26. Stator Condition	Requires rewind	P26
<div><div>

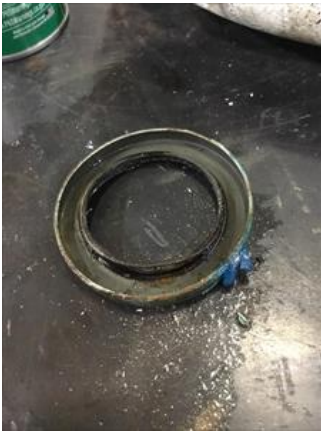
45.	Drive End Seal	Yes	P45
	VA45

6311 2rs C3
6309 2rs C3
VA 45 x2
cr19995 seal

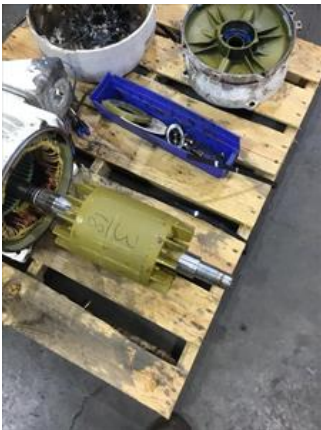
P50

50. Rotor Condition

Pass

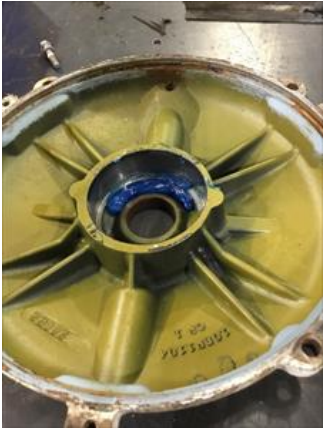
64. Opposite Drive End - Endbell Bearing Fit

0 Degrees	60 Degrees	120 Degrees
3.9377	3.9377	3.9377

Tolerance is 3.9370-3.9379
