AC Inspection as Found
GEORGIA PACIFIC GYPSUM
150 TEMPLE DR
CUMBERLAND, TN 37050

AC Inspection - Rev. 2

Description: 300 HP AC

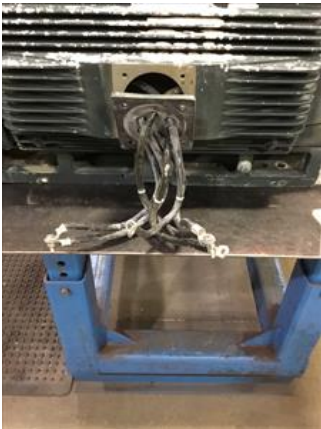
P13

13. Lead Condition (P) Pass

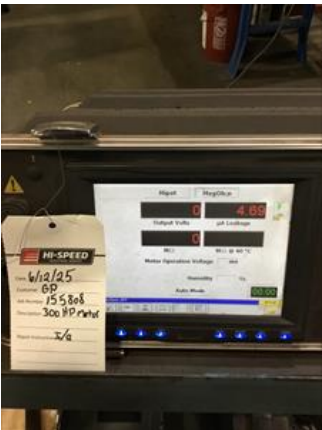
22. Insulation Resistance/Megger	0 Megohms	P22

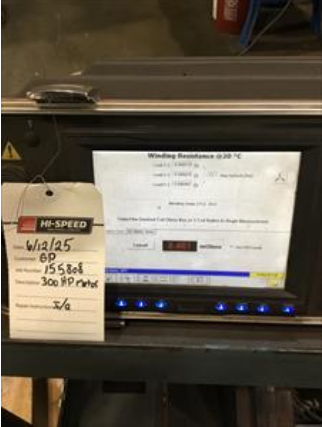
23. Winding Resistance	P23	
1-2	1-3	2-3

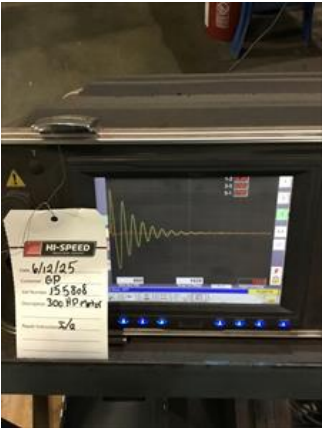
24. Perform Surge Test	(F) Fail	P24

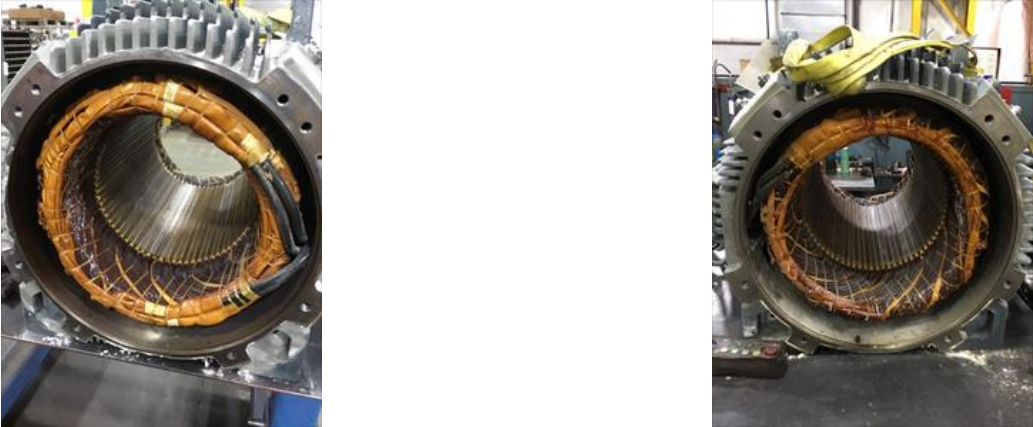
25. Number of Stator Slots	72	
26. Stator Condition	Requires rewind	P26

Windings blown

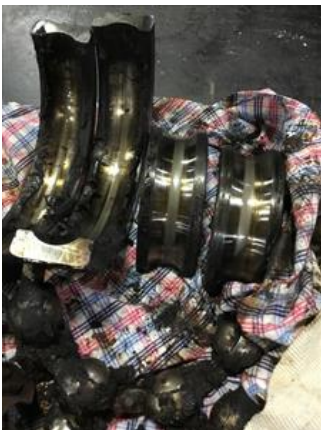
Windings grounded. No machine work. Bearings were heavily fluted . Recommend adding aegis ring and insulated bearing.

30. Drive End Bearing Number-	6318 C3	
31. Drive End Bearing Qty.	1	
32. Drive End Bearing Type	(Ball) Ball Bearing	
33. Drive End Lubrication Type	(Grease) Grease Lubricated	
34. Drive End Bearing Insulation or Grounding Device?	None	
35. Drive End Wavy Washer/Snap-Ring Other Retention Device?	Snap Ring	
36. Drive End Bearing Condition	heavy electrical fluting!	P36

47. Rotor Type/Material	(Squirrel Aluminum) Squirrel Cage Aluminum Die Cast	
48. Growler Test	(Pass) Pass	
49. Number of Rotor Bars	58	
50. Rotor Condition	Pass	
51. List the Parts needed for the Repair Below 6318 C3 6318 C3 insulated Aegis ring SGR-100.1-3FH [Mfr# SGR-100.1-129.5-3FH] VA90		
52. Signature of Technician that Disassembled Motor	Brandon Woodard

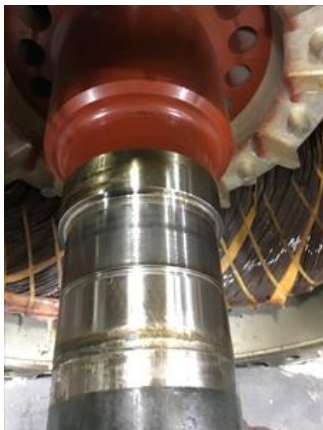
P57

0 Degrees	60 Degrees	120 Degrees
3.5438	3.5438	3.5438

Tolerance is 3.5434-3.5440

(P) Pass

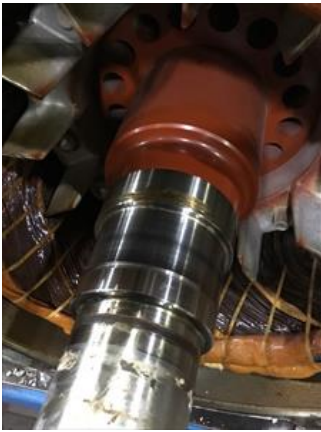
0 Degrees	60 Degrees	120 Degrees
3.5435	3.5435	3.5435

Tolerance is 3.5434-3.5440

(P) Pass

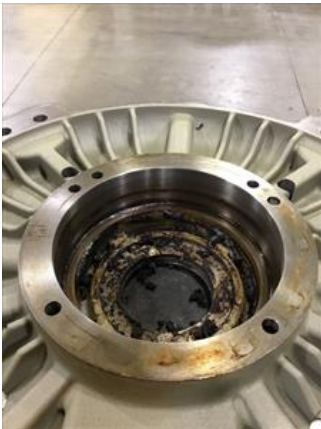
P62

0 Degrees	60 Degrees	120 Degrees
7.4816	7.4816	7.4816

Tolerance is 7.4803-7.4814. .0002 over tolerance recommend no machine work.

(P) Pass

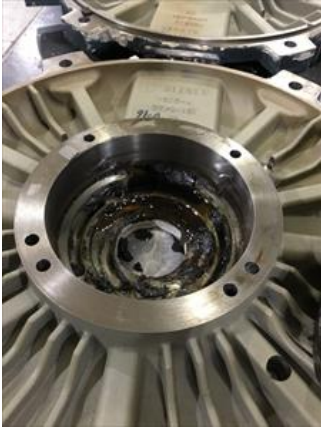
0 Degrees	60 Degrees	120 Degrees
7.4813	7.4813	7.4813

Tolerance is 7.4803-7.4814
