**Atlantic Dry Ice
Brandon, MS
3rd Quarter Infrared Survey Report
August 2025**

All three ammonia compressor MCC electrical panels were scanned using a **FLIR T865** infrared camera. The following report contains pictures of all items scanned during the survey. Below is our classification system for each defect included in this report. If there are any questions or comments, please feel free to contact us at any time.

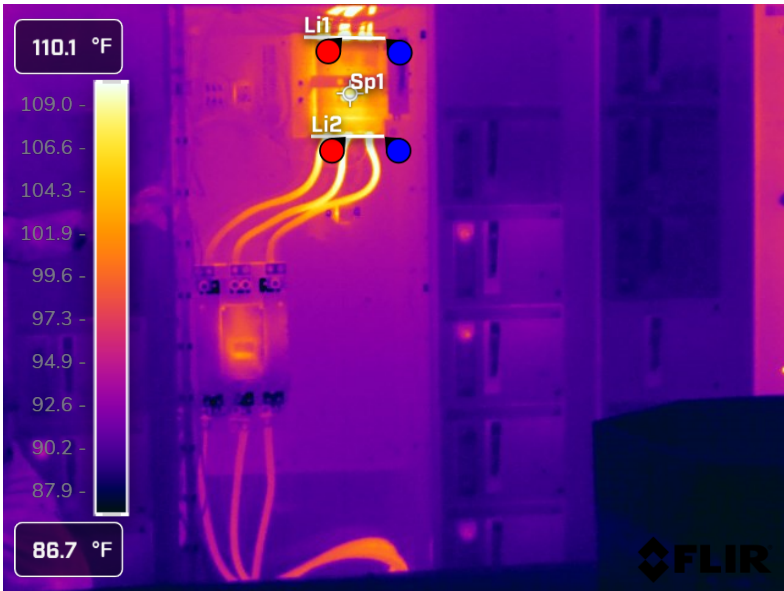
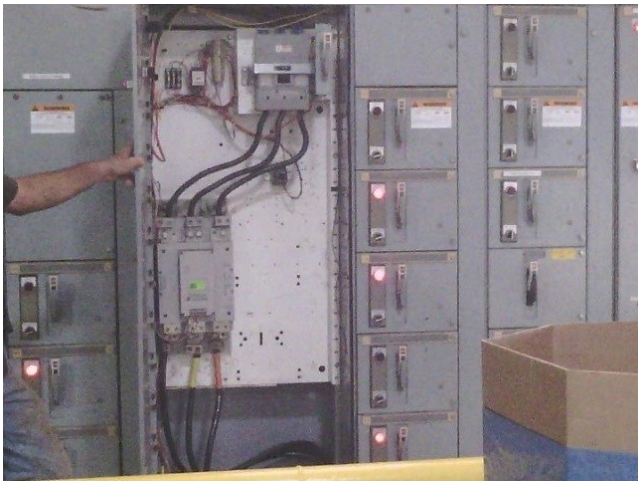
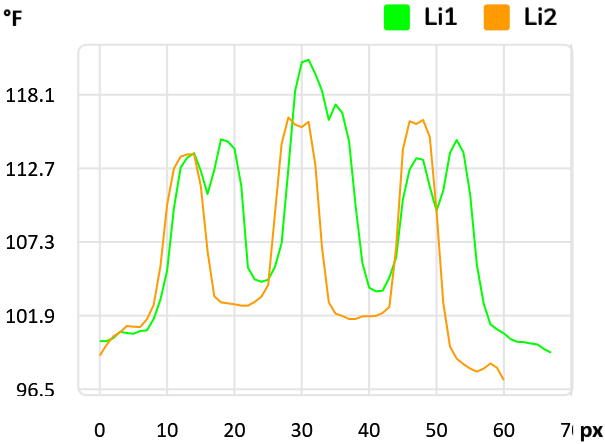
C-1

Breaker and starter

Li1	
Max	120.7 °F
Avg	108.0 °F
Min	99.2 °F
Li2	
Max	116.5 °F
Avg	105.5 °F
Min	97.2 °F
Sp1	
	108.6 °F

None

No issues to note this survey.

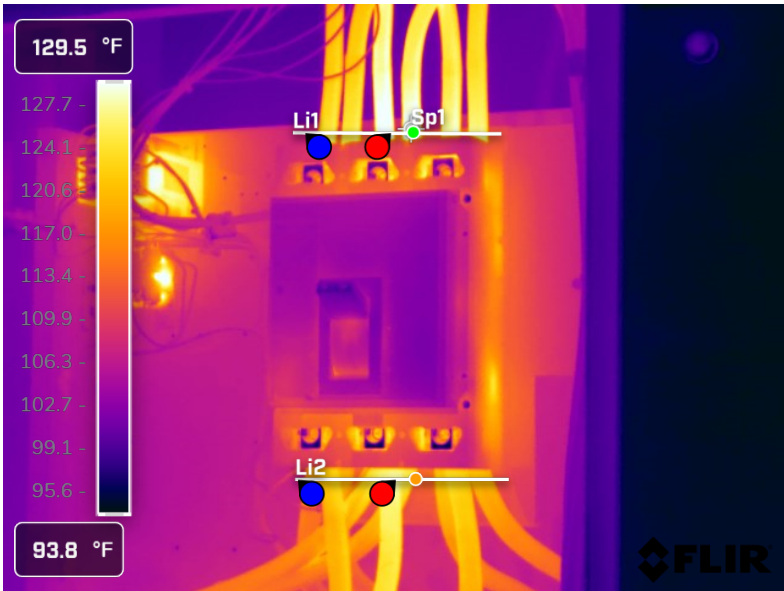
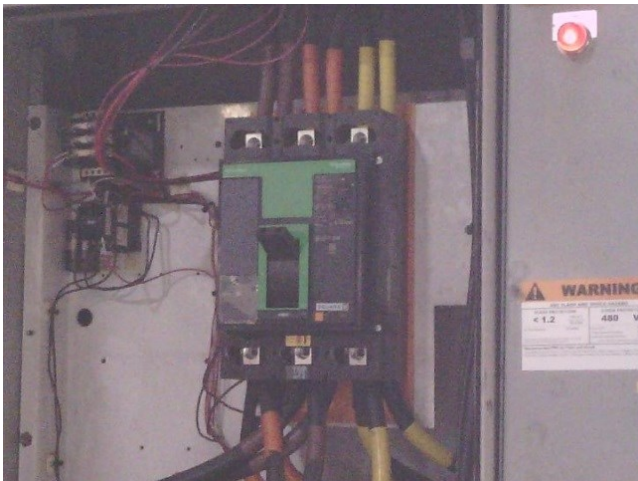
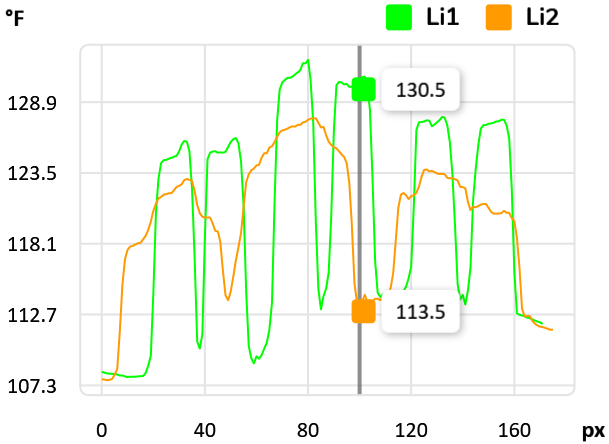
C-3

Breaker

Li1	
Max	132.2 °F
Avg	120.3 °F
Min	108.0 °F
Li2	
Max	127.7 °F
Avg	120.1 °F
Min	107.7 °F
Sp1	129.8 °F

None

No issues to note this survey.

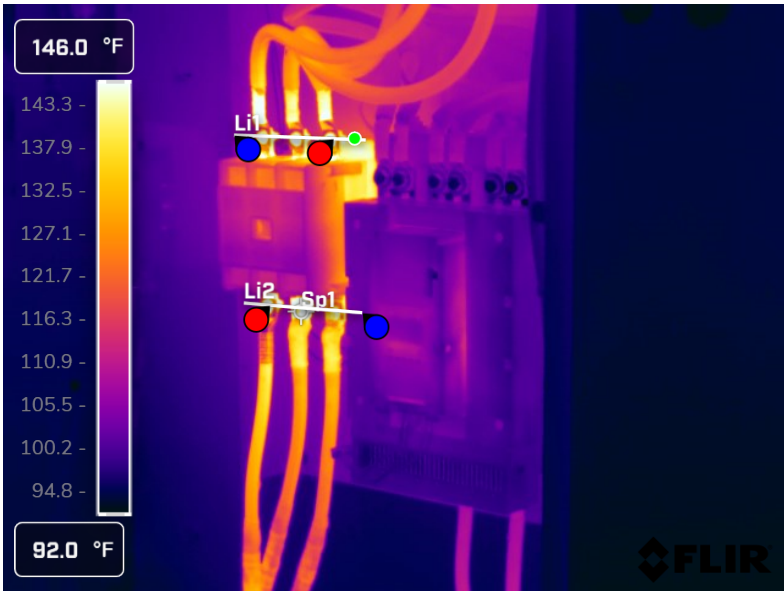
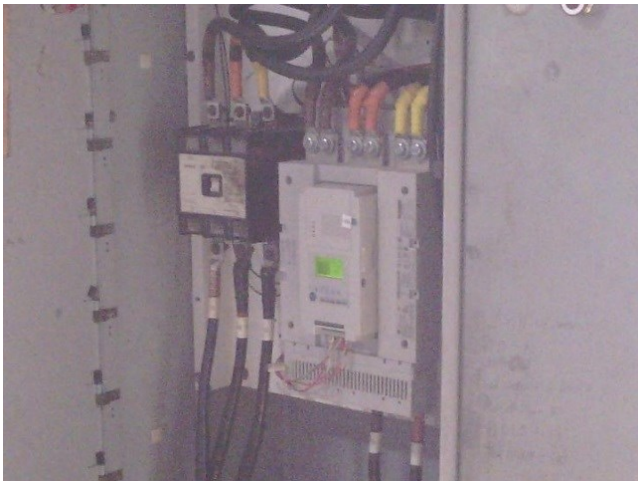
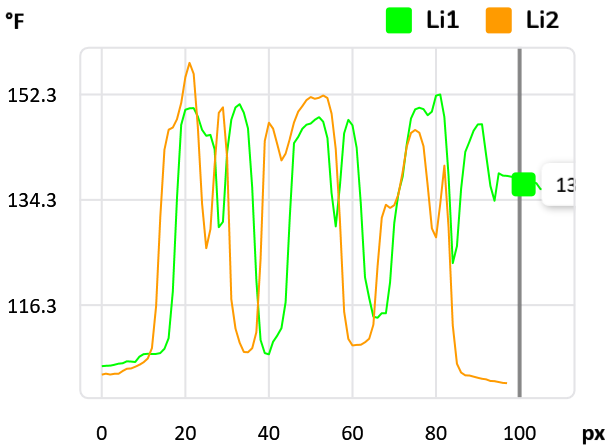
C-3

Starter and contactor

Li1	
Max	152.4 °F
Avg	132.6 °F
Min	105.9 °F
Li2	
Max	157.8 °F
Avg	126.9 °F
Min	103.0 °F
Sp1	147.6 °F

None

No issues to note this survey.

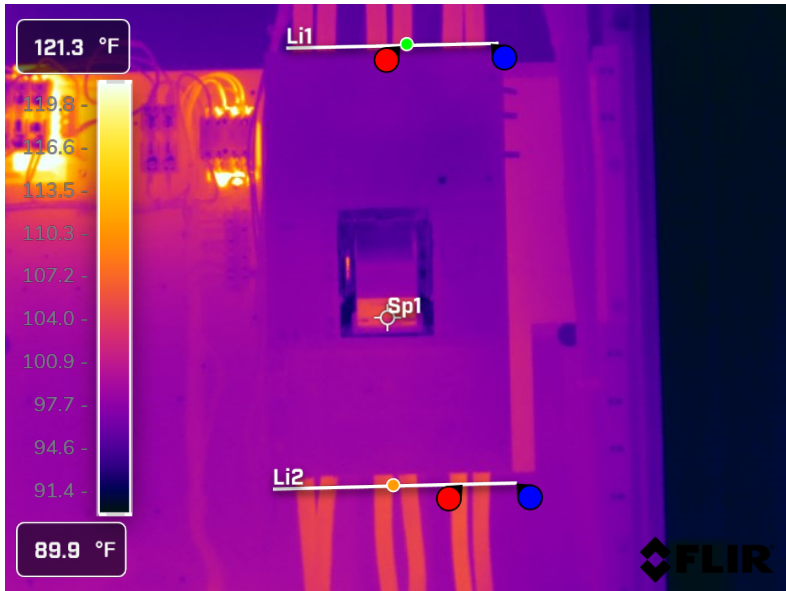
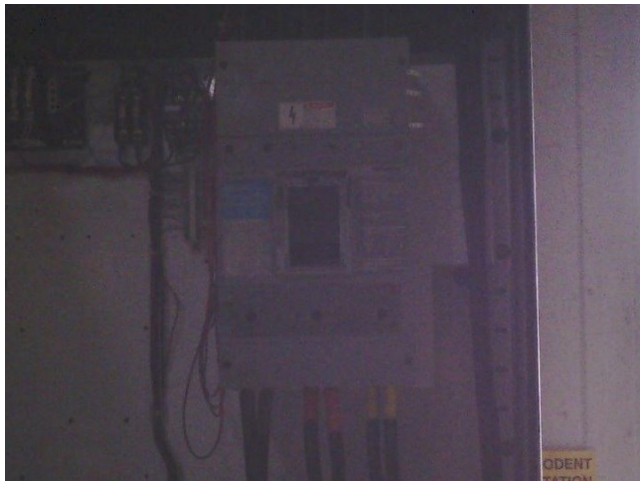
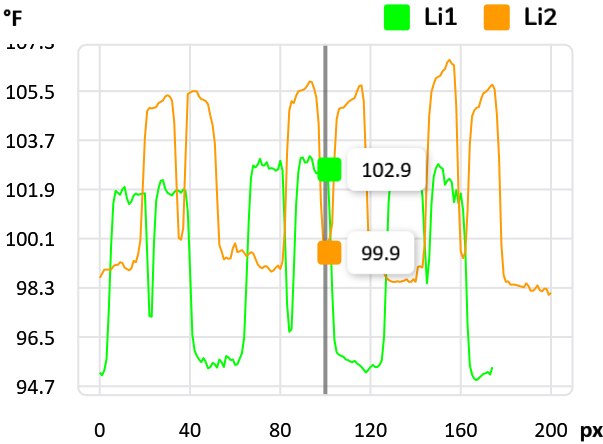
C-2

Breaker

Li1	
Max	103.2 °F
Avg	99.4 °F
Min	95.0 °F
Li2	
Max	106.7 °F
Avg	101.8 °F
Min	98.1 °F
Sp1	
	104.3 °F

None

No issues to note at this time.

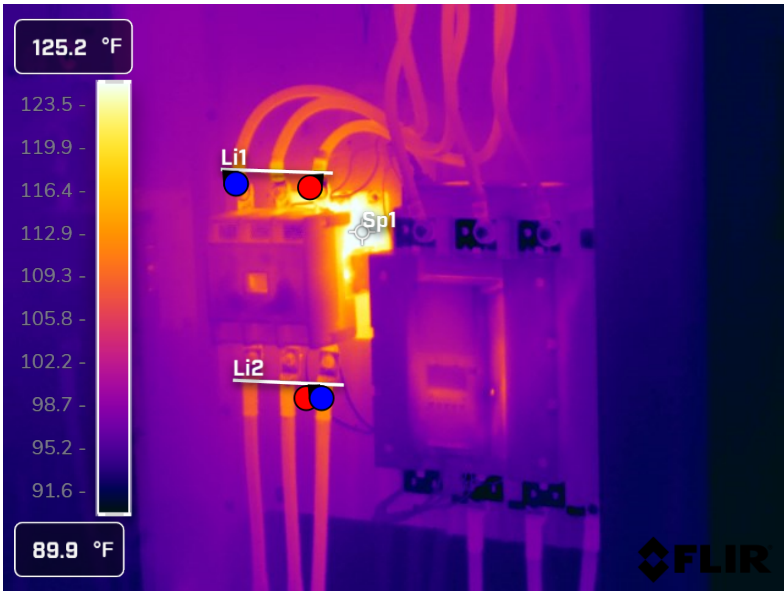
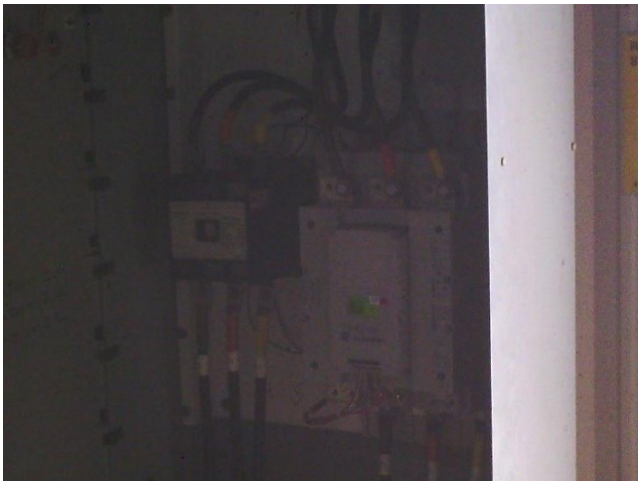
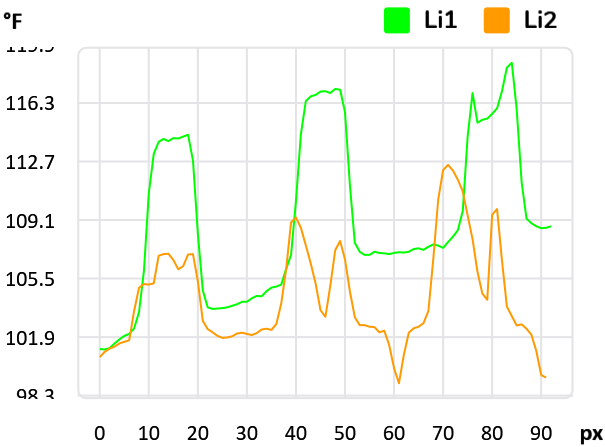
C-2

Starter and contactor

Li1	
Max	118.8 °F
Avg	109.2 °F
Min	101.2 °F
Li2	
Max	112.5 °F
Avg	104.4 °F
Min	99.1 °F
Sp1	
	125.7 °F

None

No issues to note at this time.
