## Gearbox Inspection

Quikrete (0001756)

Manufacturer:: Dodge

Model#:: TXT625ET

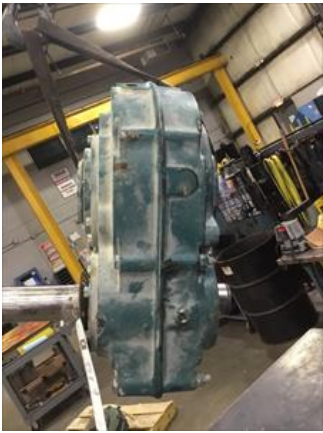
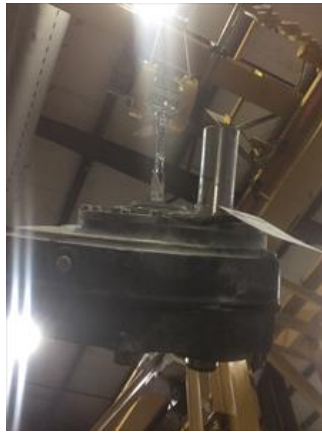
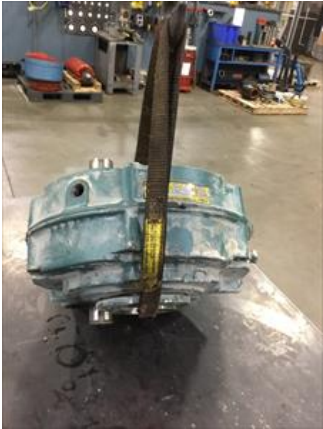
Wear

Physical

Contaminants

None

3. Gears:

normal

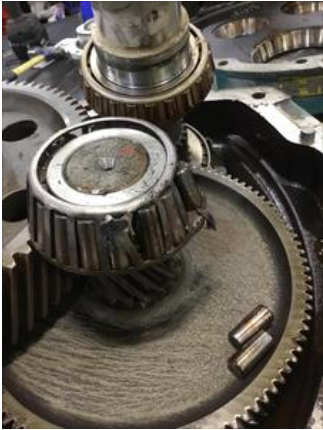
Ambient Temperature (F)		Humidity	
6. Physical Issues			
Signs of Excessive Heat?		Signs of Lubricant Leaks?

*Missing mounting hardware, breather, cover for any reverse bearing and anti reverse bearings needs new seal and bearings to recondition. Gear box was locked up from bearing failure.*
