**Atlantic Dry Ice
Brandon, MS
January 2025 Infrared Survey Report**

All electrical panels were scanned using a

**FLIR** T865 infrared camera. The following report only contains defects that were found during the survey. Below is our classification system for each defect included in this report. If there are any questions or comments, please feel free to contact us at any time.

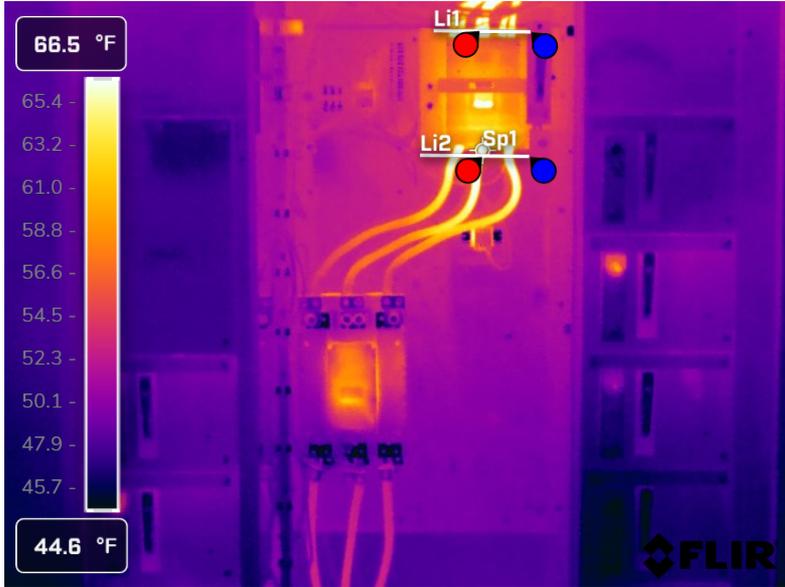
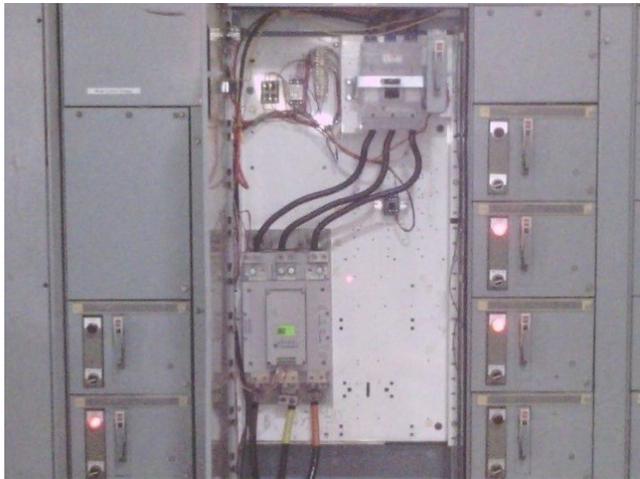
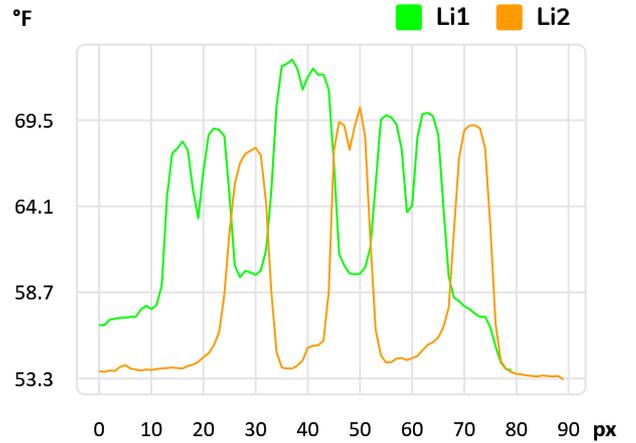
CM-1

Breaker/Starter

None

N/A

No issues to note.

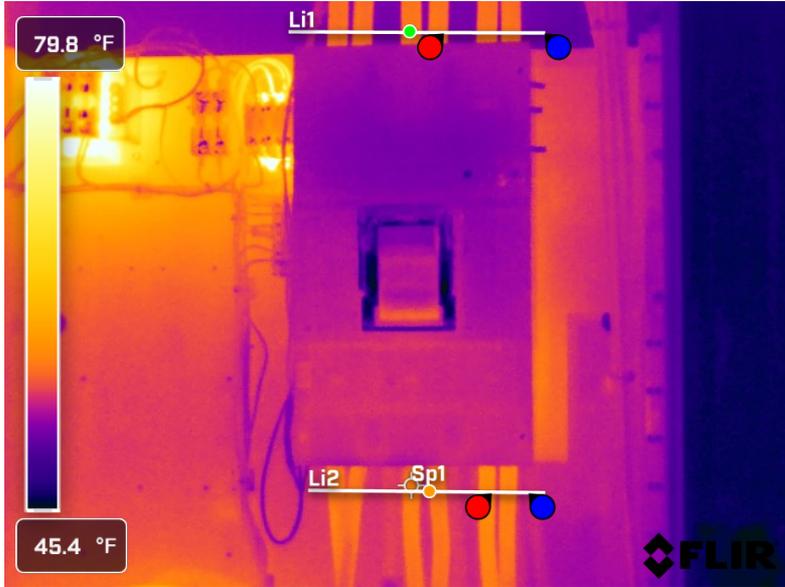
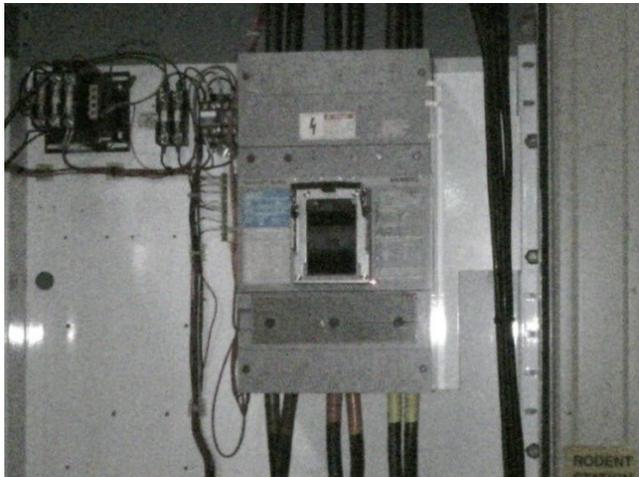
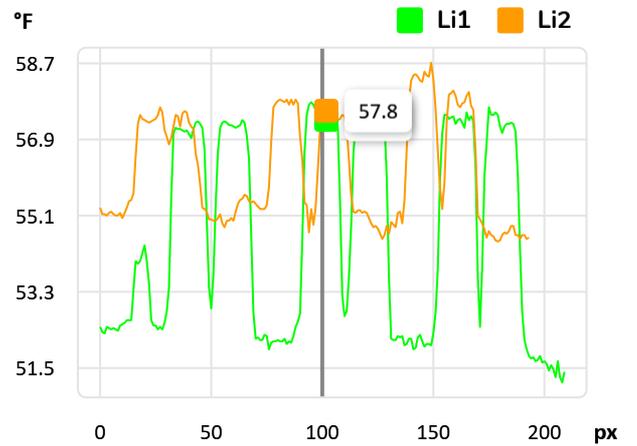
CM-2

Breaker

None

N/A

No issues to note

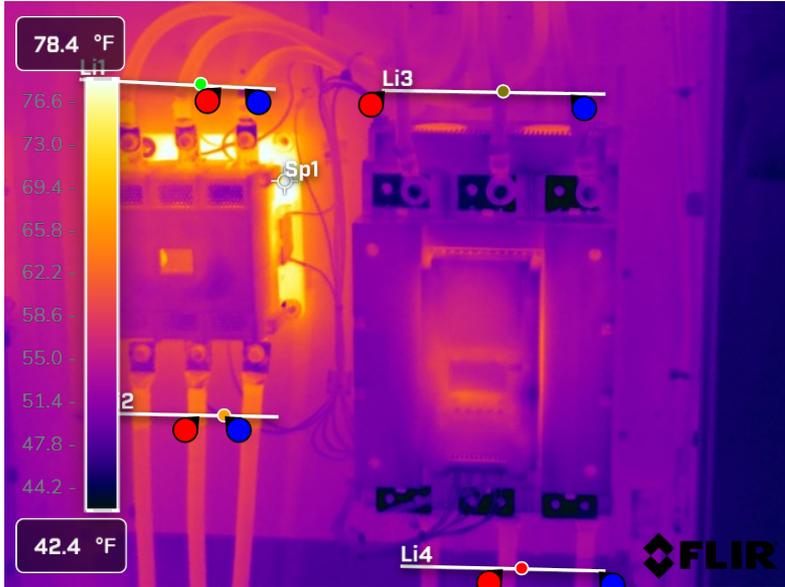
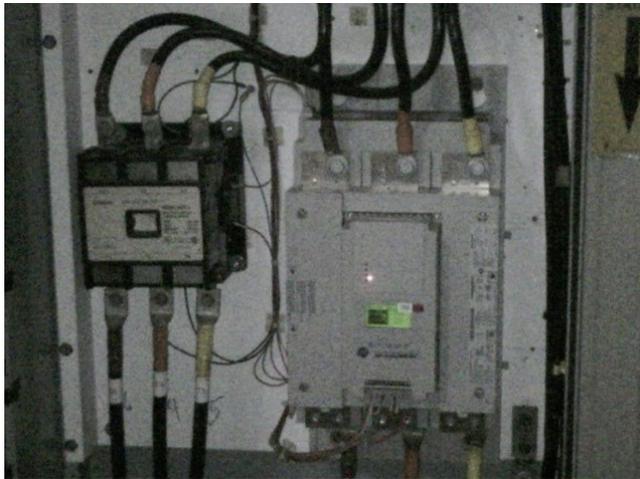
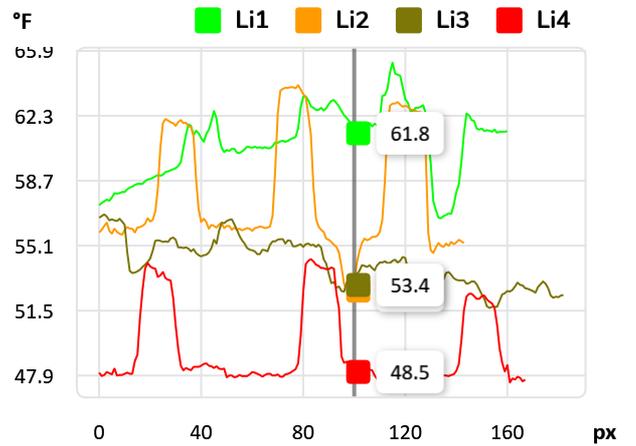
CM-2

Starter/Contactor

None

N/A

No issues to note.

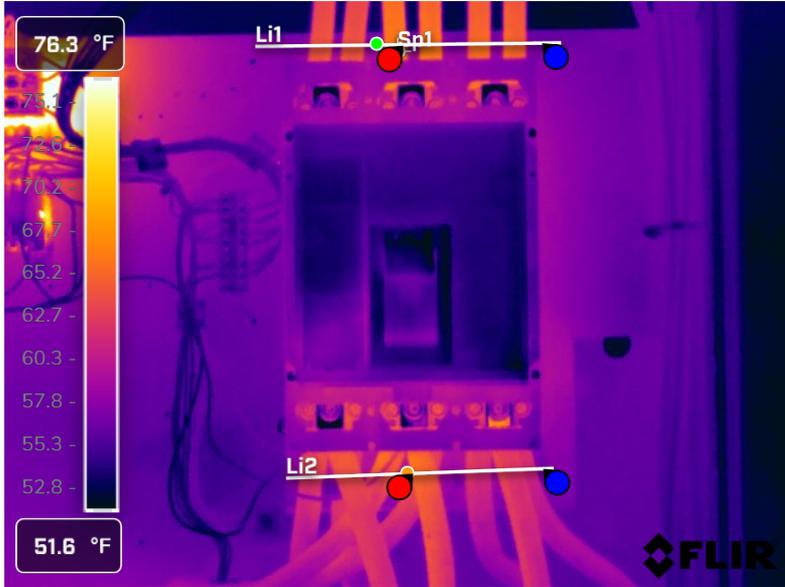
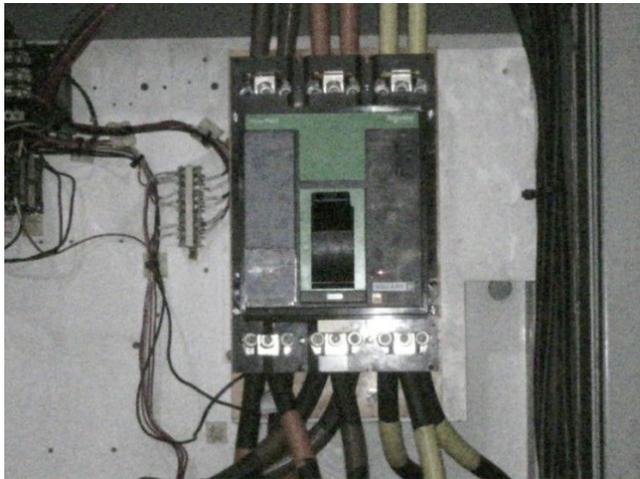
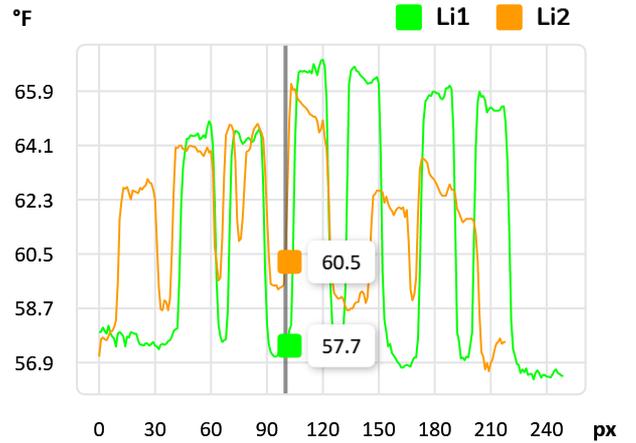
CM-3

Breaker

None

N/A

No issues to note.

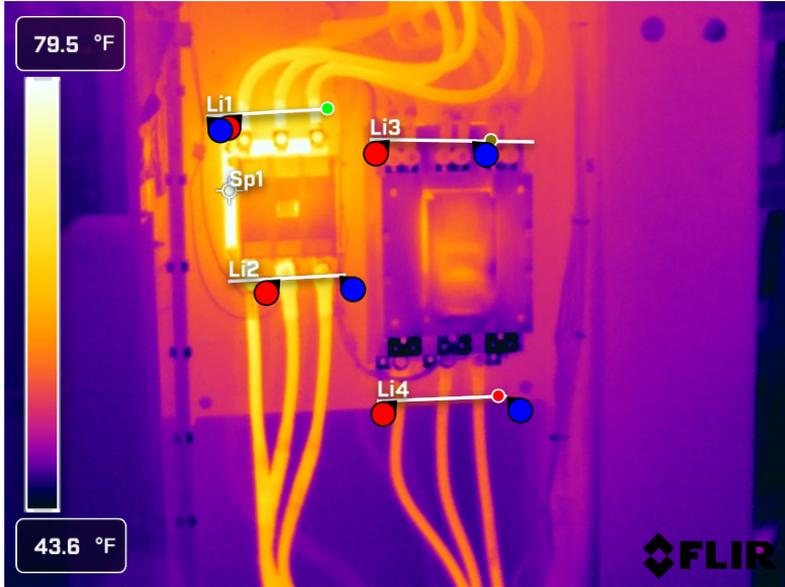
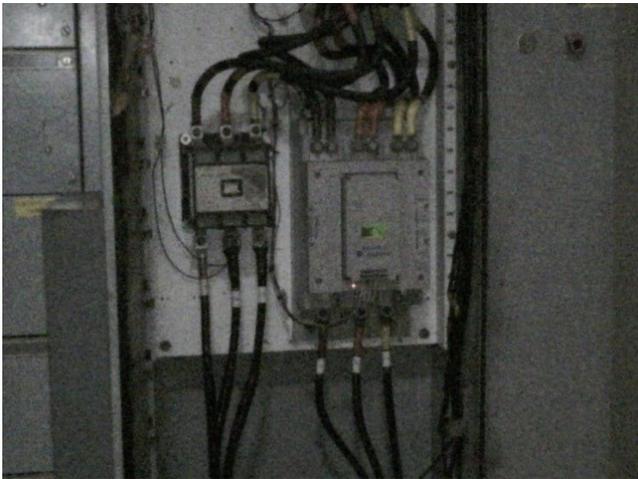
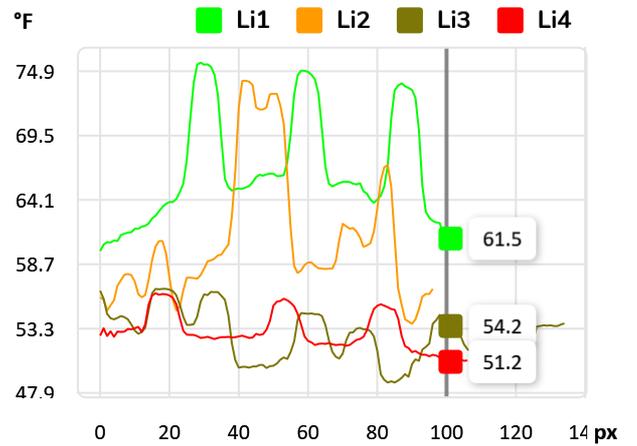
CM-3

Starter/Contactor

None

N/A

NO issues to note.
