**QualiTest® Diagnostics**

Nucor General Recycling

Subject: January vibration survey

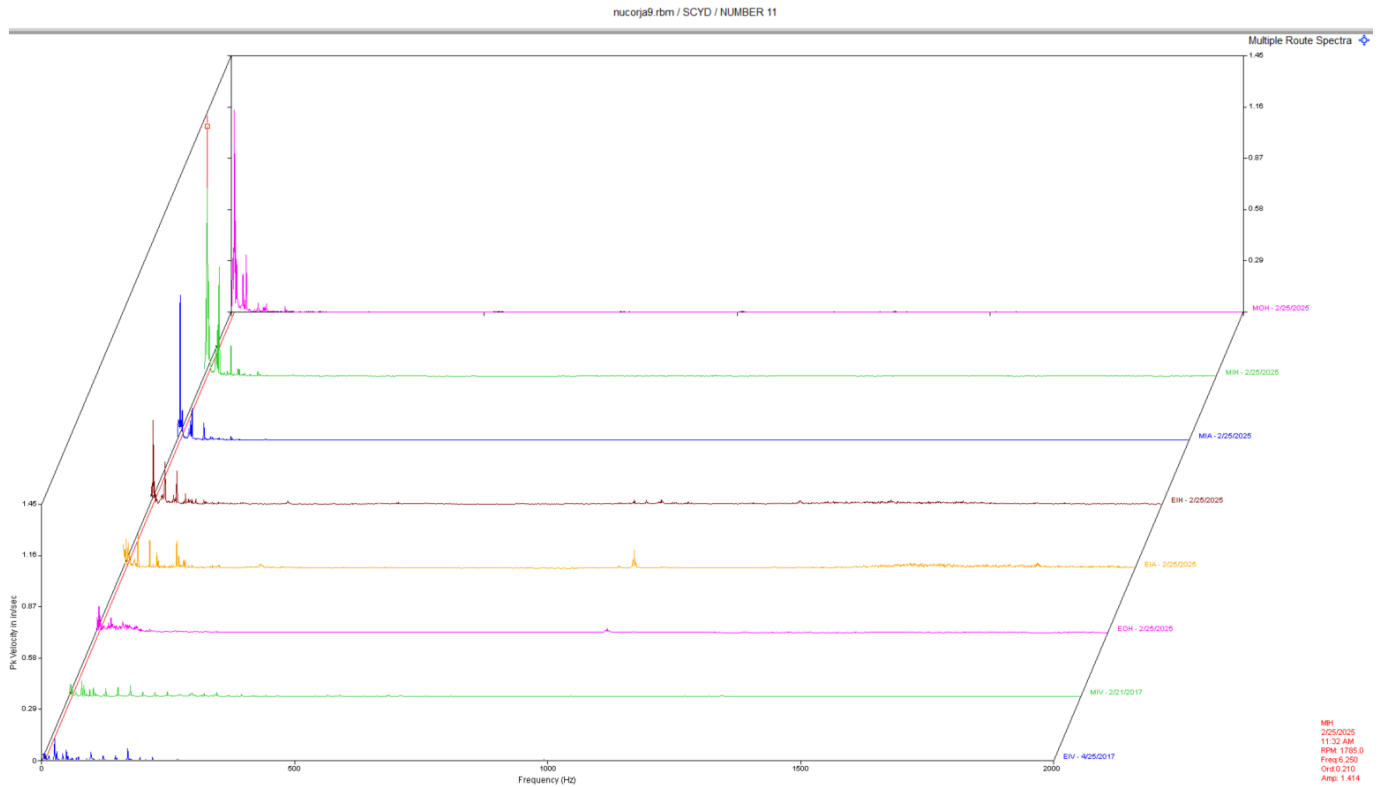
### Conveyor 11

Overall vibration is lower since last survey but still remains above alarm level. Vib appears to be at a low frequency of 6 Hz. This may be belt frequency or output frequency. Ensure sheaves are aligned properly. Ensure conveyor shaft or gear output shaft is not bent. Gearbox data also shows some signs of internal wear. Rated as a **CLASS II** defect.
