January 2025 Infrared Survey Report

All electrical panels were scanned using a

**FLIR T865** infrared camera. The following report only contains defects that were found during the survey. Below is our classification system for each defect included in this report. If there are any questions or comments, please feel free to contact us at any time.

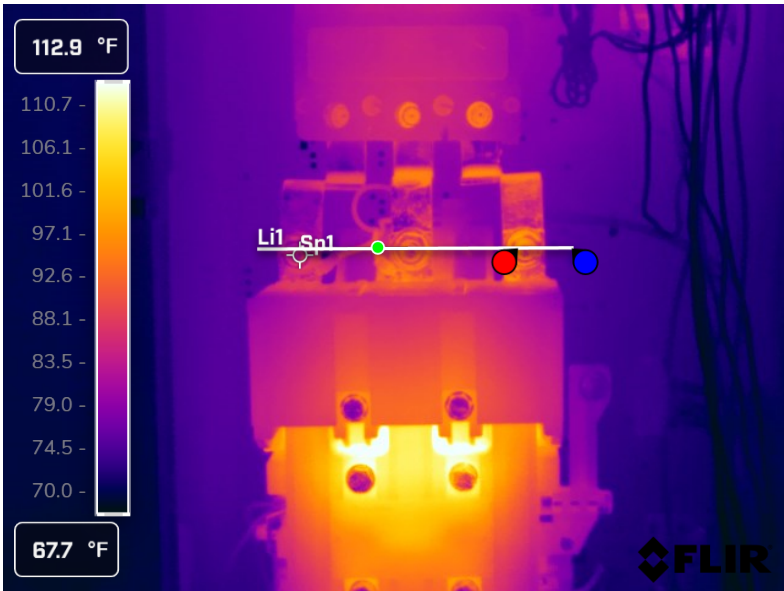
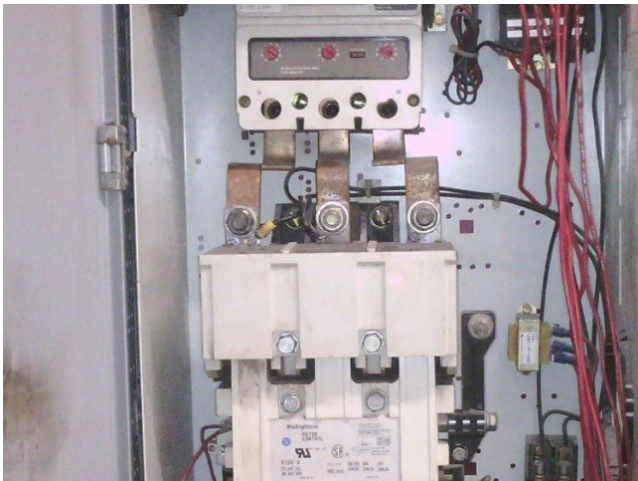
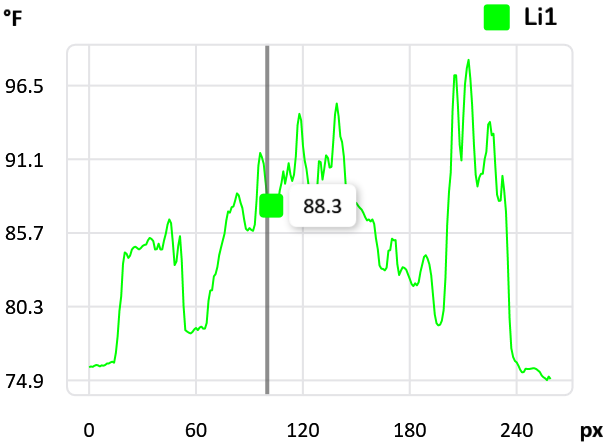
#7 Expander Dust Collector Fan M2248

RECHECK GOOD Starter Lug Connection A Phase

Li1	
Max	98.4 °F
Avg	85.0 °F
Min	74.9 °F
Sp1	83.2 °F

None

N/A

Recheck image shows no issues to report.

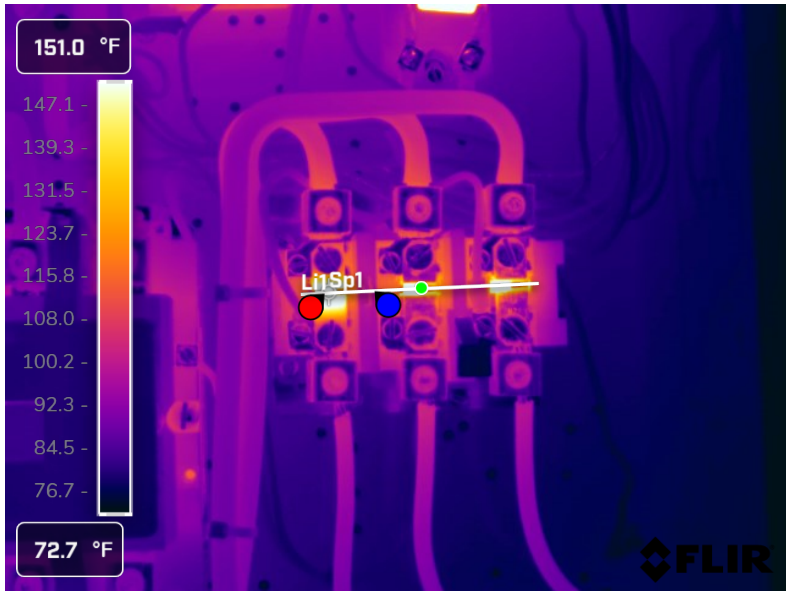
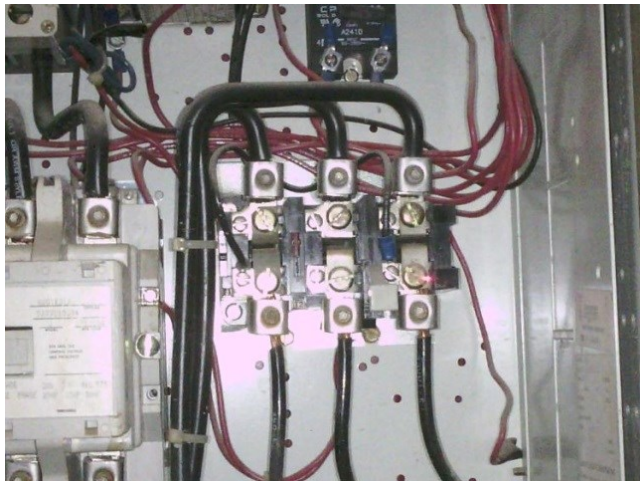
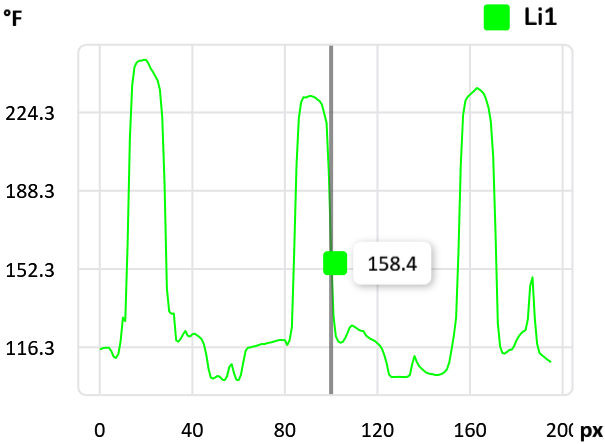
BOARD MILL Air Knife Blower M2746

Thermals

Li1	
Max	*248.6 °F
Avg	*143.6 °F
Min	101.2 °F
Sp1	*250.5 °F

Thermal Issue

CLASS II

IR image shows excessive heat on the thermals especially the A phase thermal. Temps are over 260 F on A Phase. It is recommended to replace thermals soon.

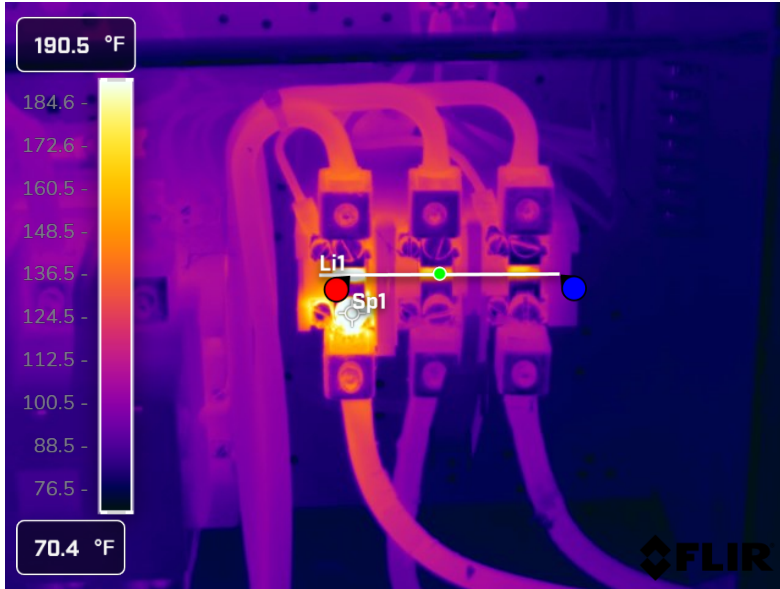
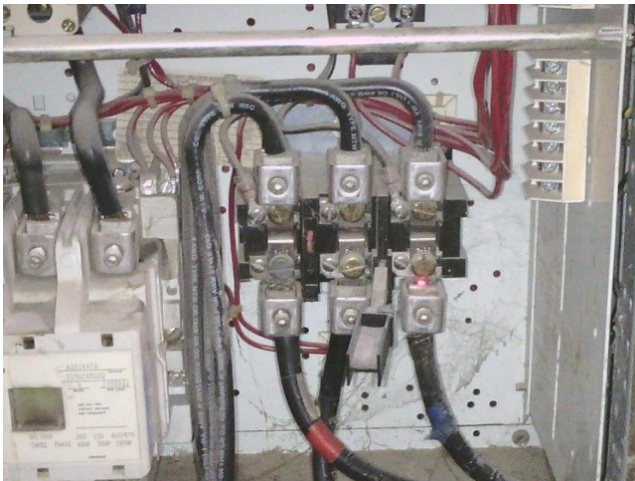
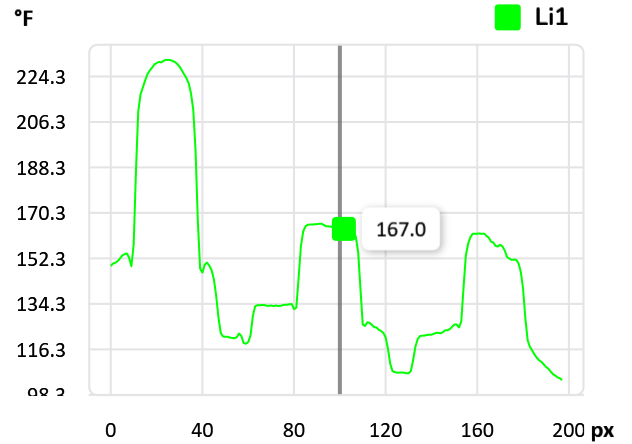
#3 Machine Whitewater Pump M1377

A phase lead connection

Li1	
Max	230.9 °F
Avg	148.8 °F
Min	104.2 °F
Sp1	192.0 °F

Faulty connection

CLASS II

A phase connection shows to have an significant issue. Disconnect, clean, and reconnect ensuring a clean and tight connection SOON.

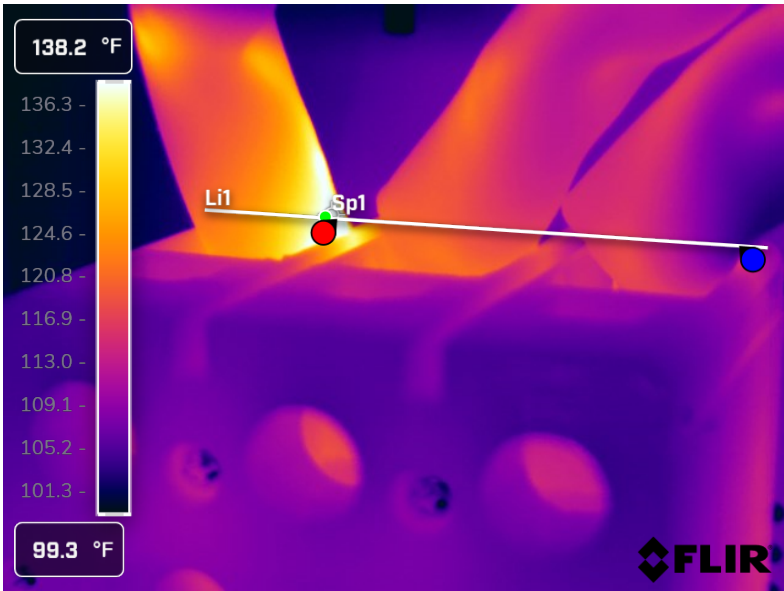
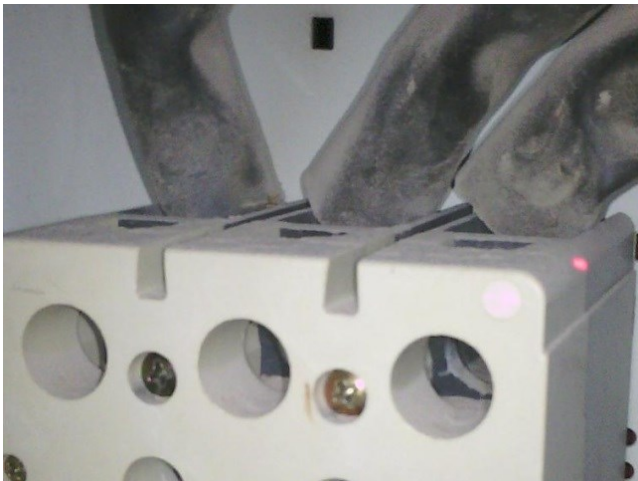
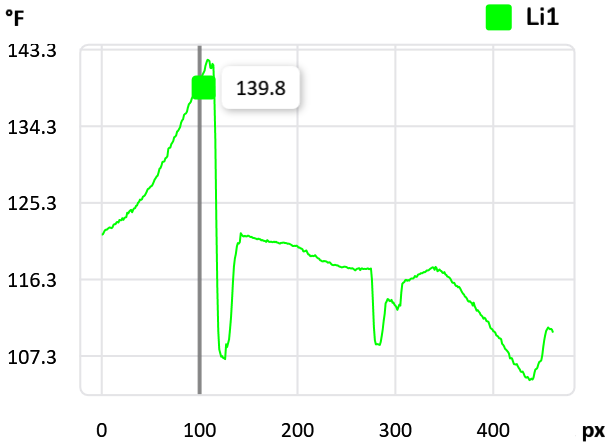
BOARD MILL Wet Zone Combustion Air Blower M5936

A phase connection

Li1	
Max	142.1 °F
Avg	118.9 °F
Min	104.5 °F
Sp1	140.1 °F

Faulty connection

CLASS I

IR image shows some localized heat on the A phase connection (line side). Disconnect, clean, and reconnect ensuring a clean and tight connection.
