USG
Greenville, MS
July 2025 Infrared Survey Report

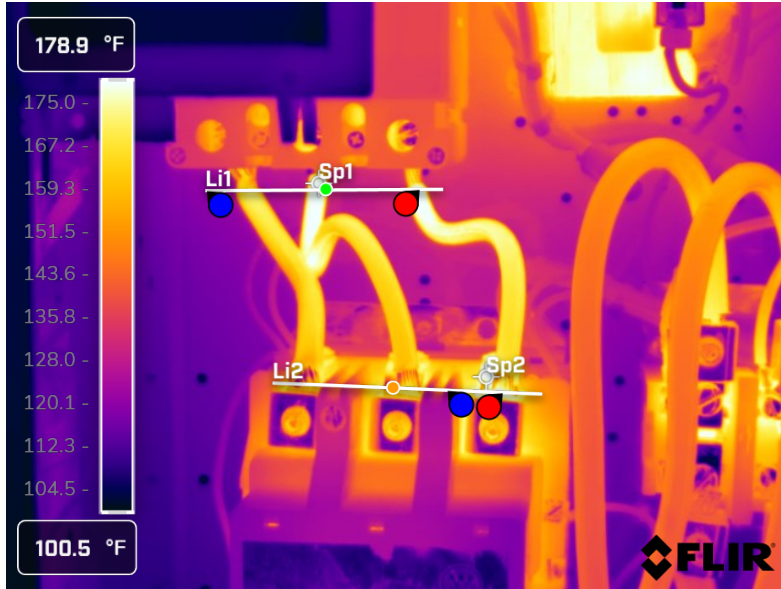
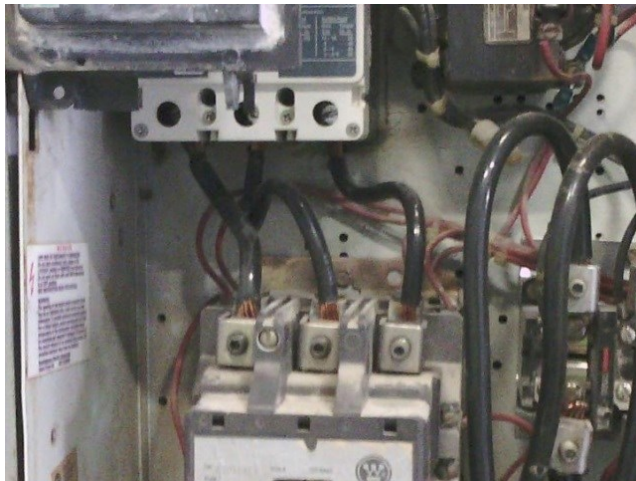
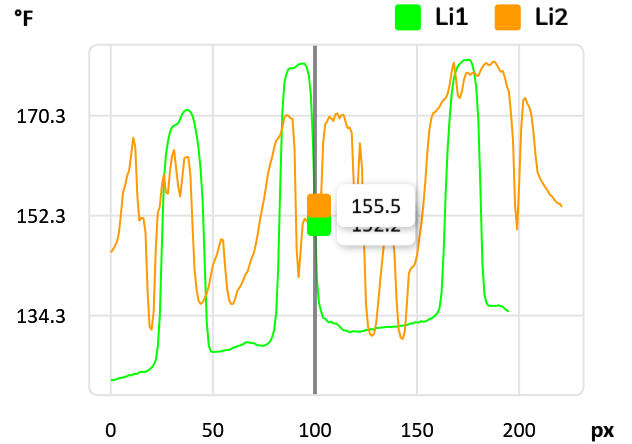
MCC 2C2 White Water Loop #1 Pump

Lead wires

Li1	
Max	180.4 °F
Avg	142.8 °F
Min	122.7 °F
Li2	
Max	180.1 °F
Avg	157.1 °F
Min	130.1 °F
Sp1	179.2 °F
Sp2	180.8 °F

heavy loaded leads

CLASS I

The size of the jumper leads going from breaker to contactor may need to be increased. There appears to be some elevated heat on these lead wires. It is recommended to increase wire size and ensure all lead connections are clean and tight.
