**Atlantic Dry Ice  
Brandon, MS  
Compressor Motor MCC  
Infrared Survey Report June 2025**

All three compressor motor MCC's were scanned using a **FLIR T865** infrared camera. The following report only contains defects that were found during the survey. Below is our classification system for each defect included in this report. If there are any questions or comments, please feel free to contact us at any time.

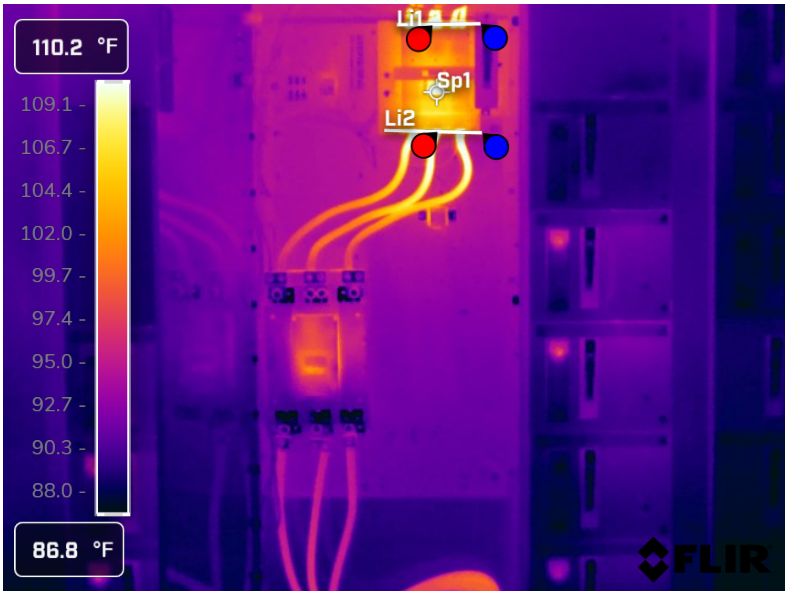
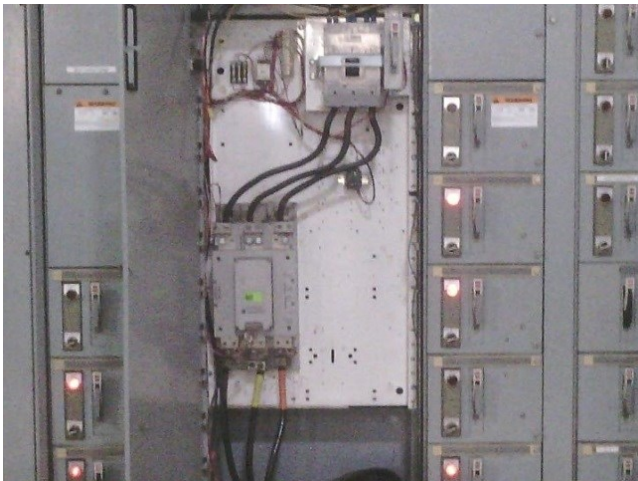
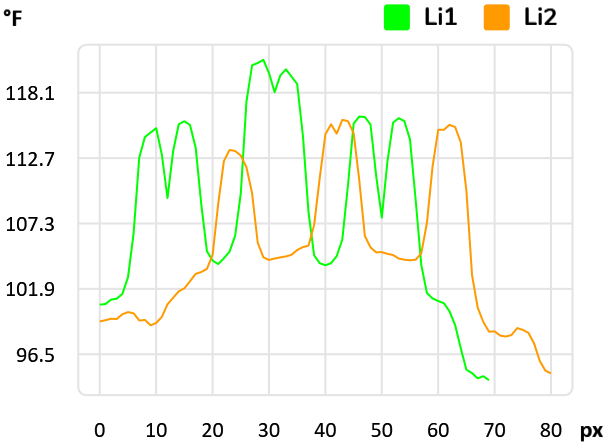
C-1

<b>Li1</b>	
Max	120.8 °F
Avg	108.8 °F
Min	94.4 °F
<b>Li2</b>	
Max	115.9 °F
Avg	104.9 °F
Min	95.0 °F
<b>Sp1</b>	
	117.4 °F

None

IR image shows no issues to report at this time.

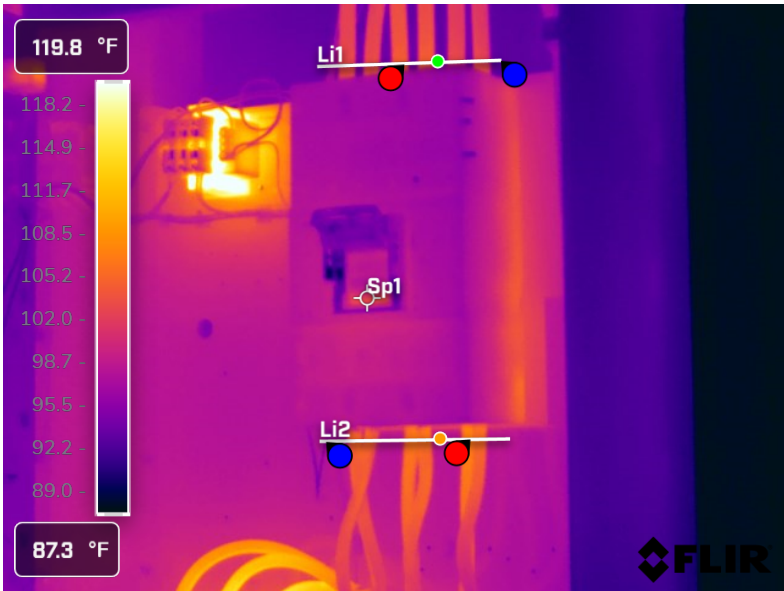
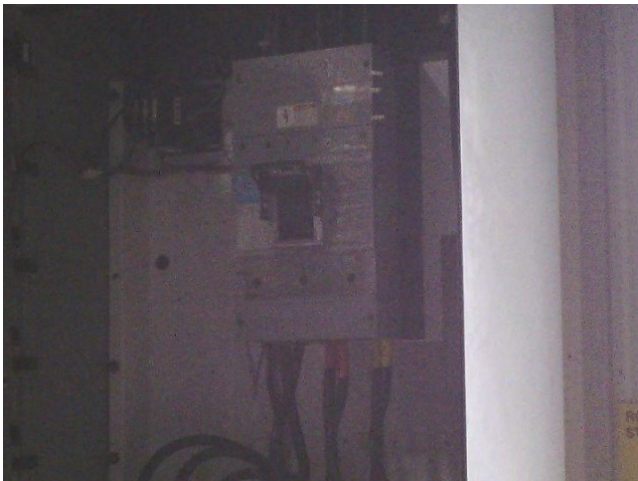
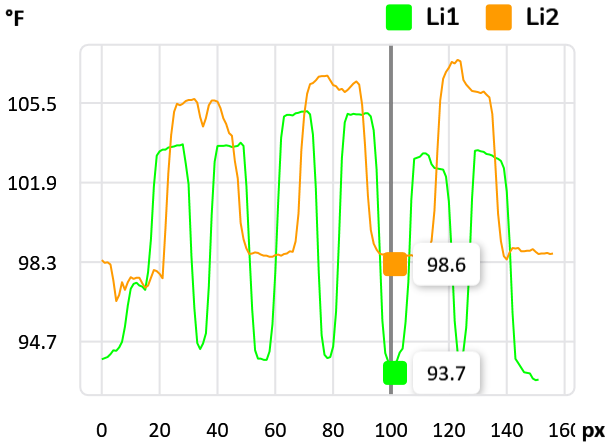
C-2

<b>Li1</b>	
Max	105.2 °F
Avg	99.6 °F
Min	93.0 °F
<b>Li2</b>	
Max	107.5 °F
Avg	101.7 °F
Min	96.6 °F
<b>Sp1</b>	
	103.5 °F

None

IR image shows no issues to report at this time.

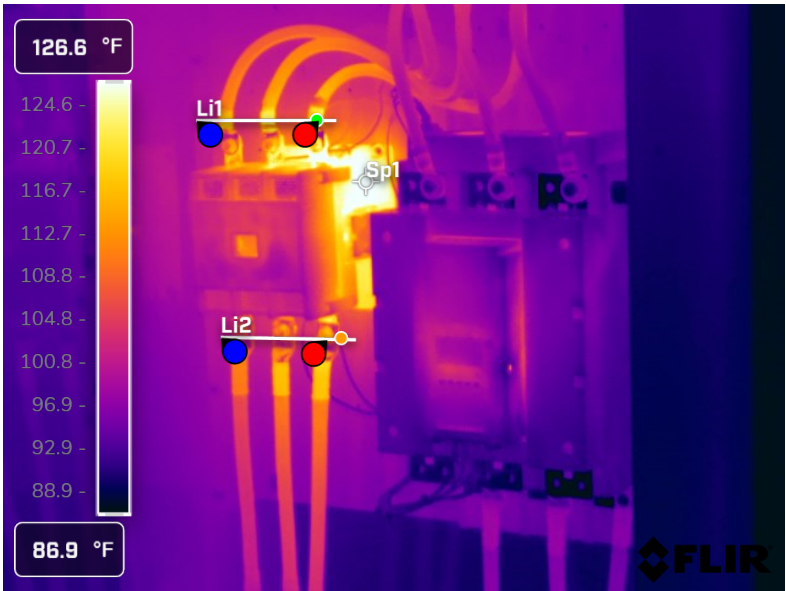
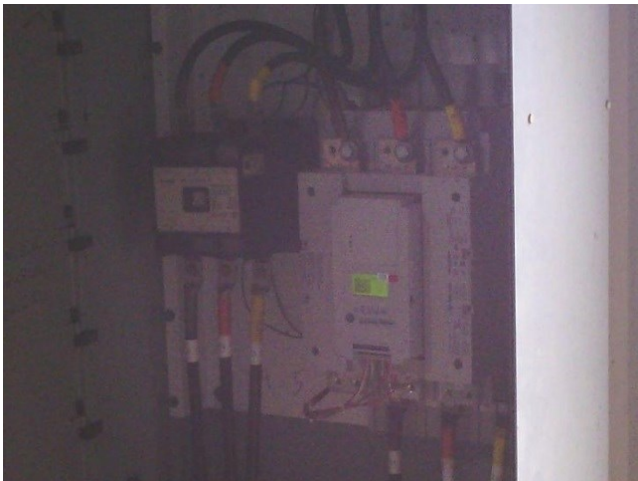
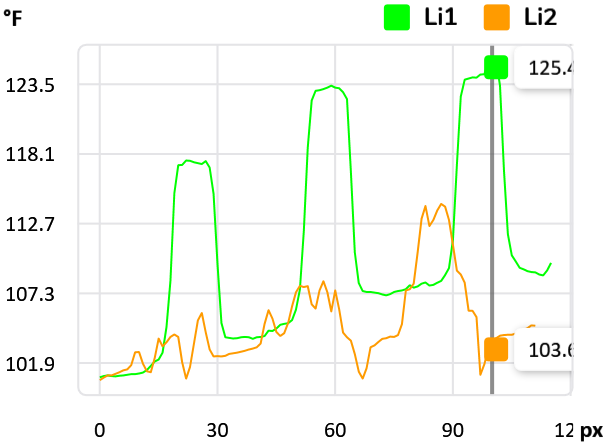
C-2

<b>Li1</b>	
Max	125.4 °F
Avg	110.6 °F
Min	100.8 °F
<b>Li2</b>	
Max	114.3 °F
Avg	104.8 °F
Min	100.6 °F
<b>Sp1</b>	127.0 °F

None

IR image shows no issues to report at this time.

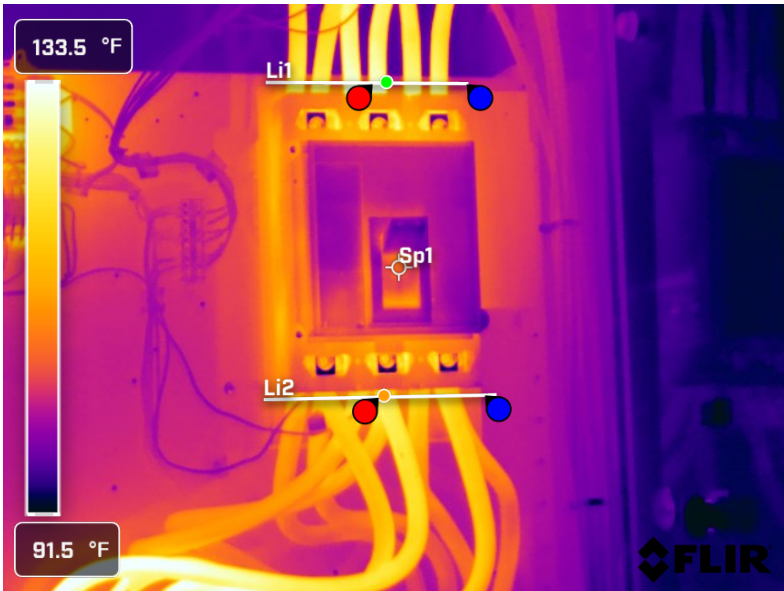
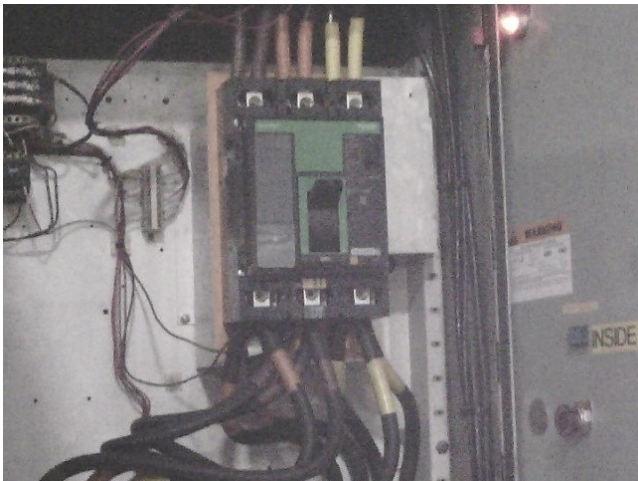
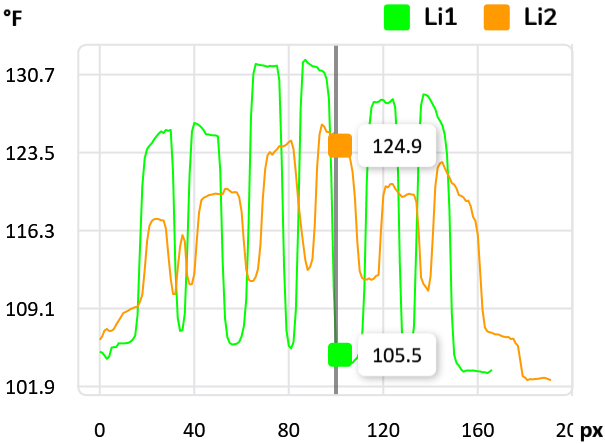
C-3

Li1	
Max	132.1 °F
Avg	116.9 °F
Min	103.2 °F
Li2	
Max	126.1 °F
Avg	115.2 °F
Min	102.5 °F
Sp1	
	107.9 °F

None

IR image shows no issues to report at this time.

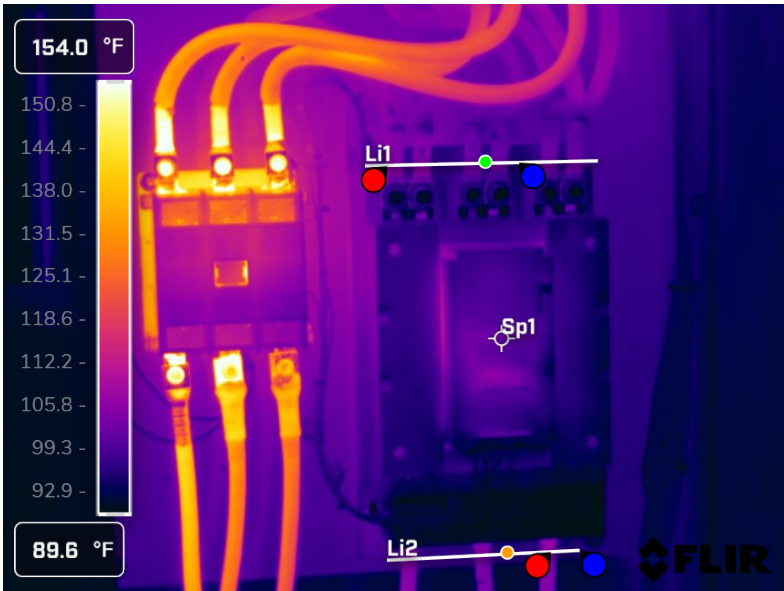
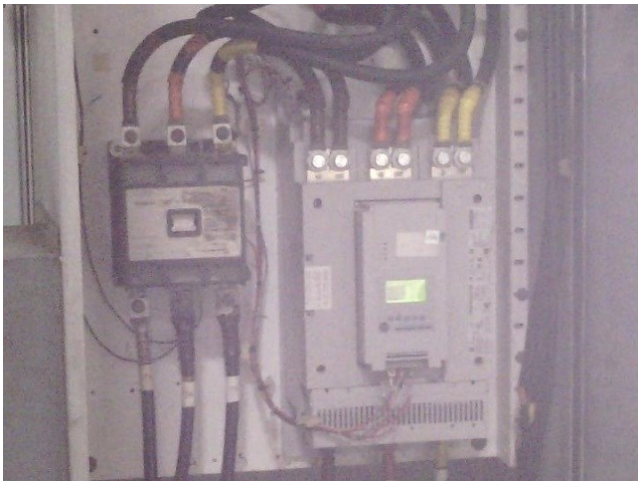
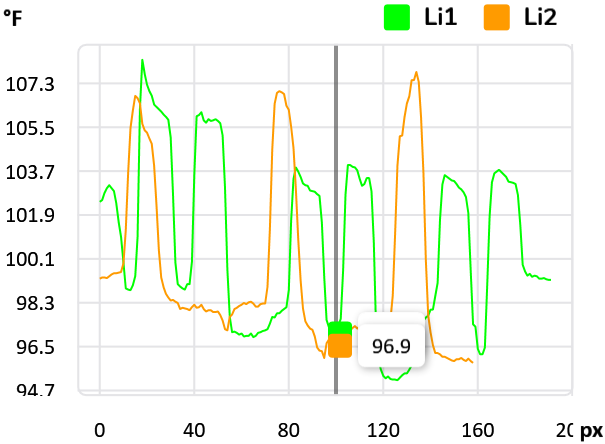
C-3

<b>Li1</b>	
Max	108.3 °F
Avg	100.7 °F
Min	95.2 °F
<b>Li2</b>	
Max	107.8 °F
Avg	99.6 °F
Min	95.9 °F
<b>Sp1</b>	102.9 °F

None

IR image shows no issues to report at this time.

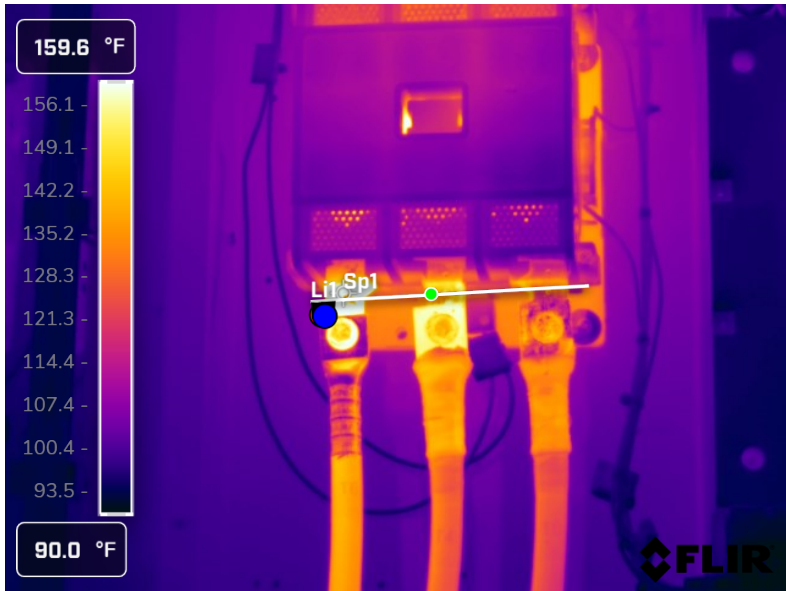
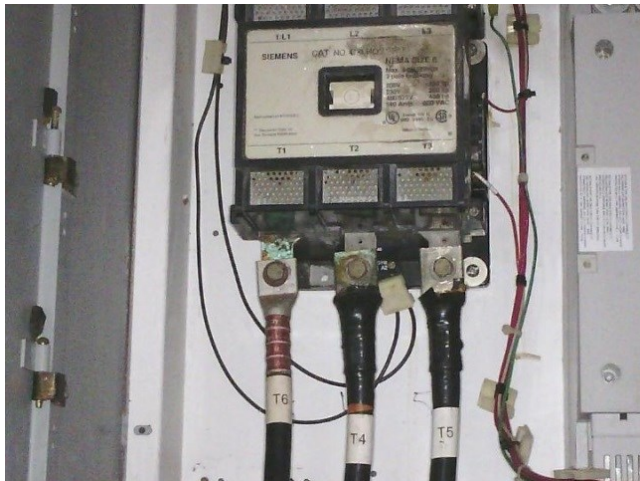
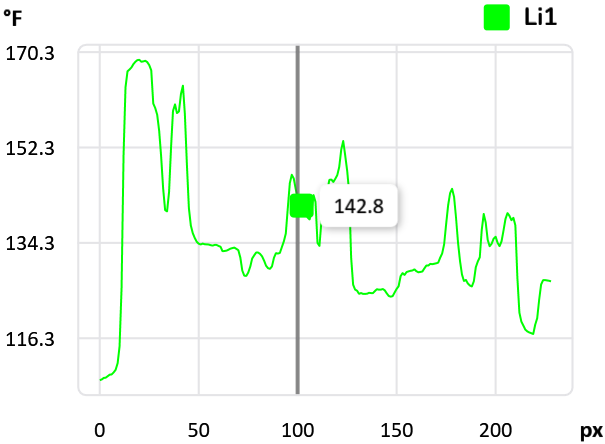
C-3

<b>Li1</b>	
Max	168.9 °F
Avg	135.5 °F
Min	108.4 °F
<b>Sp1</b>	168.7 °F

Faulty connection

CLASS I

IR image shows A phase to have some delta-T and may be caused by a loose/dirty connection. There is some visible oxidizing on the lug connector. Inspect and clean to ensure a clean and tight connection.
