Unipres USA, Inc. Forest, MS June 2025 Infrared Survey Report

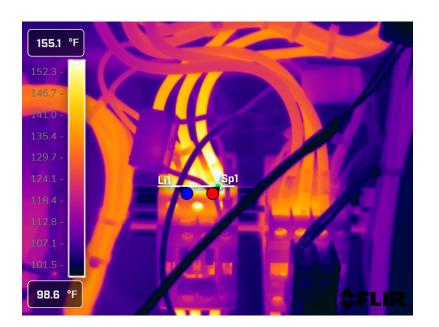
P-1 source: MCC 1-14

C phase line side connection

Li1	
Max	166.0 °F
Avg	142.3 °F
Min	104.5 °F
Sp1	162.8 °F

connection issue

CLASS I

C phase lead on line side of this breaker shows to have some slight delta-T. Check connection ensuring a clean and tight connection. Inspect breaker lug connection as well.

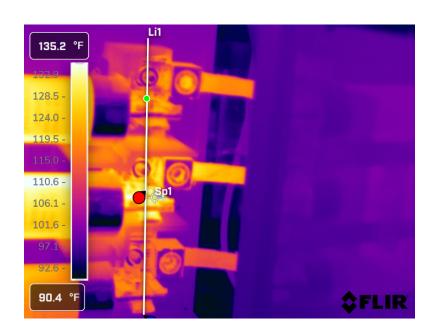
Air Compressor #3

B phase fuse clip

Li1	
Max	133.1 °F
Avg	116.0 °F
Min	99.8 °F
Sp1	131.9 °F

connection issue

CLASS I

B phase fuse clip may have some connection issue. Check fuse clip for wear and ensure a clean and tight connection.

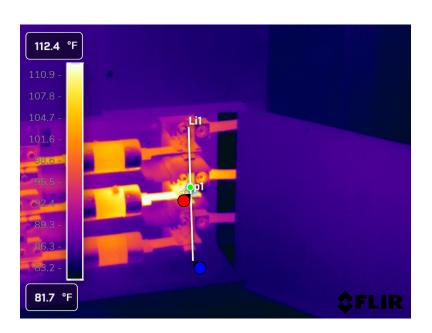
SB6-FS16 Dust Collector

B phase fuse

Li1	
Max	117.6 °F
Avg	98.2 °F
Min	84.5 °F
Sp1	111.9 °F

connection issue

CLASS I

B phase fuse appears to have delta-T over 25 degress F. This may be an issue with fuse clip but could also be internal issue with the fuse. Inpsect fuse clip and fuse for wear and defects and ensure a clean and tight connection.

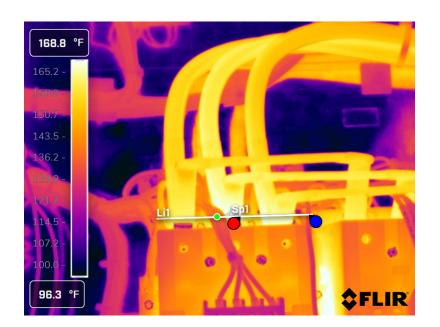
Air Compressor #5

lead connection

Li1	
Max	168.6 °F
Avg	156.4 °F
Min	133.4 °F
Sp1	168.7 °F

connection issue

CLASS I

This issues appears to be minor but there may be issue with the B and C phase connections on the line side. Ensure clean and tight connections.

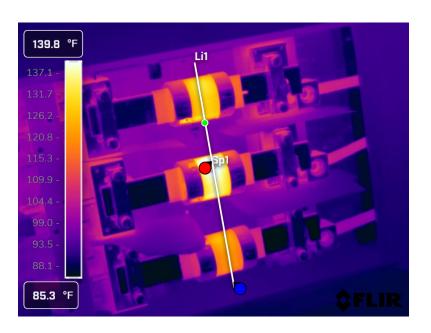
HVAC-24

B phase fuse

LII	
Max	146.2 °F
Avg	116.4 °F
Min	91.5 °F
Sp1	144.4 °F

Weak fuse or load imbalance

CLASS I

B phase fuse has some delta-T on the fuse body. This may be load imbalance or a weak fuse. Check amp load on each phase and change fuse as needed.
