USG Greenville, MS
June 2025 Infrared Survey Report

Scheduled rechecks after repairs were scanned on June 19th, 2025 using a

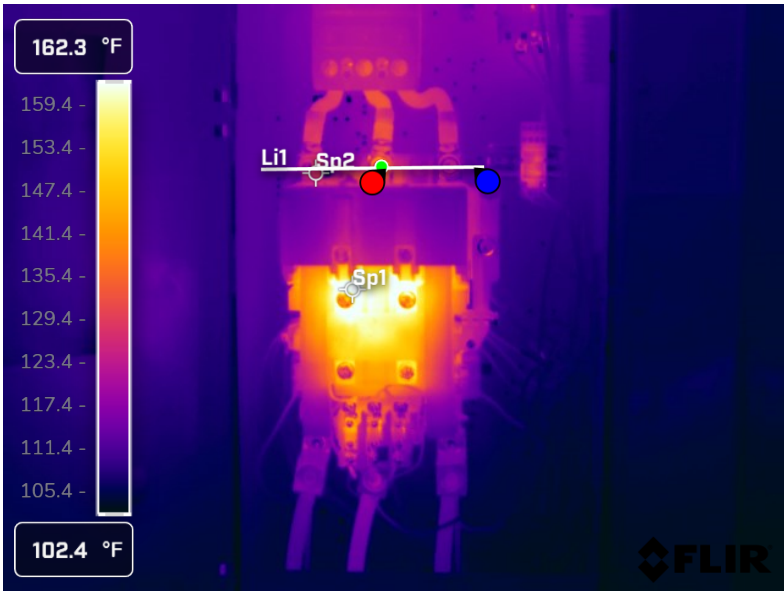
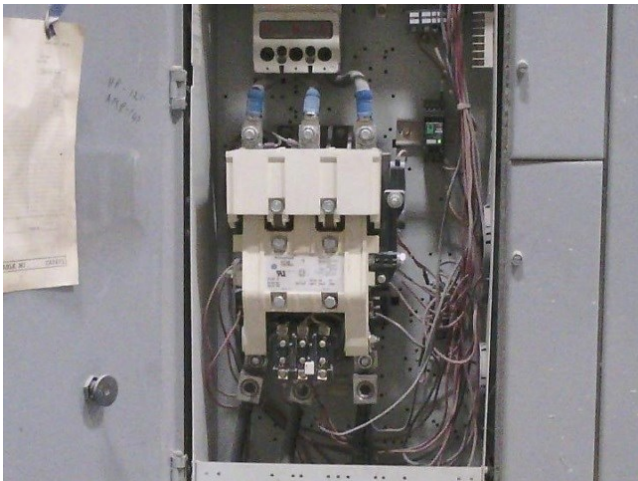
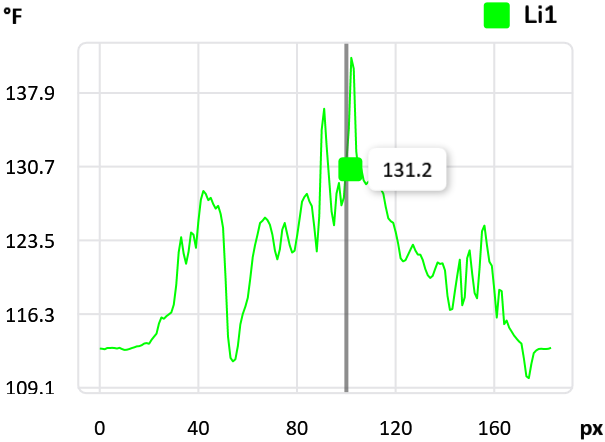
West Zone Combustion Blower MCC 7E1 Kiln M5936

Recheck GOOD

Li1	
Max	141.4 °F
Avg	121.0 °F
Min	110.1 °F
Sp1	169.5 °F
Sp2	128.5 °F

none

N/A

IR image shows no issues to be present at this time.

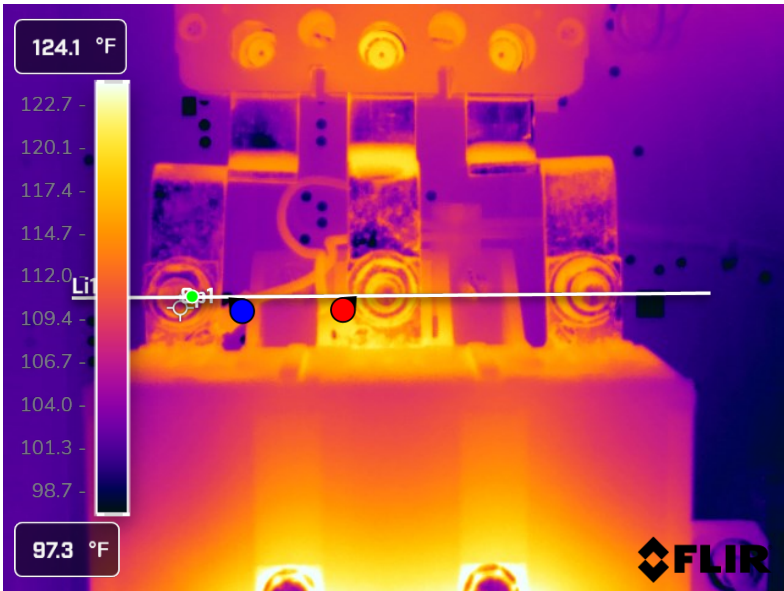
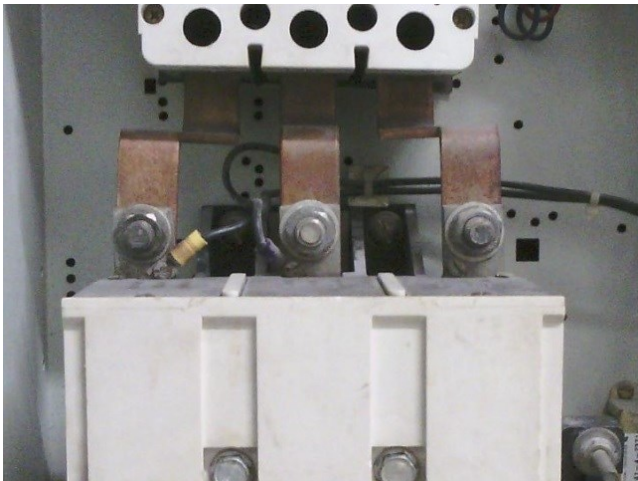
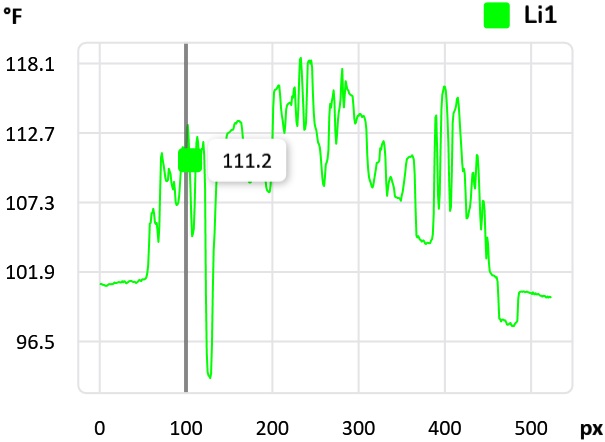
Perlite Dust Collector Exp 7 M2248

Recheck GOOD

Li1	
Max	118.6 °F
Avg	108.0 °F
Min	93.7 °F
Sp1	108.9 °F

none

N/A

IR image shows no issues to report at this time.

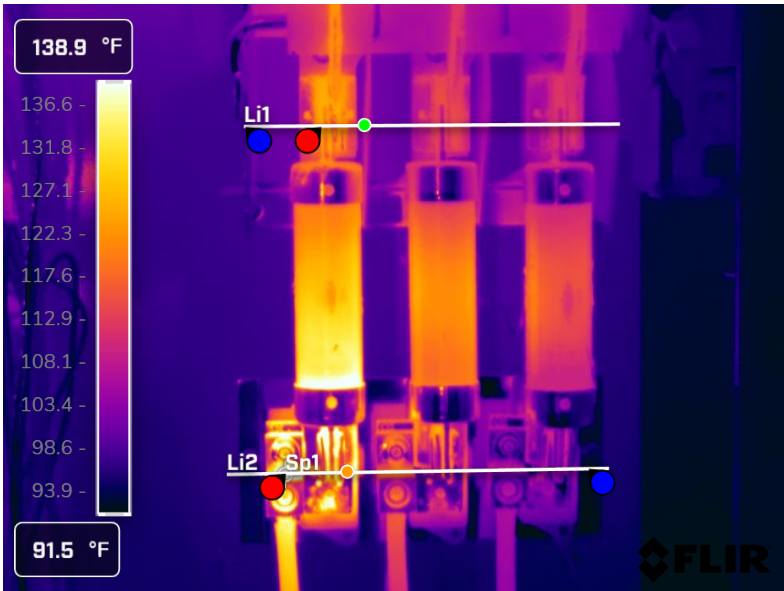
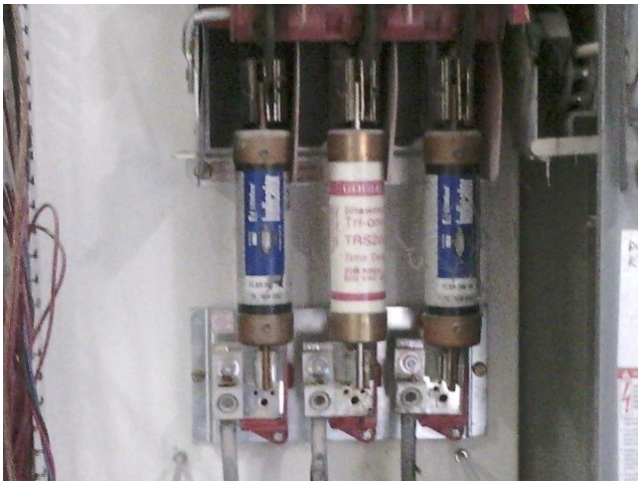
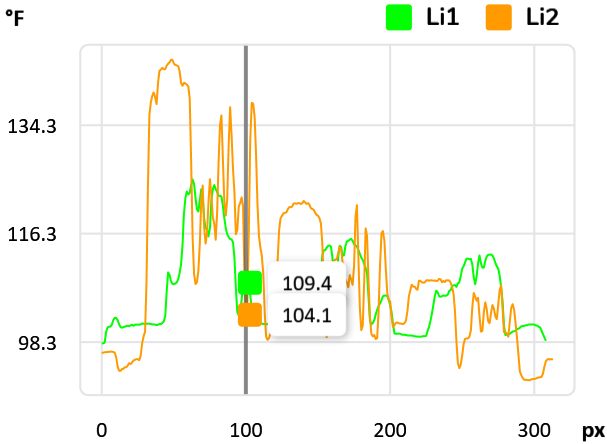
Old Line Fiberglass Dust Collector Panel

A phase fuse connections

Li1	
Max	125.3 °F
Avg	106.8 °F
Min	98.1 °F
Li2	
Max	145.2 °F
Avg	110.9 °F
Min	92.0 °F
Sp1	145.2 °F

connection issues

CLASS I

IR image shows some delta-T on A phase fuse connections. Inspect fuse components for wear and ensure all connections are clean and tight.
