April 21, 2025

Nucor General Recycling Subject: March vibration survey

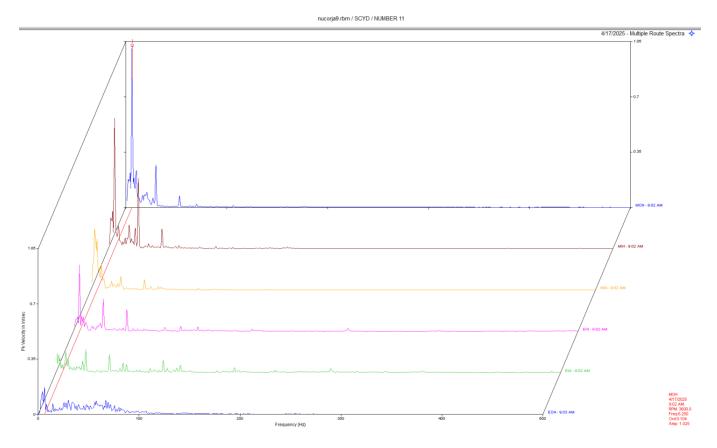
## Conveyor 11

Overall vibration is lower since last survey but still remains above alarm level. Vib appears to be at a low frequency of 6 Hz. This may be belt frequency or output frequency. Ensure sheaves are aligned properly. Ensure conveyor shaft or gear output shaft is not bent. Gearbox data also shows some signs of internal wear. Rated as a **CLASS II** defect.
