**May 2025  
Infrared Survey Report**

All electrical panels in FIBERGLASS area were scanned using a **FLIR T865** infrared camera. The following report only contains defects that were found during the survey. Below is our classification system for each defect included in this report. If there are any questions or comments, please feel free to contact us at any time.

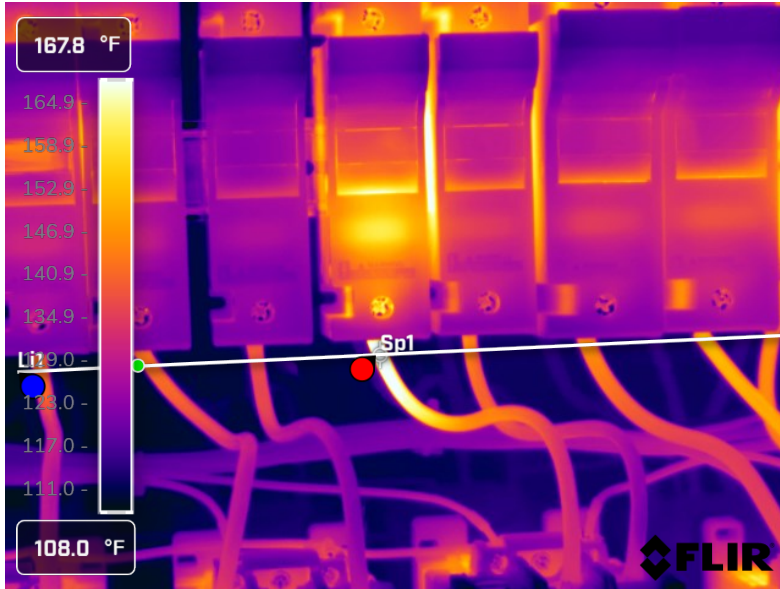
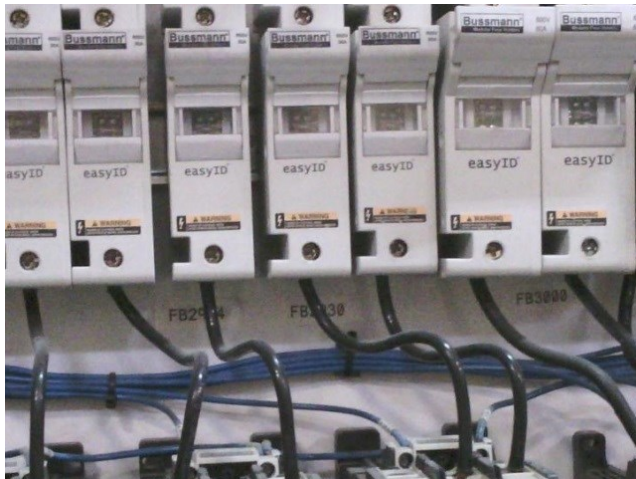
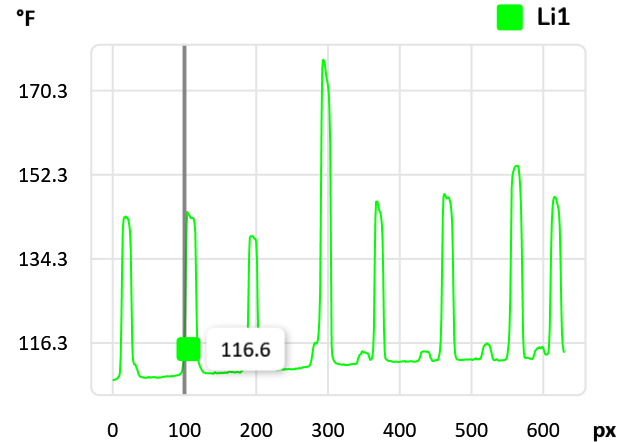
FB3000 Fuse and Lead connection

FB3000/Fiberglass 2nd pass paint heater panel

<b>Li1</b>	
Max	176.9 °F
Avg	118.6 °F
Min	108.4 °F
<b>Sp1</b>	174.0 °F

Faulty connection/fuse

**CLASS I**

IR image shows heat on FB3000 fuse and lead connection. Fuse should be inspected and ensure lead connection has a tight and clean connection.

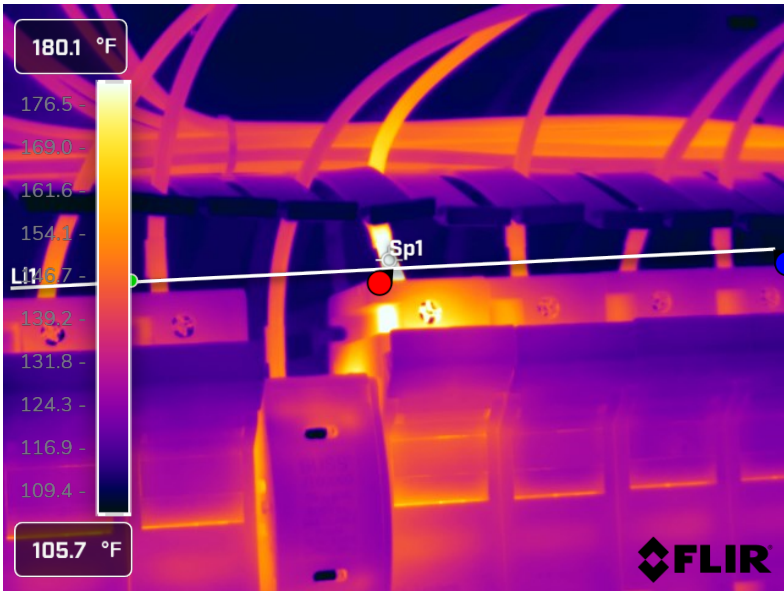
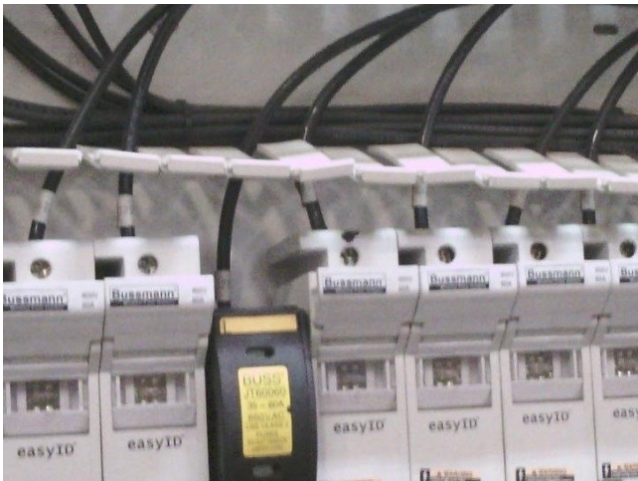
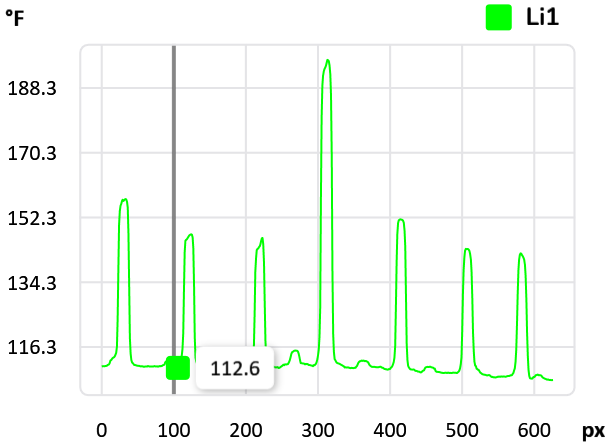
FB6000 lead connection

FB6000/Fiberglass 2nd pass paint heater panel

<b>Li1</b>	
Max	196.2 °F
Avg	117.8 °F
Min	107.1 °F
Sp1	192.4 °F

Faulty connection

**CLASS II**

IR image shows a likely connection issue on FB6000 fuse lead connection. Check lead ensuring a clean and tight connection.

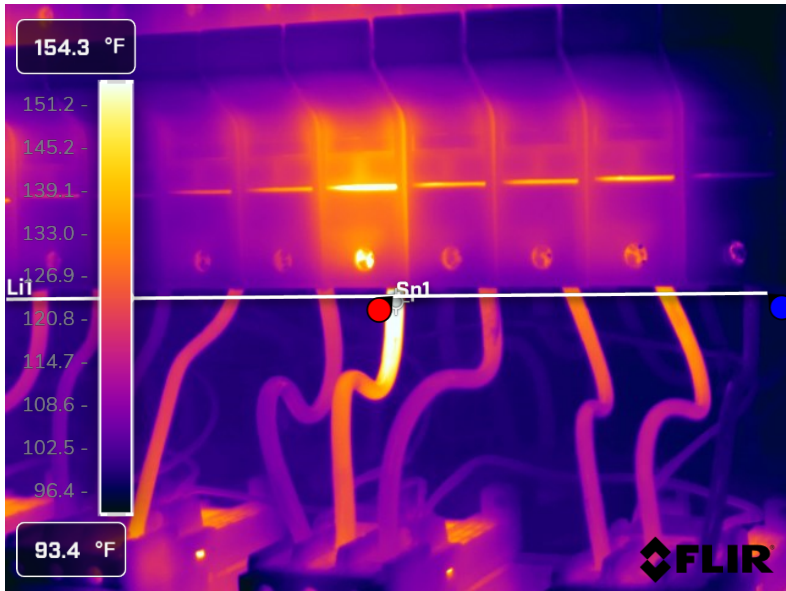
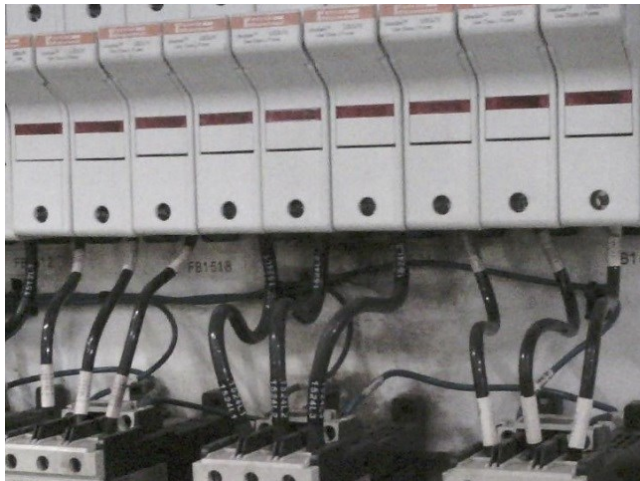
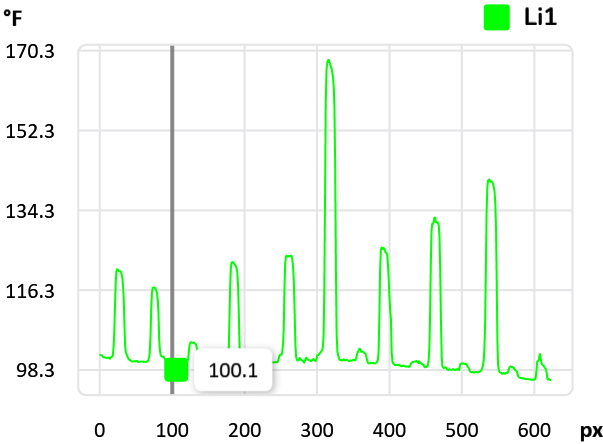
FB1524 Fuse lead connection

FB1524/Fiberglass 1st pass paint heater panel

<b>Li1</b>	
Max	168.3 °F
Avg	105.5 °F
Min	96.0 °F
Sp1	165.9 °F

Faulty connection

**CLASS I**

IR image shows a likely connection issue on FB1524 fuse lead connection. Check lead ensuring a clean and tight connection.

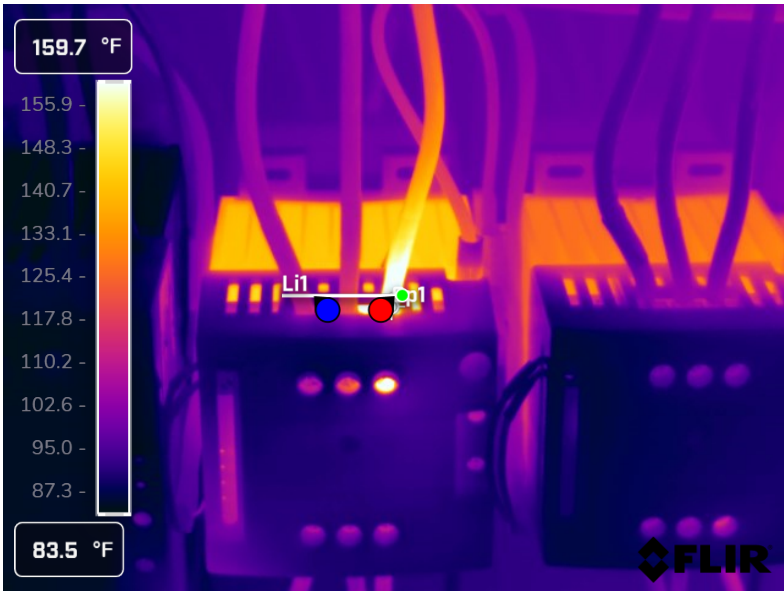
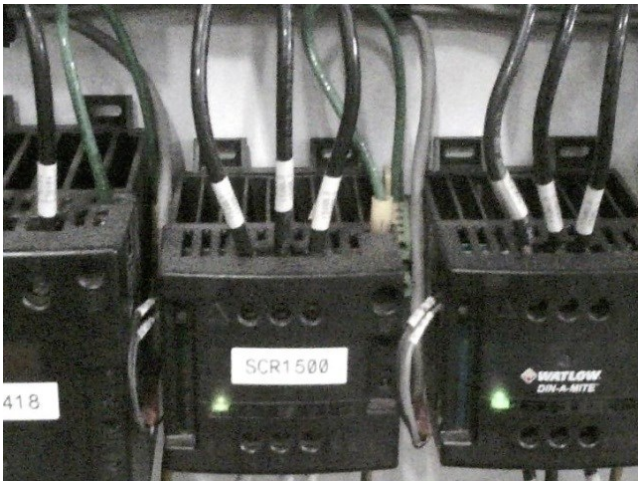
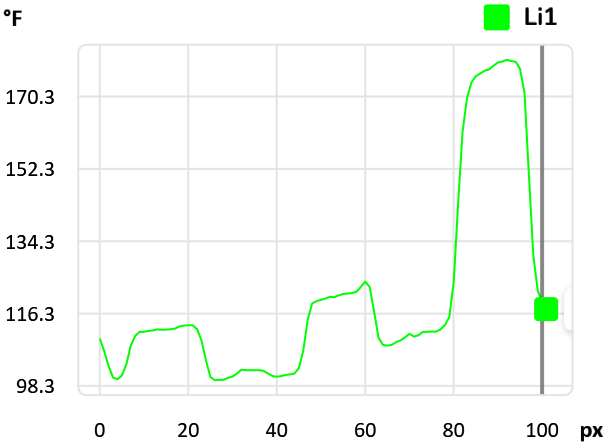
SCR1500 lead connection

SCR1500/Fiberglass 1st pass paint heater panel

<b>Li1</b>	
Max	179.5 °F
Avg	120.8 °F
Min	99.8 °F
Sp1	183.8 °F

Faulty connection

**CLASS I**

IR image shows a likely connection issue on SCR1500 lead connection. Check lead ensuring a clean and tight connection.

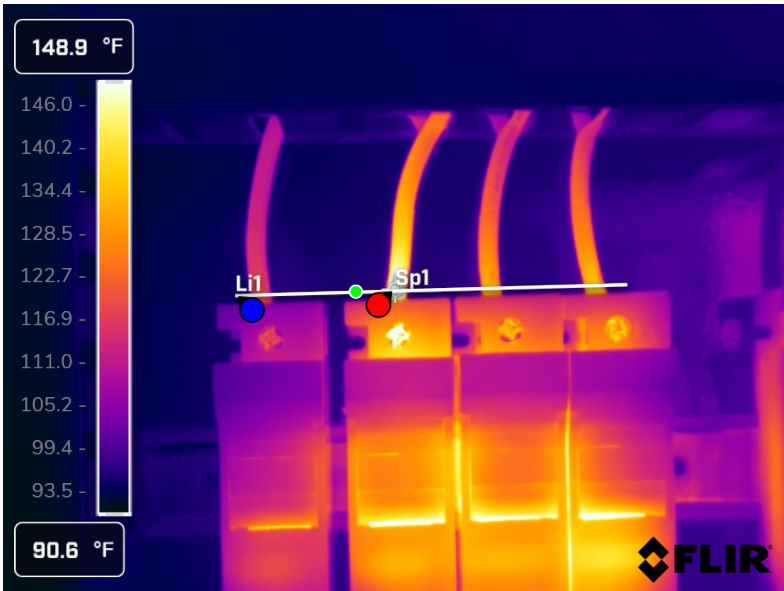
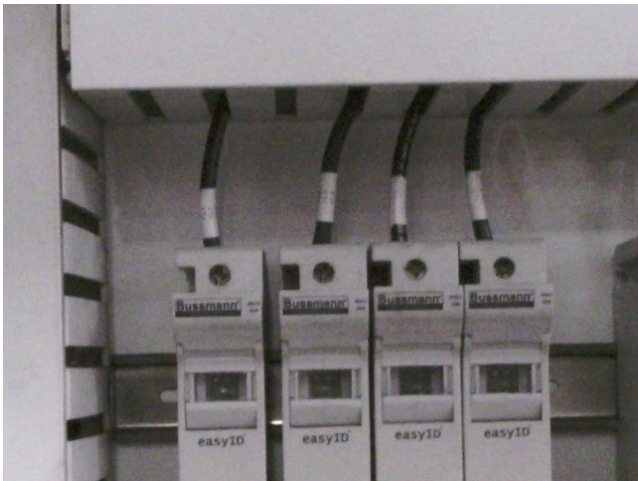
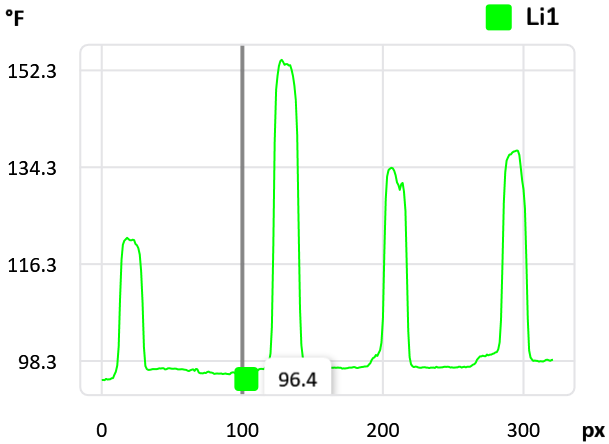
FB1400 lead connection

FB1400/Fiberglass 1st pass paint heater panel

<b>Li1</b>	
Max	154.3 °F
Avg	105.3 °F
Min	94.8 °F
Sp1	153.0 °F

Faulty connection

**CLASS I**

IR image shows a likely connection issue on FB1400 fuse lead connection. Check lead ensuring a clean and tight connection.
