NuVasive
Memphis, TN
March 2025 Infrared Survey Report

On March 13, 2025, all electrical breaker panels, transformers, disconnects in the entire facility along with the main switch distribution panels outside were scanned using a

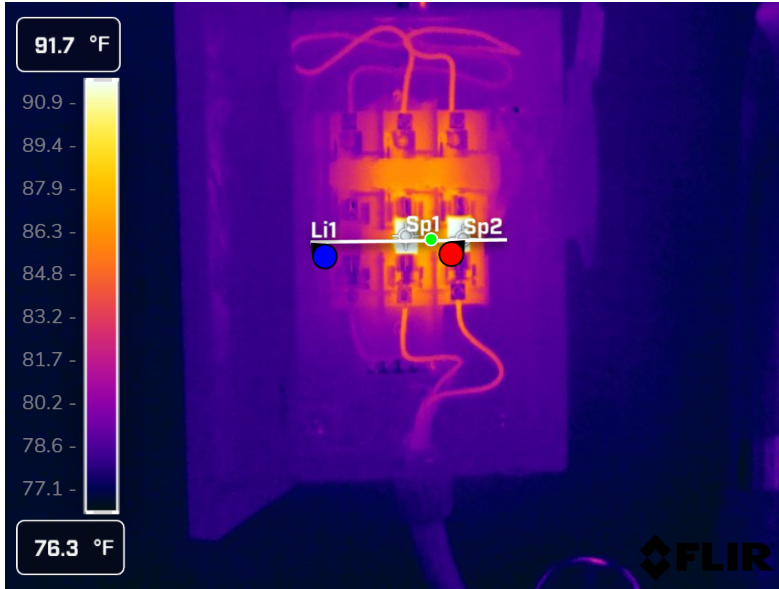
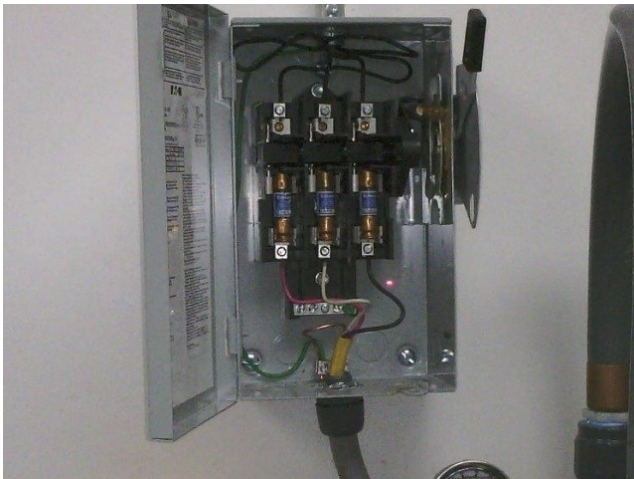
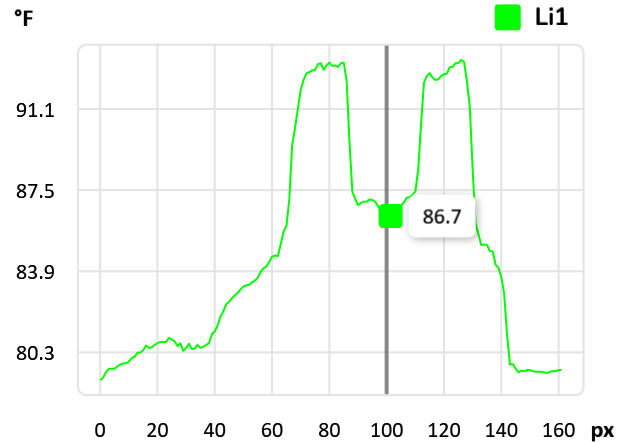
Panel A5 distribution pump ckt 26/28/30

Li1	
Max	93.3 °F
Avg	85.0 °F
Min	79.1 °F
Sp1	92.6 °F
Sp2	93.2 °F

Possible load issue

CLASS I

IR image shows no heat on far left fuse circuit. Amp load was checked while on site by Gephart tech. We found zero current on the far left fuse. There is a balanced load on the other two fuses. This may or may not be an issue. We recommend further investigation to determine why no load exists on this circuit.

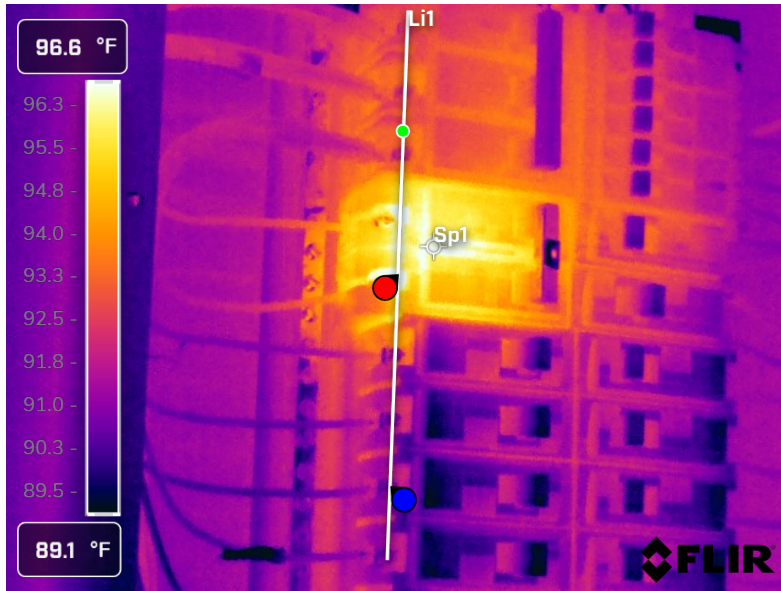
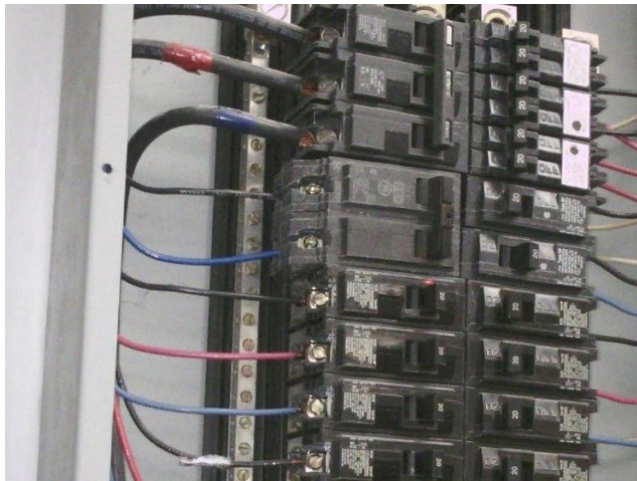
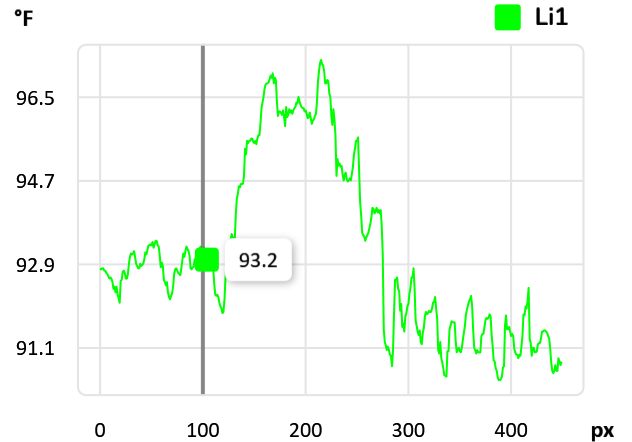
Panel A1 circuits 7 and 9

Li1	
Max	97.3 °F
Avg	93.2 °F
Min	90.4 °F
Sp1	96.7 °F

Faulty breaker

CLASS I

IR image shows heat on this breaker. Amp load was measured on circuits 7 and 9 and found no load exists on these circuits. This indicates a breaker fault either internally in the breaker or the buss connection at the back of the breaker. It is highly recommended to replace this breaker. Also inspect the buss to ensure new breaker has a clean and tight connection to the service buss.
