AC Recondition Repair Report

Almatis Inc/RCP Bauxite (10014)
4701 Alcoa Road
Bauxite, AR 72011

1. Job Number	98081
2. Report Date	04/09/2021
3. Customer	ALMATIS

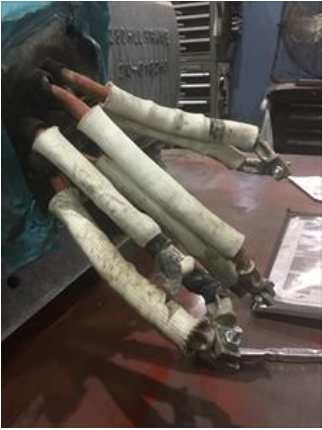
18. Number of Leads	6	P13

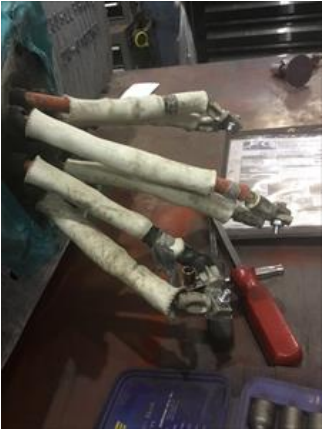
19. Lead Length	10 Inches	P20

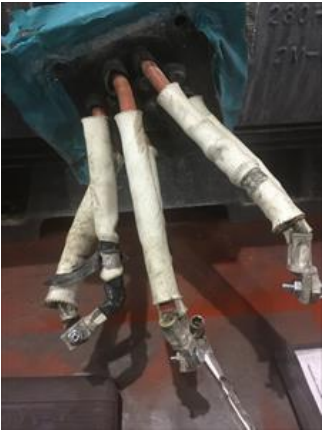
21. Lead Condition	(P) Pass	P42

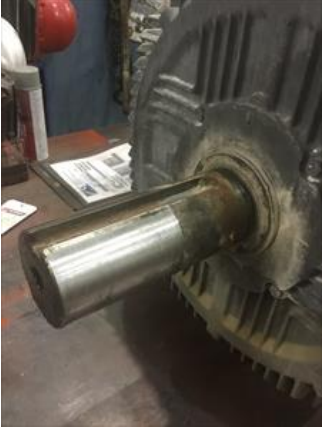
26.	Shaft Run Out	0.001	
27.	Does Shaft Turn Freely	yes	
28.	Does Shaft Have Visible Damage	no	P94

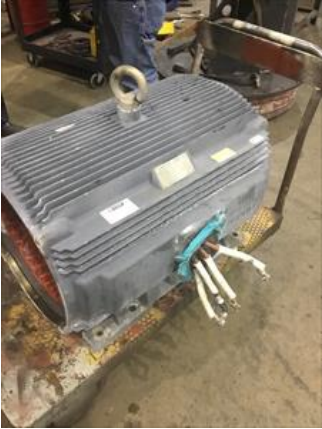
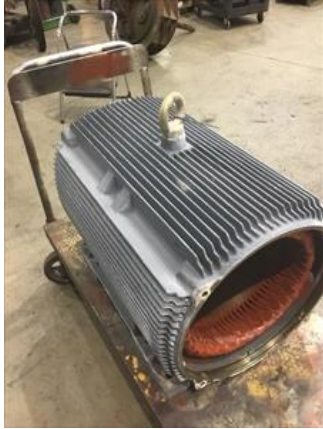
29.	Bearing Rtd's		
30.	Bearing Rtd's Condition		
31.	Contamination		
● 32.	Frame Condition	(P) Pass	P106
<div>

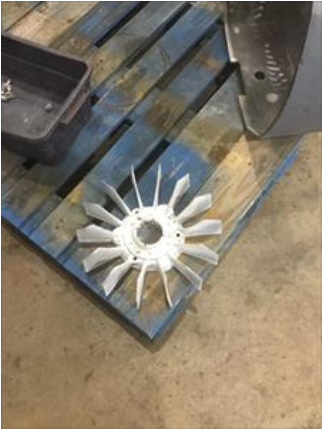
</div>			
● 33.	Fan Condition	(P) Pass	P109

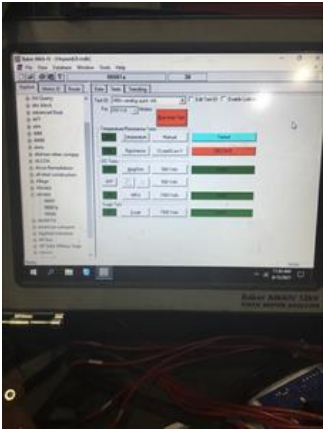
36.	Winding Resistance 1-2		
37.	Winding Resistance 2-3		
38.	Winding Resistance 1-3		
39.	Resistive Imbalance		
40.	Hi-Pot		
41.	Surge Test	(P) Pass	P58

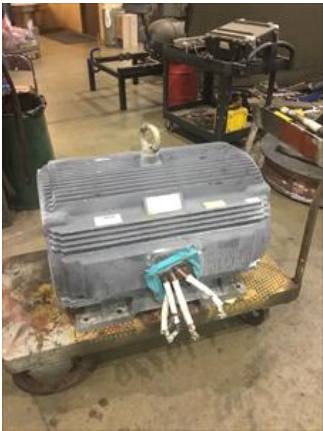
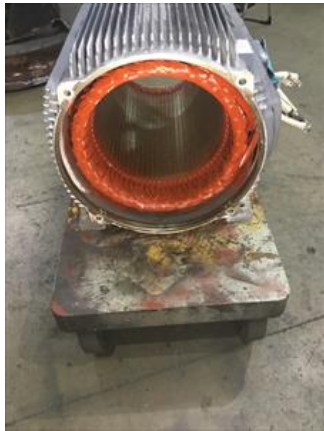
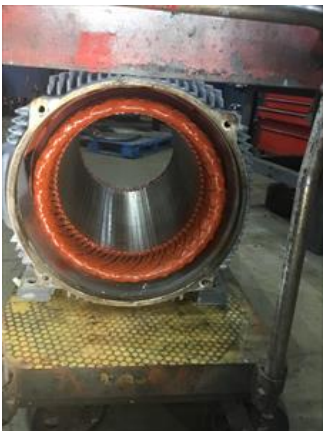
42.	Stator Condition	good	P65
-----	------------------	------	-----

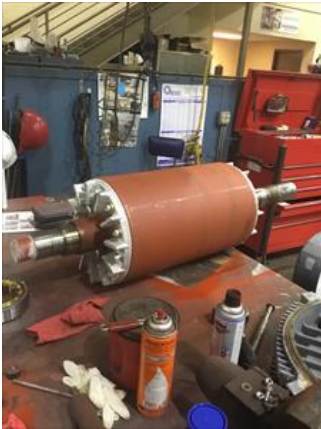
P50

☒ 49. Rotor Condition**(P) Pass**

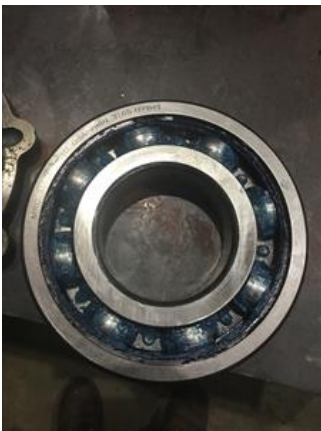
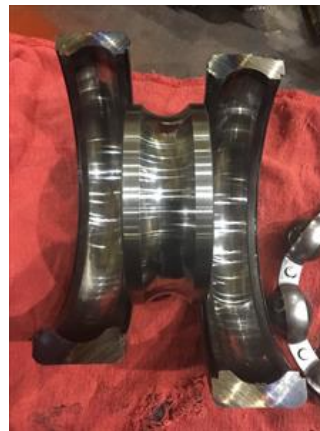
P43

54. Bearing ODE Size

MRC 316S-HYB#1. (HYBRID)

66.	Component Failure	Both bearings.	
	<i>Drive end bearing had an excessive amount of electrical fluting. The opposite drive end bearing had true brinelling on the inner and outer races.</i>		
67.	Cause of Failure	<i>Grease from the drive end housing contaminated the aegis ring grounding brushes and reduced their current grounding effectiveness.</i>	
68.	Comments	<i>Recommend further spacing between the aegis ring and the D.E. bearing cap. Aegis size is 4.0215</i>

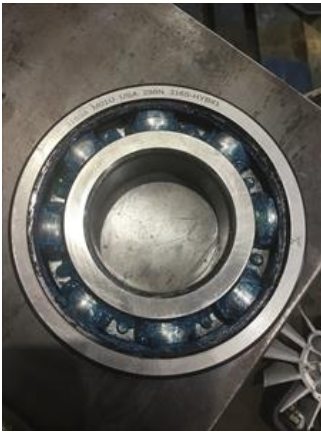
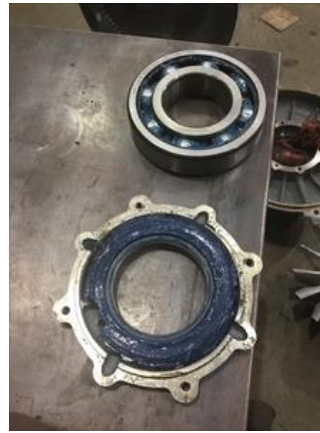
P53

55. Bearing ODE Type

MRC 316S-HYB#1 (hybrid)

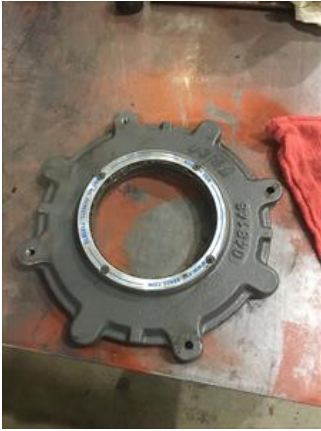
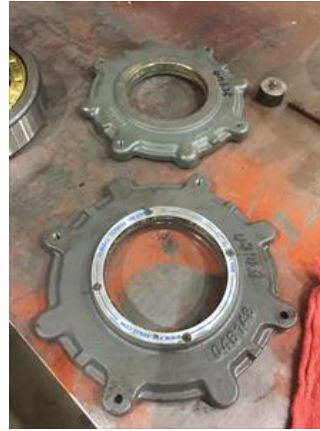
56.	ODE Bearing Qty.	1	
57.	Insulated Bearing	yes (hybrid)	
58.	Lubrication Type	grease	
59.	Grease Condition	(P) Pass	
60.	Bearing Retainers	(Y) Yes	P80
