AC Recondition As Found

Arauco-Malvern MDF (10298)

Description: 75HP Siemens 1800RPM 365T

Repair Stage: Teardown Inspection

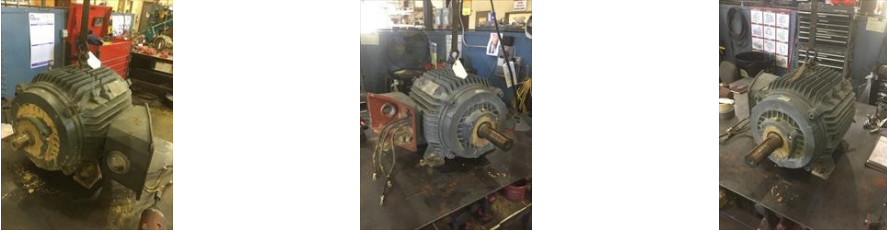
11. Stator Temperature Detector Rating and Function			
Quantity	Rating	Quantity Passed	
12. Bearing Temperature Detector Rating and Function			
Quantity	Rating	Quantity Passed	
13. Frame Condition			P52

<div> <div></div> 14. Fan Condition </div>			(F) Fail P54
