## AC Recondition As Found

### Sage V Foods

#### AC Recondition - Rev. 2

Description: 50HP Baldor 1800RPM 326TDZ

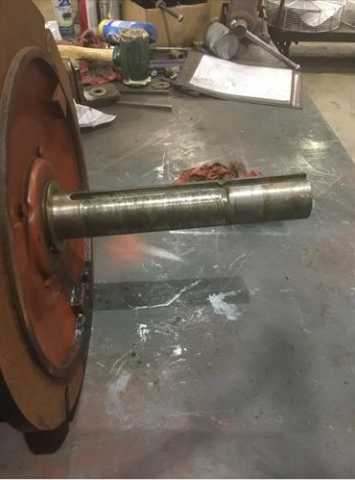
| | 5. Does Shaft Have Visible Damage? | (Yes) Yes |

●	6. Assembled Shaft Runout	2.897 Inches	P6

*New shaft*

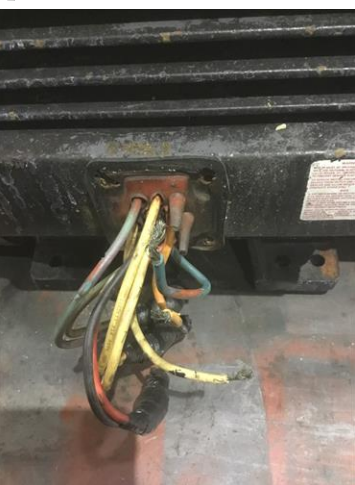
7. Assembled Shaft End Play		
	8. Air Gap Variation <10%		
●	9. Lead Condition	(P) Pass	P9

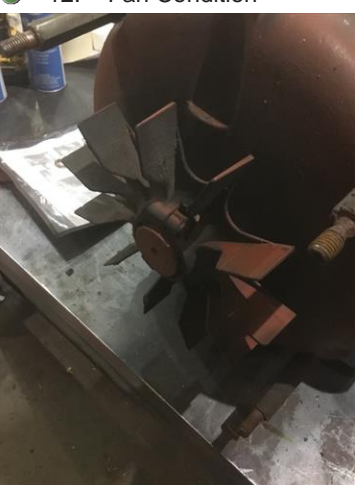
10. Lead Length	12 Inches	
	11. Frame Condition		
●	12. Fan Condition	(P) Pass	P12

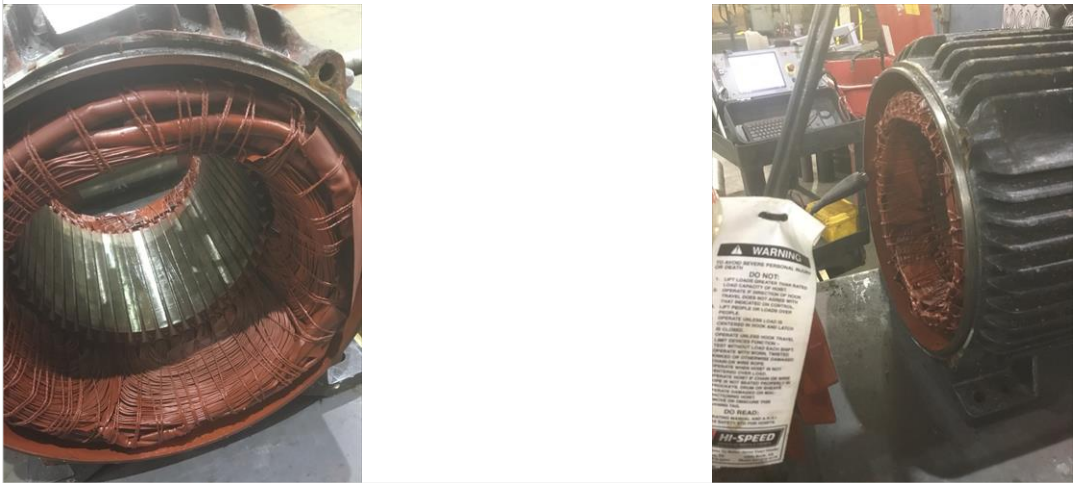
15. Winding Resistance	1-2	1-3	2-3
16. Perform Surge Test	(P) Pass		
17. Stator Condition	P17

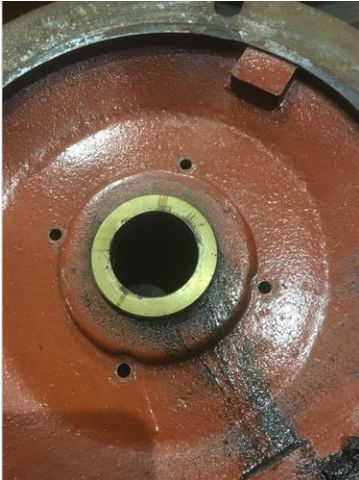
P32

32. Drive End Seal

Inpro

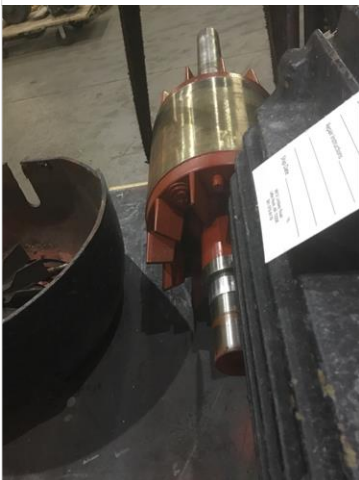
P34

34. Rotor Type/Material

(Squirrel Aluminum) Squirrel  
Cage Aluminum Die Cast

37. Rotor Condition

good

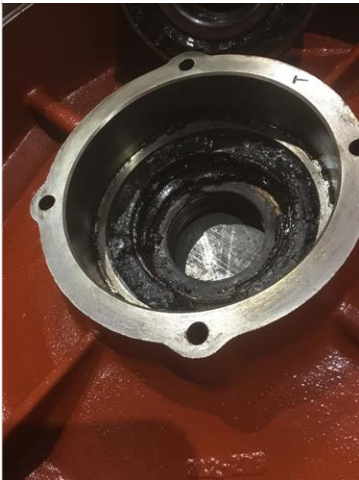
40.	Shaft Runout	inches	
41.	Rotor Runout		
	Drive End Bearing Fit	Rotor Body	Opposite Drive End Bearing
42.	Coupling Fit Closest to Bearing Housing		
	0 Degrees	90 Degrees	120 Degrees
43.	Coupling Fit Closest to the end of the Shaft		
	0 Degrees	60 Degrees	120 Degrees
44.	Drive End Bearing Shaft Fit		
	0 Degrees	60 Degrees	120 Degrees
45.	Drive End Bearing Shaft Fit Condition		
46.	Opposite Drive End Bearing Shaft Fit		
	0 Degrees	60 Degrees	120 Degrees
47.	Opposite Drive End Bearing Shaft Fit Condition		
48.	Shaft Air Seal Fits		
	Drive End Air Seal	Opposite Drive End Air Seal	
Mechanical Fits- Bearing Housings			
49.	Drive End - Endbell Bearing Fit		
	0 Degrees	60 Degrees	120 Degrees
	5.1188	5.1188	5.1188
50.	Drive End - Endbell Bearing Fit Condition	(P) Pass

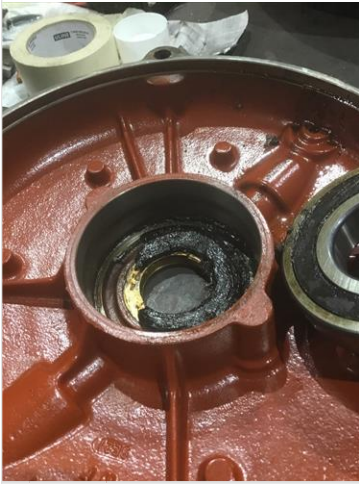
51.	Opposite Drive End - Endbell Bearing Fit		
	0 Degrees	60 Degrees	120 Degrees
	4.7253	4.7253	4.7253
