AC Recondition As Found

Sage V Foods

AC Recondition - Rev. 2

Location: MOTOR SHOP LR
Serial Number: C0906200018
Description: 50HP Baldor 1800RPM 326TDZ

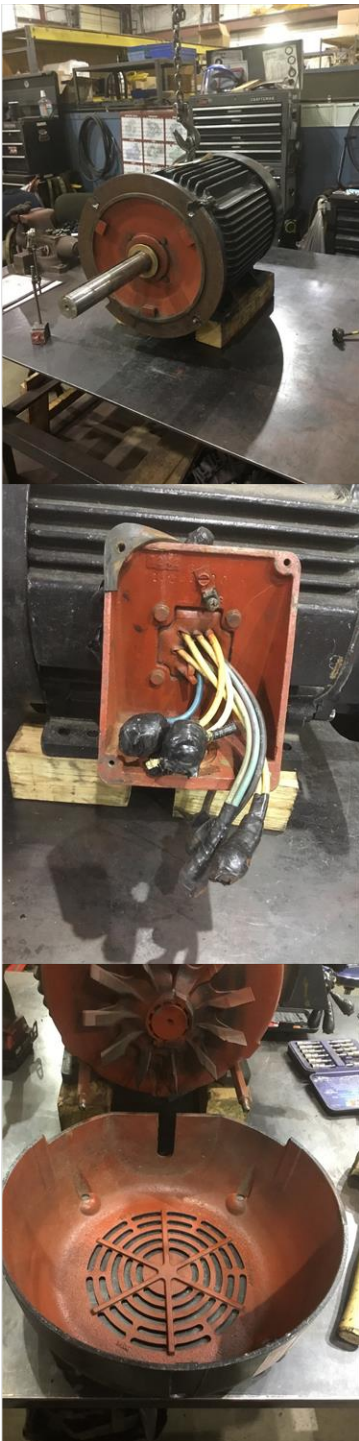
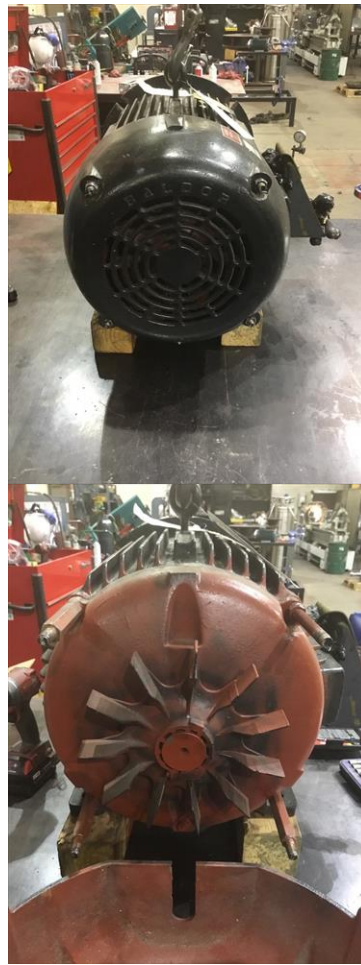
3. Describe the Overall Condition of the Equipment as Received
Shaft excessively bent...greater than 2.987

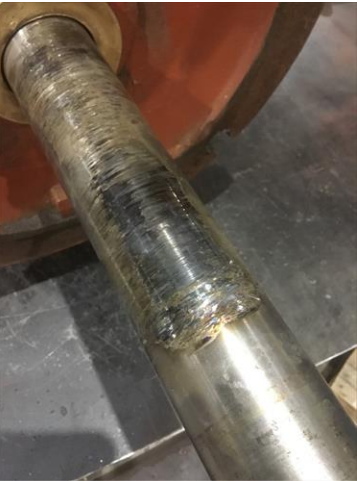
6.	Does Shaft Have Visible Damage?	(Yes) Yes	P12

<i>Bent key way. Chunk missing out of shaft.</i>		
7.	Assembled Shaft Runout	2.987 Inches	
8.	Assembled Shaft End Play	0 inches	
9.	Air Gap Variation <10%		
10.	Lead Condition	(P) Pass	P31

66.	Post Rewind Winding Resistance		
	1-2	1-3	2-3
67.	Post Rewind Surge Test		
68.	Post Rewind Hi-Pot		
69.	Technician		
Root Cause of Failure			
70.	Failure locations <i>D.E. Rotor shaft bent beyond repair</i>

71.	Root cause of failure <i>Bent shaft</i>		
Mechanical Fits- Rotor - Post Repair			
72.	Shaft Runout Post Repair		
73.	Rotor Runout Post Repair		
	Drive End Bearing Fit	Rotor Body	Opposite Drive End Bearing

55.	End Bell Air Seal Fits		
	Drive End Air Seal	Opposite Drive End Air Seal	
56.	List Machine Work Needed Below <i>New shaft.</i>		
57.	Technician		Terrence. Holland

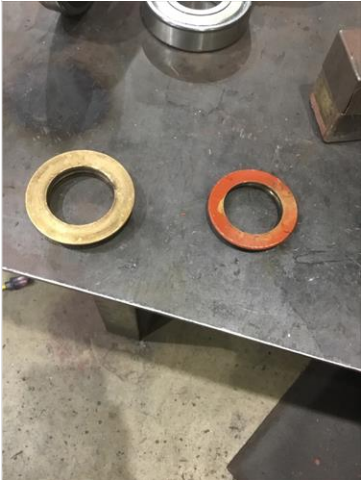
P56

in pro seals worn

35. Rotor Type/Material	(Squirrel Aluminum) Squirrel Cage Aluminum Die Cast
36. Growler Test	(Pass) Pass
37. Number of Rotor Bars	40
38. Rotor Condition	fail. shaftbent
39. List the Parts needed for the Repair Below <i>In pro seal,</i>	
40. Signature of Technician that Disassembled Motor	Terrence. Holland

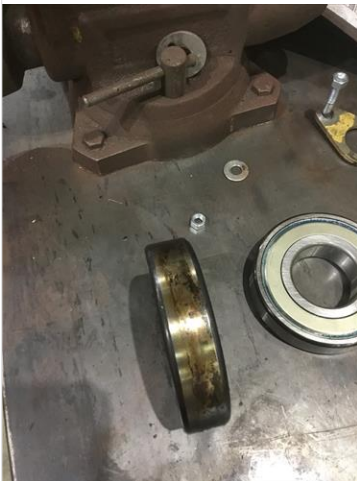
P41

25. Drive End Bearing Condition

fail

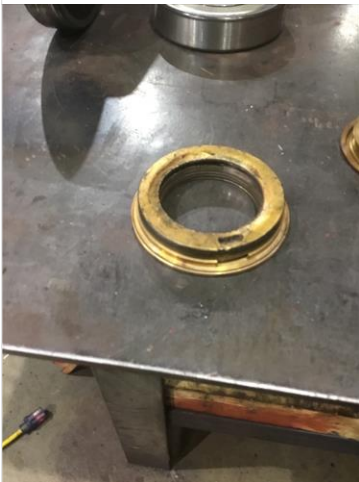
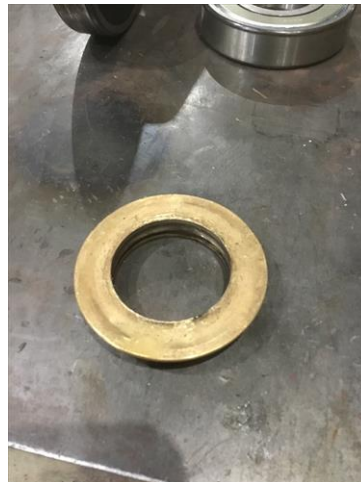
P57

33. Drive End Seal

worn/ replace

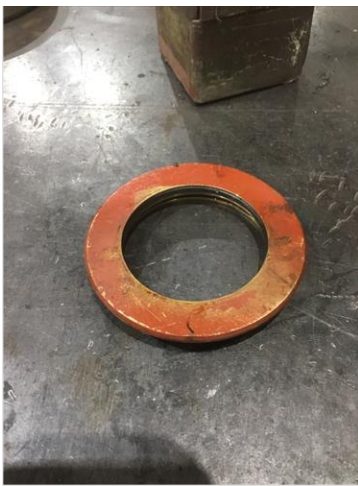
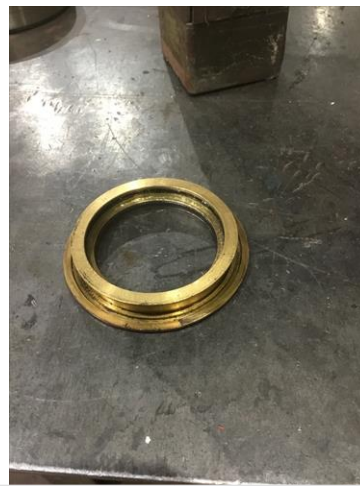
P58

34. Opposite Drive End Seal

replace
