AC Recondition As Found

Kroger

AC Recondition - Rev. 2

Description: 6HP ILG INDUSTRIES 900RPM 32
FRAME

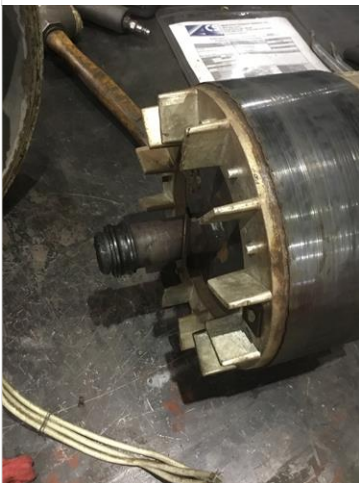
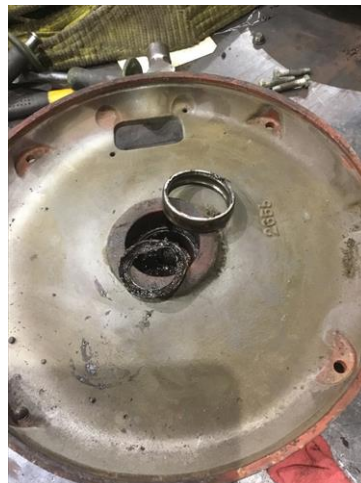
5. Does Shaft Turn Freely?

ODE bearing destroyed.

Resolved: (6/20/2022)

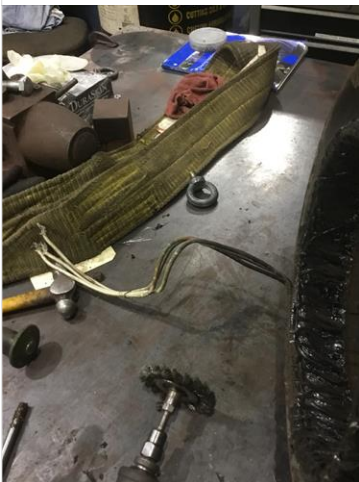
10. Lead Condition

(P) Pass

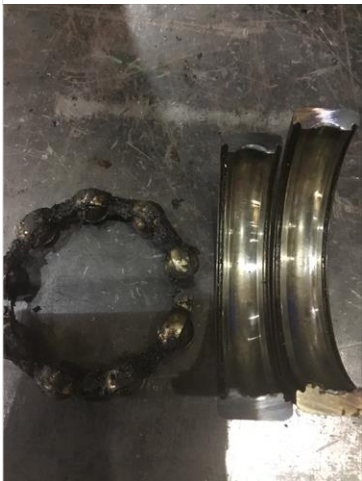
19.	Drive End Bearing Number-	6208	P8

23.	Drive End Bearing Insulation or Grounding Device?	none	
24.	Drive End Wavy Washer/Snap-Ring Other Retention Device?	none	
25.	Drive End Bearing Condition	failed. complete cage failure.

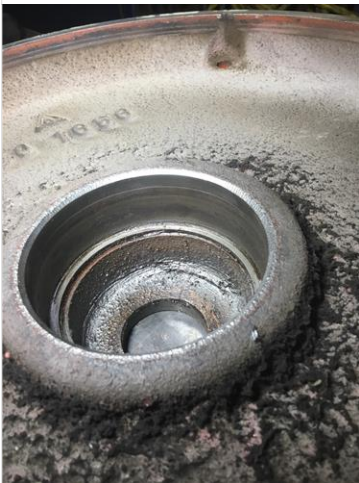
51.	Drive End - Endbell Bearing Fit Condition	(F) Fail

Bad. Lip worn in.

Groove worn in

Sleeve both end bell housing fits

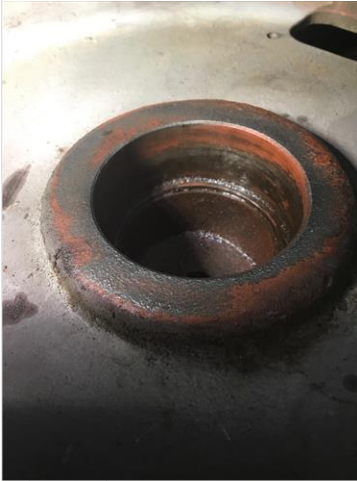
52.	Opposite Drive End - Endbell Bearing Fit		
	0 Degrees	60 Degrees	120 Degrees

Bad

**Pitted**

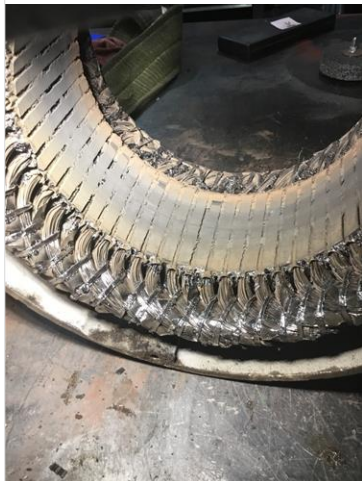
70.	Failure locations		P6
	Windings overloaded.
