## AC Recondition As Found

Sage V Foods

### AC Recondition - Rev. 2

Description: 2.5HP BALDOR 1200RPM 213Z

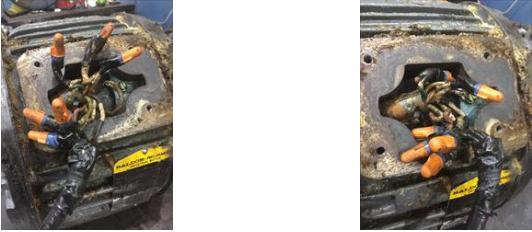
9.	Lead Condition	(F) Fail	P31
	Insulation cracked/brittle

14.	Insulation Resistance/Megger		
15.	Winding Resistance		
	1-2	1-3	2-3
16.	Perform Surge Test	(NA) Not Applicable	
	Lead wire insulation cracked and broken in multiple places.

*Winding leads insulation cracked and brittle showing exposed wire in multiple locations.*

*Lead wire insulation bad.*
