AC Recondition As Found

Almatis Inc/RCP Bauxite (10014)

Description: 50HP MARATHON 1800RPM 326T

Repair Stage: Teardown Inspection

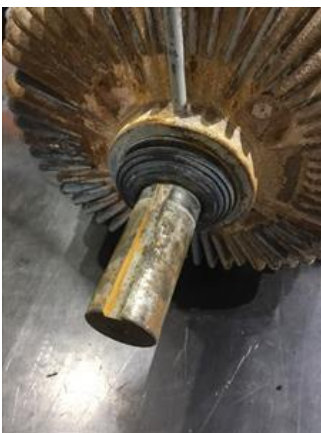
| | 5. Does Shaft Have Visible Damage? | (No) No | P12 |

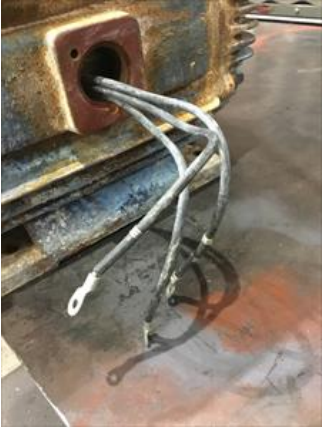
●	9. Lead Condition	(P) Pass	P31

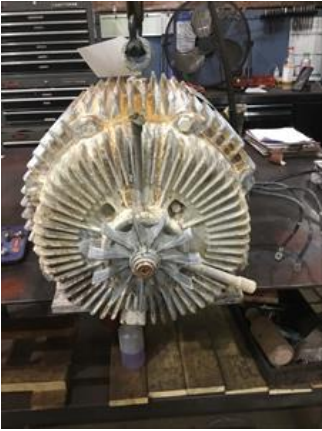
10. Lead Length		13 Inches	
11. Frame Condition		good	P50

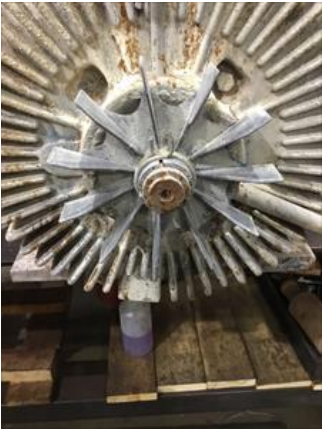
●	12. Fan Condition	(P) Pass	P52

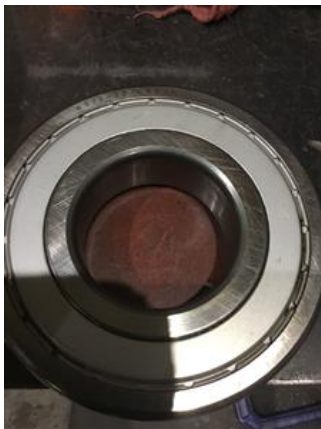
P41

18. Drive End Bearing Number-	6312-2Z/C3
19. Drive End Bearing Qty.	1
20. Drive End Bearing Type	(Ball) Ball Bearing
21. Drive End Lubrication Type	(Grease) Grease Lubricated
22. Drive End Bearing Insulation or Grounding Device?	none
23. Drive End Wavy Washer/Snap-Ring Other Retention Device?	none
24. Drive End Bearing Condition

Bearing grease contaminated

Recondition/bearings

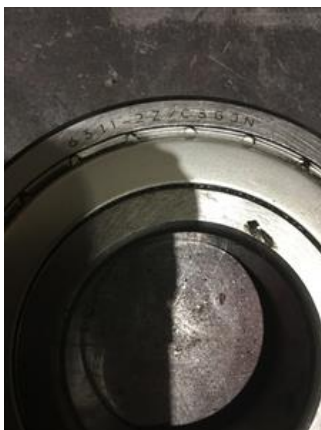
P45

25. Opposite Drive End Bearing Number-

6311/2Z

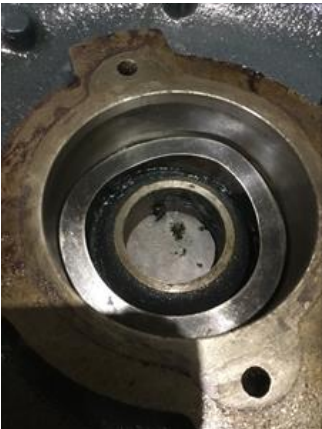
26. Opposite Drive End Bearing Qty.	1	
27. Opposite Drive End Bearing Type	(Ball) Ball Bearing	
28. Opposite Drive End Lubrication Type	(Grease) Grease Lubricated	
29. Opposite Drive End Bearing Insulation or Grounding Device?	none	
30. Opposite Drive End Wavy Washer/Snap-Ring Other Retention Device?	yes	P54

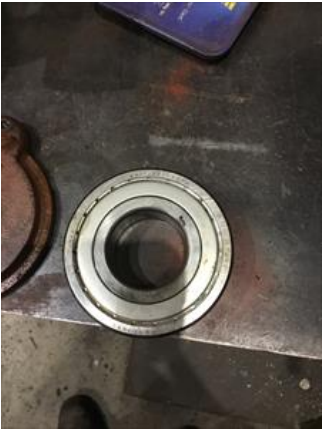
31. Opposite Drive End Bearing Condition		P55

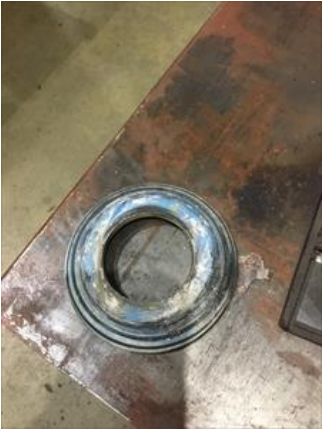
32. Drive End Seal		P57

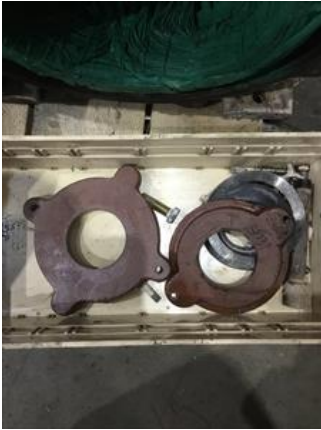
P29

53. Bearing Cap Condition
