Job Information

Job #:	136440			Date:	June 1, 2018	
Priority:	-	Authorized OT:	No	Authorized by:

Name:	Chemours		Reason:	
Contact:		Motor#:		PO#:
Application:	_	Special notes:

Manufacturer:	Siemens	Enclosure :	Open Drop Proof (ODP)	Enclosure Type image
Serial#:	1-5113-38799-1-1	Model#:	· · /	
Service Factor:		Frame:	507us	
Horsepower/kW:	250	Rated RPM:		
Rated Amps:		Rated Voltage:	460	
Phase:	3	Cycles:		
Special design:	No

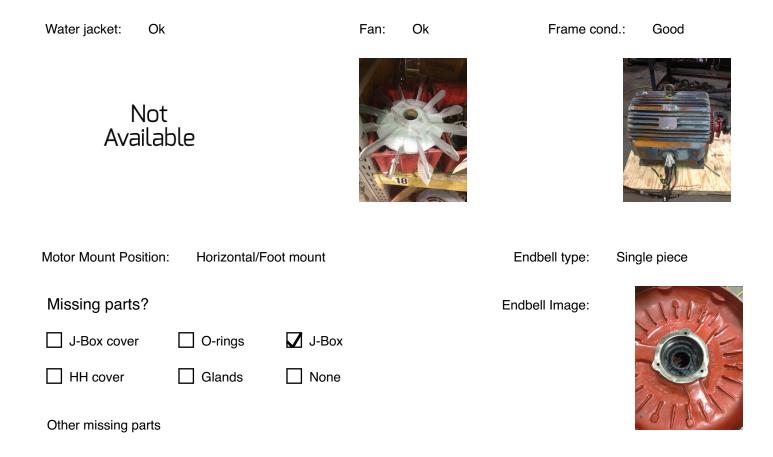
Bushings/sleeves image:

Not Available
