Job Information

Job #:	137188				Date:
Priority:	2	Authorized OT:	No	Authorized by:

Name:	University of Memphis			Reason:	
Contact:	Jake	Motor#:	137188		PO#:
Application:	Direct Drive	Special not	es:

Manufacturer:	Us	Enclosure :	Totally Enclosed Fan Cooled	Enclosure Ty
Serial#:	Co-r900a-m	Model#:	R900a	
Service Factor:	1.15	Frame:	284t	
Horsepower/kW:	25	Rated RPM:	1775	
Rated Amps:	29.2	Rated Voltage:	460	
Phase:	3	Cycles:	3	
Special design:	No

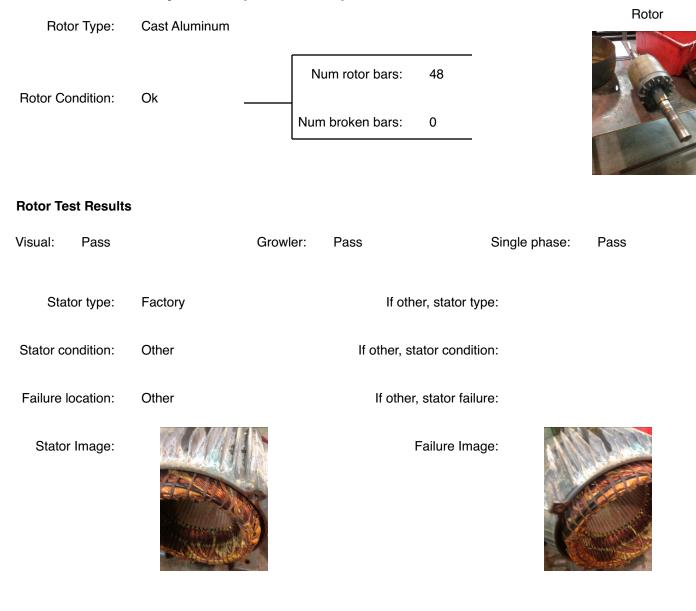
AC Electrical Inspection (Continued)

Number of leads:	3	Terminal Markings:			
Length of leads:	7in	REF: NEMA Stds. MG 1-2009, Rev. 1-2010, 2.41-Terminal Markings Identified By Color:			
Size of leads:	8	1-Blue 2-White 3-Orange	5-Black 6-No color assigned 7-No color assigned	P1-No color assigned P2-Brown	
Lead condition:	Bad	4-Yellow	8-Red		
Lug type:		Connections As Re	ceived:		
Lug Condition:	_		Terminal	Lugs	
Lug size:			N 1 1		
Lug Attachment:	_	Not Not Available Availab

Winding color:	Like new	Winding	g image	Winding Therma	I Protection:	Yes
Winding condition :	Brittle				N	ot
Winding Thermal Protection DE:	_				Avai	ot lable
Winding Thermal Protection ODE:	-					
Stator test results:	Rewind					
Megs incoming: Bad		Surge incoming:	Bad	Hi-pot in	coming: B	ad
Winding Resistance In	coming					
Phase	es A to B	Phases B to C	Phase	es C to A	Resistive imb	balance
Incoming						
Leads/jumpe	ers: Ok		Lead jur	nper Image. :		
If other, leads/jumpe	ers:				No Availa	it able

Water damage winding lots of corrosion spots on windings insulation is dry rotted
