Job Information

Job #:	140003				Date:	June 24, 2019
Priority:	_	Authorized OT:	No	Authorized by:	Terry f

Manufacturer:	Siemens	Enclosure :	Open Drop Proof (ODP)	Enclosure Type image
Serial#:		Model#:	(ODF)	
Service Factor:		Frame:	B449	
Horsepower/kW:	250	Rated RPM:	1185	
Rated Amps:	280	Rated Voltage:	460	
Phase:		Cycles:		
Special design:	No

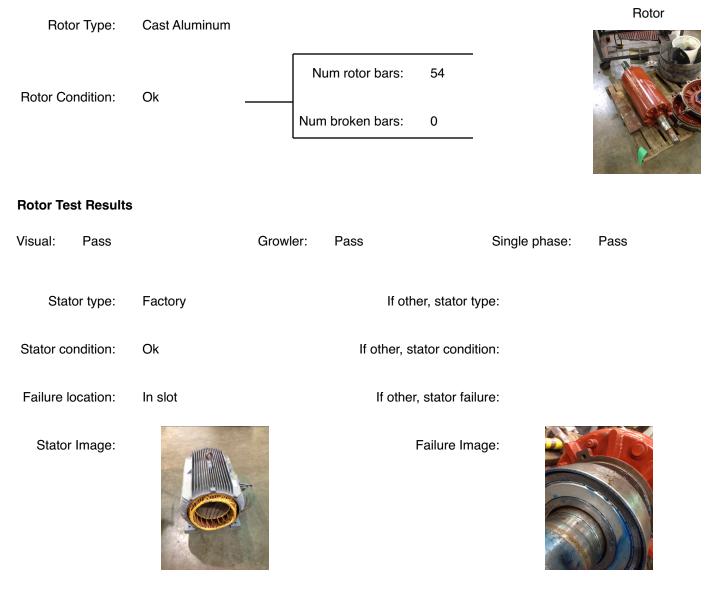
AC Electrical Inspection (Continued)

Short in windings , d.e bearing bushing was to tight locked on bearing spun in end bell

Rewind stator
