## **Job Information**

Job #:	142845				Date:	July 9, 2020
Priority:	_	Authorized OT:	No	Authorized by:

## **Mechanical Inspection**

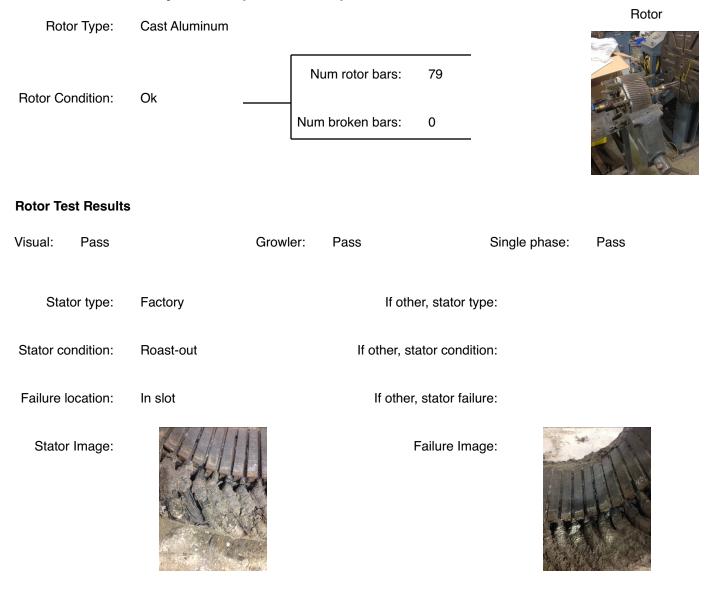
Winding co	olor:	Dull black	Winding	g image	Winding Therma	I Protection:	No
Winding condit	ion :	Charred					NY.
Winding The Protection	rmal DE:	_					
Winding The Protection C		_	2			- Barris	
Stator test res	ults:	Rewind					
Megs incoming:	Bad		Surge incoming:	Bad	Hi-pot in	coming: B	ad
Winding Resista	ance In	coming					
	Phase	es A to B	Phases B to C	Phase	es C to A	Resistive imb	balance
Incoming	3.116	6	13.626	12.3	52	108.00	
Lead If other, lead	s/jumpe s/jumpe			Lead jur	nper Image. :

Winding roasted and full of dirt. Bearing grease charred and dirty
