## **Job Information**

Job #:	94380				Date:	June 22, 2018
Priority:	_	Authorized OT:	No	Authorized by:

Name:	Certainteed		Reason:	
Contact:		Motor#:		PO#:
Application:	_	Special notes:

Manufacturer:	Leeson	Enclosure :	Totally Enclosed Fan Cooled
Serial#:	C447T17FB7C	Model#:	50004
Service Factor:	1.15	Frame:	447T
Horsepower/kW:	200	Rated RPM:	1790
Rated Amps:	22.3	Rated Voltage:	460
Phase:	3	Cycles:	60
Special design:	No

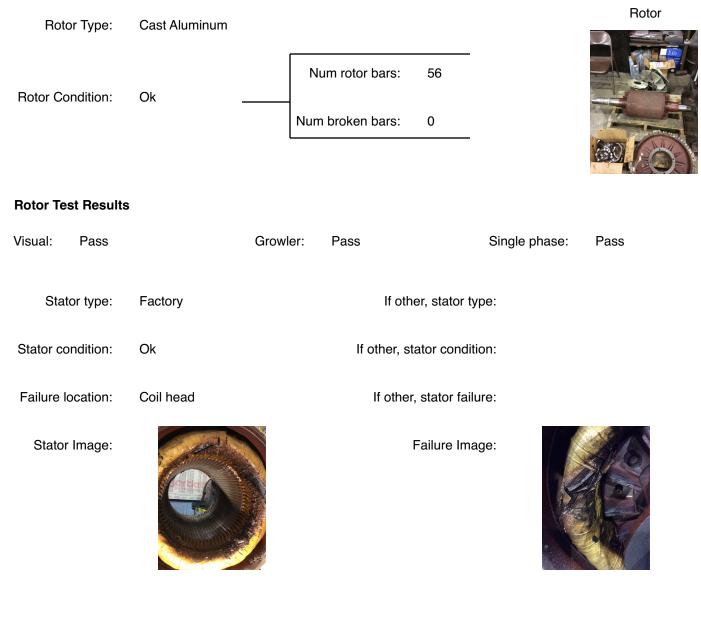
#### **AC Electrical Inspection (Continued)**

Winding color:	Dull black	Winding	g image	Winding Therma	I Protection:	No
Winding condition :	Charred	10			Ser	
Winding Thermal Protection DE:	_					
Winding Thermal Protection ODE:	_				U.	
Stator test results:	Rewind					
Megs incoming: Bad		Surge incoming:	Bad	Hi-pot in	coming: Ba	ad
Winding Resistance In	coming					
Phase	es A to B	Phases B to C	Phase	es C to A	Resistive imb	alance
Incoming						
Leads/jumpe	ers: Replace		Lead jur	nper Image. :		
If other, leads/jumpe	ers:

Windings failed on the coil edge. Also the grease inside the stator was contaminated with dirt particles.
