Job Information

Job #:	94044				Date:	March 9, 2018
Priority:	_	Authorized OT:	No	Authorized by:

Name:	Future Fuel	Reason:		
Contact:		Motor#:		PO#:
Application:	_	Special notes:

Manufacturer:	Reliance	Enclosure :	Weather Protected II (WPII)	Enclos
Serial#:	X337332A3-WF	Model#:		
Service Factor:		Frame:	5008S	the second se
Horsepower/kW:	500	Rated RPM:	3550	
Rated Amps:	115	Rated Voltage:	2300	
Phase:	3	Cycles:	60	
Special design:	No

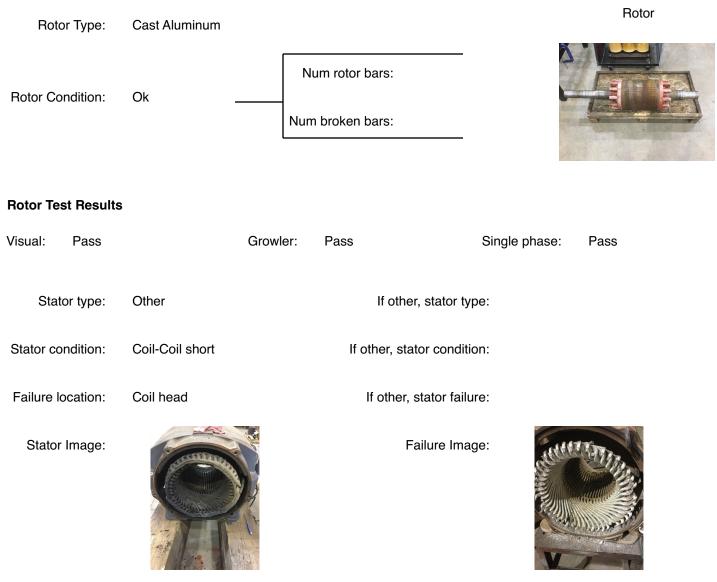
AC Electrical Inspection (Continued)

Winding color:	Dull black	Winding	g image	Winding Therma	I Protection:	No
Winding condition :	Charred				Ν	lot
Winding Thermal Protection DE:	_				Ava	lot ilable
Winding Thermal Protection ODE:	_					
Stator test results:	Rewind					
Megs incoming: Goo	d	Surge incoming:	Bad	Hi-pot in	coming: E	Bad
Winding Resistance In	coming					
Phas	es A to B	Phases B to C	Phase	es C to A	Resistive im	balance
Incoming						
Leads/jump	ers: Ok		Lead jur	mper Image. :		
If other, leads/jump	ers:				Nc Availi	ot able

Windings shorted turn to turn and coil to coil at appropriately 7:00 location and at the outer edge of the end turn
